**Assessment and Design Report
Soil-Cement Condition Assessment and Design Project
Manatee Plant Cooling Pond Dam
Parrish, Florida
Project Number 300906**

To: Mr. Lewis Rounds, P.E.
FPL Manatee Plant

Date: June 2015

From: Jeff Beriswill
Amec Foster Wheeler Environment & Infrastructure, Inc.

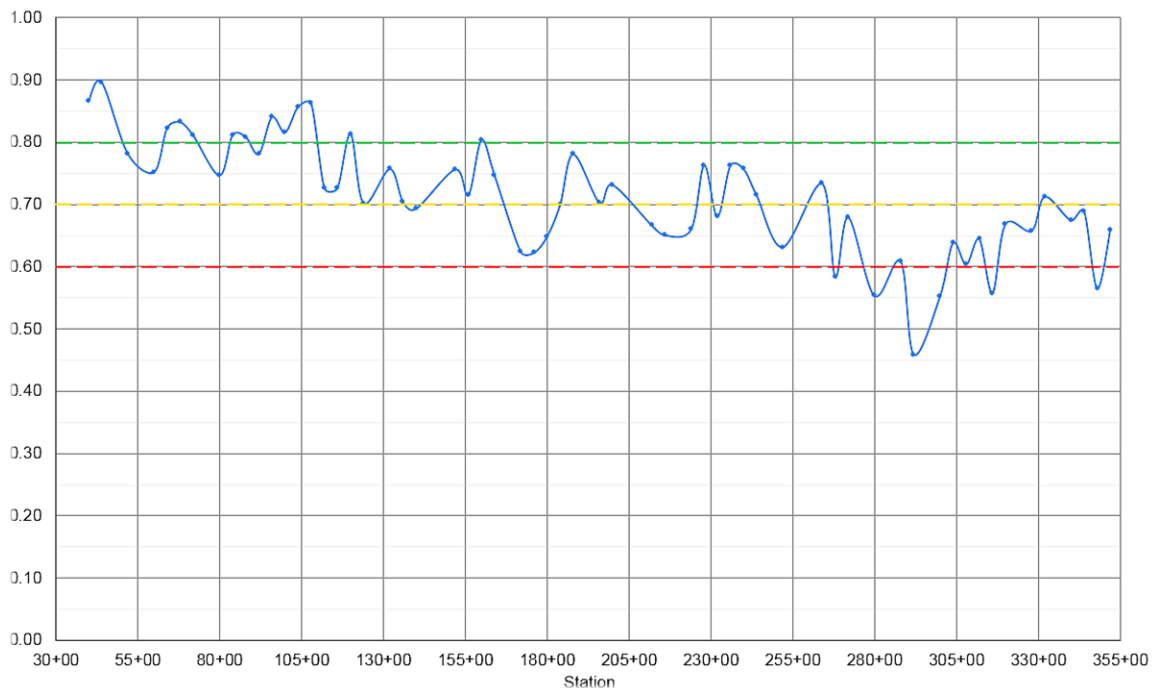
Figure ES-2
Condition Assessment Factor Profile

high wind energy during significant storm events are considered to be important contributing factors in the function of the soil-cement. Using the above influence factors, a profile of the resulting Condition Assessment Factors (CAFs) along the embankment alignment is provided on **Figure ES-2**. A CAF below 0.6 is considered to be a value at which the soil-cement should be repaired. The CAFs generally match the historical observations of the FPL dam inspection personnel.

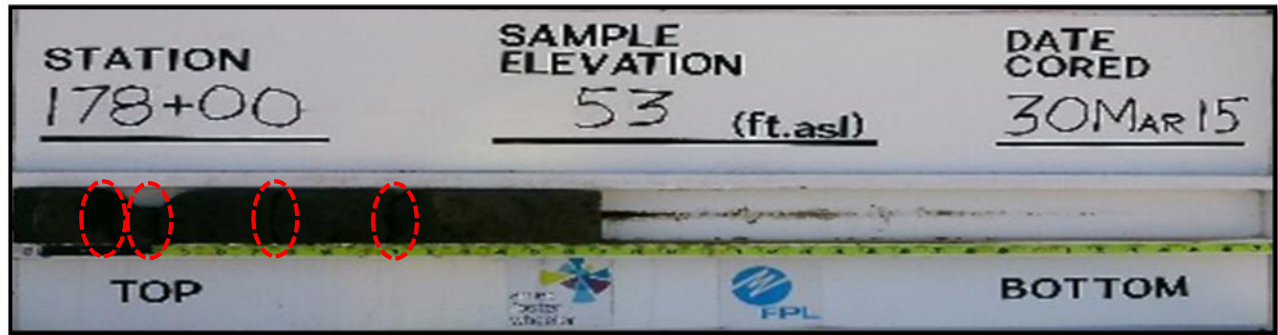
Location: STA 178+00

Core ID:	178+00 (bottom)	Date Cored:	3/30/15
Core Elevation:	53' ASL	Date Photographed:	3/30/15
Recovered Length (ft):	1.65	SC Thickness (ft):	2.0
RQD (%):	36	Void Depth (ft):	N/A
Notes:	Soft material from 0 to 0.3 and from 0.45 to 1.65 feet. Very soft material from 0.3 to 0.45 feet. Broken and fractured core pieces recovered from 0.3 to 0.45 feet.

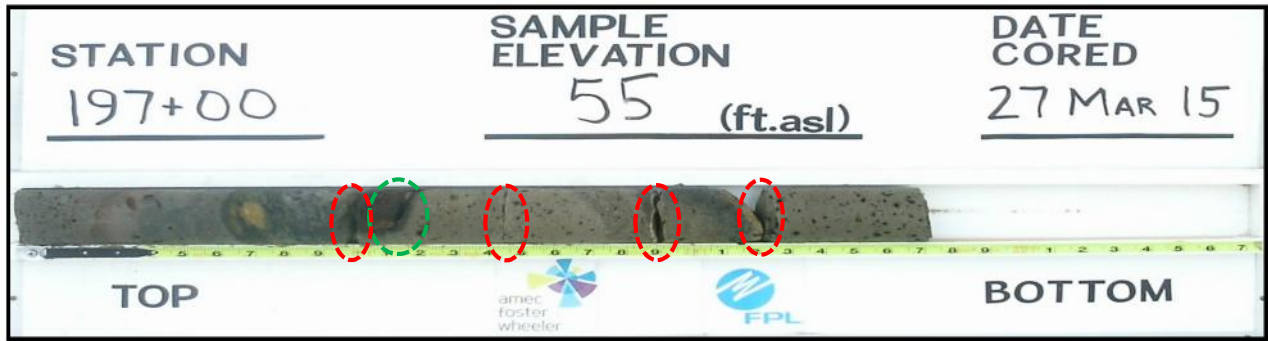
Location: STA 197+00

Core ID:	197+00 (bottom)	Date Cored:	3/27/15
Core Elevation:	55' ASL	Date Photographed:	3/27/15
Recovered Length (ft):	2.7	SC Thickness (ft):	3.0
RQD (%):	92	Void Depth (ft):	N/A
Notes:	Decaying vegetation at 1.05 feet.

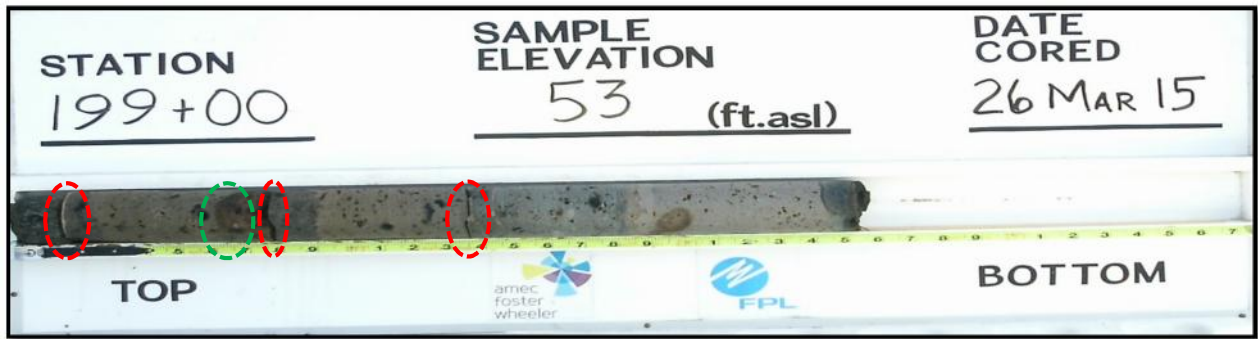
Location: STA 199+00

Core ID:	199+00 (bottom)	Date Cored:	3/26/15
Core Elevation:	53' ASL	Date Photographed:	3/26/15
Recovered Length (ft):	2.5	SC Thickness (ft):	2.92
RQD (%):	92	Void Depth (ft):	N/A
Notes:	Very soft material from 0 to 0.2 feet. Decaying vegetation at 0.65 feet.

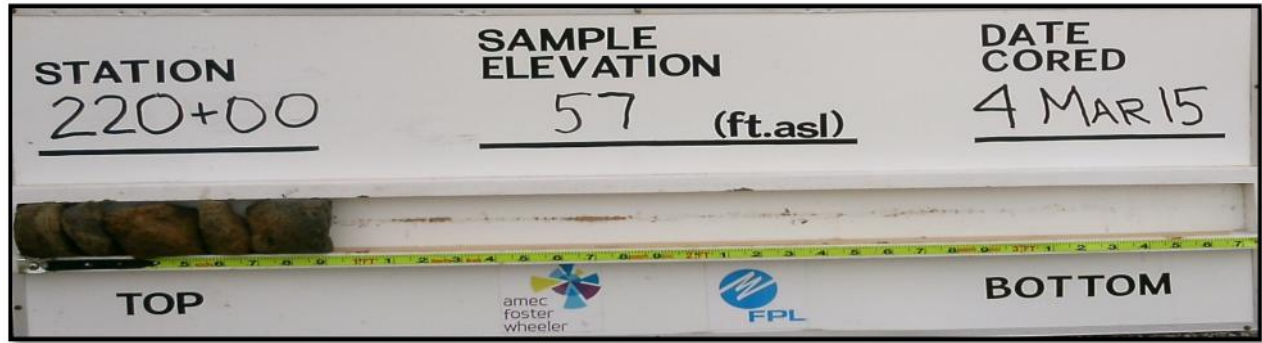
Location: STA 220+00

Core ID:	220+00 (bottom)	Date Cored:	3/4/15
Core Elevation:	57' ASL	Date Photographed:	3/4/15
Recovered Length (ft):	0.9	SC Thickness (ft):	2.5
RQD (%):	0	Void Depth (ft):	N/A
Notes:	Recovered sample very soft and friable. Unable to determine breaks and fractures.

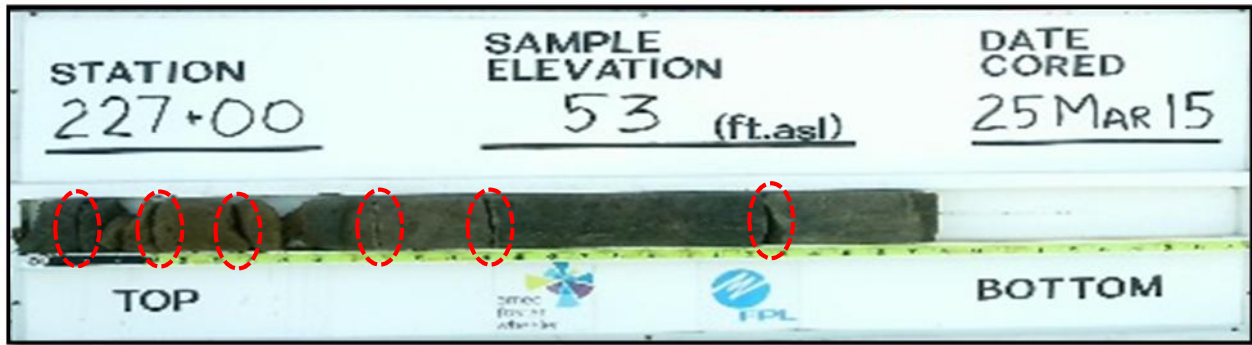
Location: STA 227+00

Core ID:	227+00 (bottom)	Date Cored:	3/25/15
Core Elevation:	53' ASL	Date Photographed:	3/25/15
Recovered Length (ft):	2.75	SC Thickness (ft):	2.75
RQD (%):	100	Void Depth (ft):	N/A
Notes:	Very soft material from 0 to 0.85 feet. Broken pieces from 0.2 to 0.45 and from 0.65 to 0.85 feet.

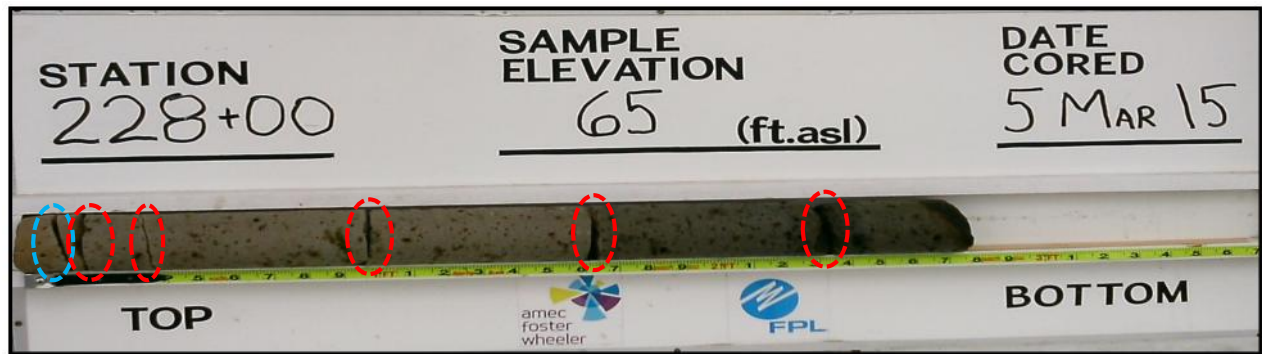
Location: STA 228+00

Core ID:	228+00 (top)	Date Cored:	3/5/15
Core Elevation:	65' ASL	Date Photographed:	3/5/15
Recovered Length (ft):	2.7	SC Thickness (ft):	2.7
RQD (%):	98	Void Depth (ft):	N/A
Notes:	Soft material from 0 to 0.2 feet.

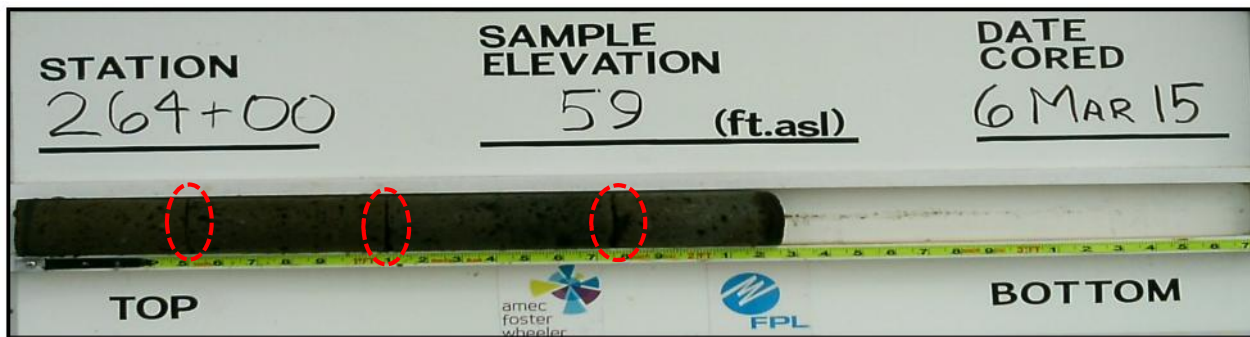
Location: STA 264+00

Core ID:	264+00 (middle)	Date Cored:	3/6/15
Core Elevation:	59' ASL	Date Photographed:	3/6/15
Recovered Length (ft):	2.25	SC Thickness (ft):	2.3
RQD (%):	100	Void Depth (ft):	N/A
Notes:	Pitting noted on the exterior of the core only.

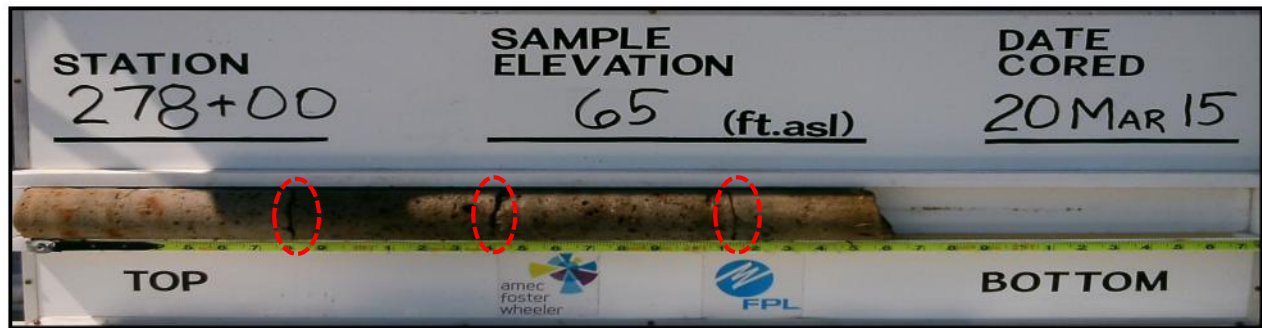
Location: STA 278+00

Core ID:	278+00 (top)	Date Cored:	3/20/15
Core Elevation:	65' ASL	Date Photographed:	3/20/15
Recovered Length (ft):	2.55	SC Thickness (ft):	2.58
RQD (%):	100	Void Depth (ft):	N/A
Notes:	Soft material from 0 to 0.1 feet. Fractured pieces from 1.9 to 2.45 feet.

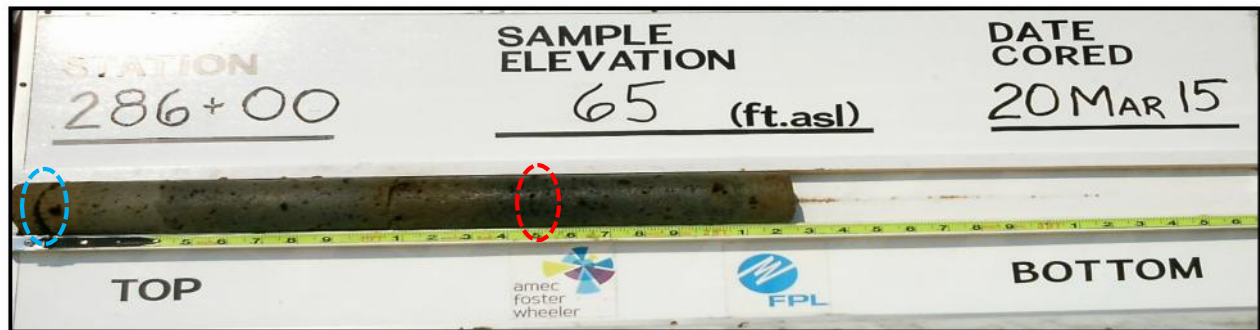
Location: STA 286+00

Core ID:	286+00 (top)	Date Cored:	3/20/15
Core Elevation:	65' ASL	Date Photographed:	3/20/15
Recovered Length (ft):	2.2	SC Thickness (ft):	2.25
RQD (%):	99	Void Depth (ft):	N/A
Notes:	Very soft material from 0 to 0.2 feet.

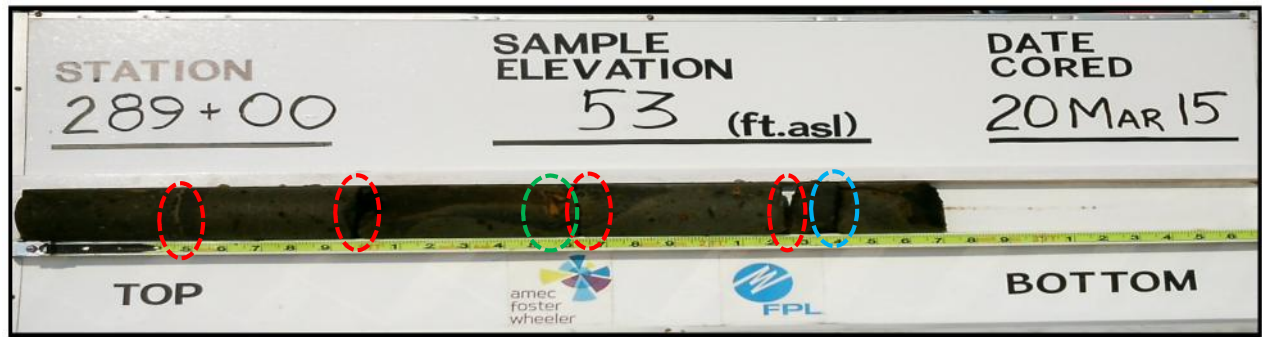
Location: STA 289+00

Core ID:	289+00 (bottom)	Date Cored:	3/20/15
Core Elevation:	53' ASL	Date Photographed:	3/20/15
Recovered Length (ft):	2.7	SC Thickness (ft):	3.0
RQD (%):	75	Void Depth (ft):	N/A
Notes:	Entire core sample comprised of soft material. Lateral fracture from 0.97 to 1.3 feet and from 2.35 to 2.7 feet. Woods parts at 1.55 feet.

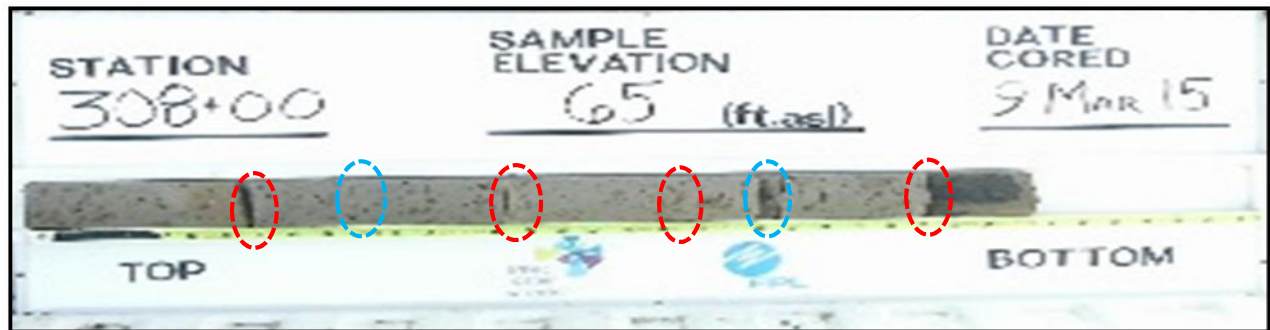
Location: STA 308+00

Core ID:	308+00 (top)	Date Cored:	3/9/15
Core Elevation:	65' ASL	Date Photographed:	3/9/15
Recovered Length (ft):	3.0	SC Thickness (ft):	3.0
RQD (%):	85	Void Depth (ft):	N/A
Notes:	Soft material from 2.67 to 3.0 feet.

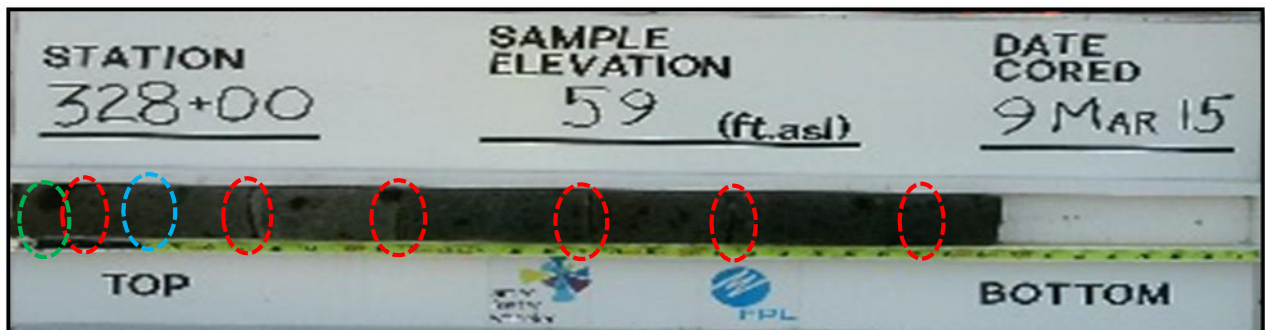
Location: STA 328+00

Core ID:	328+00 (middle)	Date Cored:	3/9/15
Core Elevation:	59' ASL	Date Photographed:	3/9/15
Recovered Length (ft):	2.9	SC Thickness (ft):	3.0
RQD (%):	76	Void Depth (ft):	N/A
Notes:	Overall condition of core heavily and deeply pitted on the exterior only. Voids left from decayed wood at 0.1 and 2.5 feet.

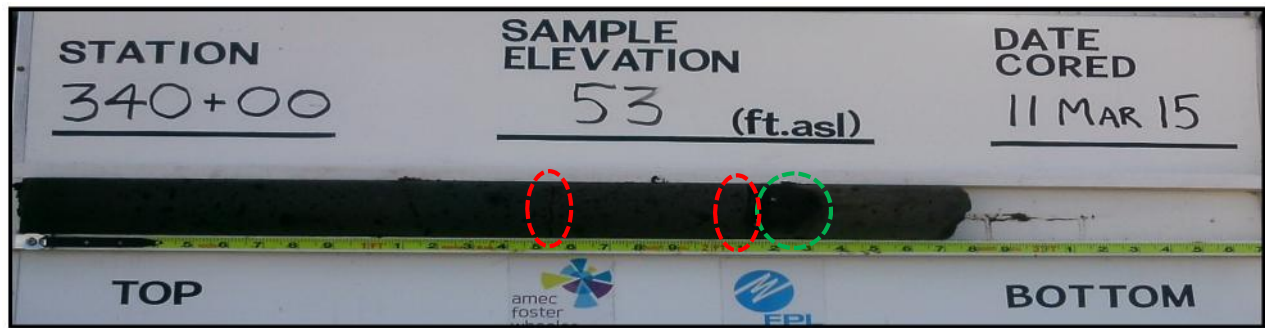
Location: STA 340+00

Core ID:	340+00 (bottom)	Date Cored:	3/11/15
Core Elevation:	53' ASL	Date Photographed:	3/11/15
Recovered Length (ft):	2.7	SC Thickness (ft):	2.9
RQD (%):	100	Void Depth (ft):	N/A
Notes:	Decaying wood from 2.1 to 2.3 feet.

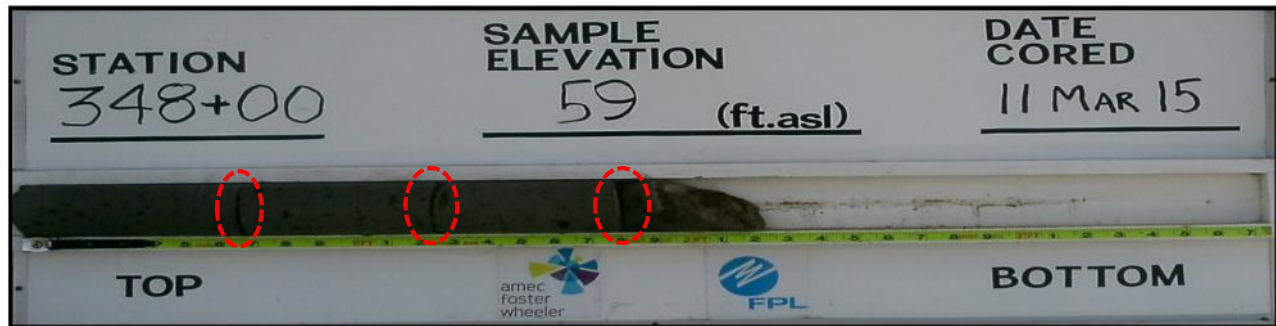
Location: STA 348+00

Core ID:	348+00 (middle)	Date Cored:	3/11/15
Core Elevation:	59' ASL	Date Photographed:	3/11/15
Recovered Length (ft):	2.2	SC Thickness (ft):	3.16
RQD (%):	82	Void Depth (ft):	N/A
Notes:	Fractured pieces between 1.8 and 2.2 feet.

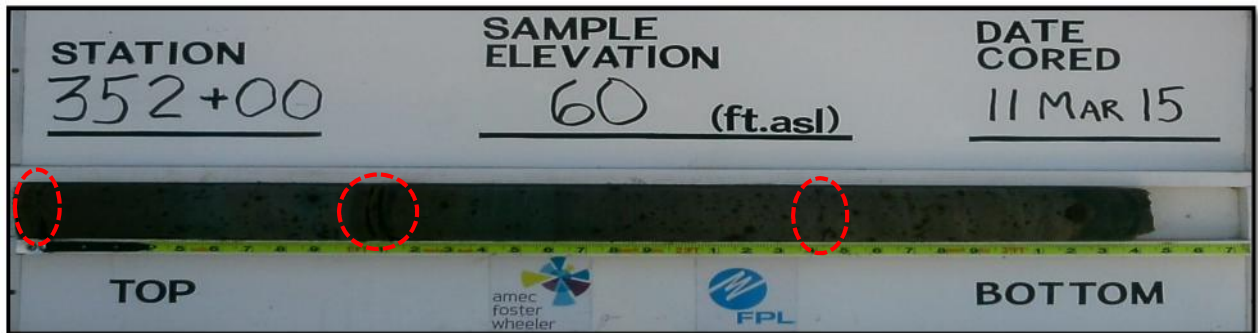
Location: STA 352+00

Core ID:	352+00 (middle)	Date Cored:	3/11/15
Core Elevation:	60' ASL	Date Photographed:	3/11/15
Recovered Length (ft):	3.4	SC Thickness (ft):	3.58
RQD (%):	99	Void Depth (ft):	N/A
Notes:	Soft material from 0 to 0.1 feet. Soft fill material between 1.05 and 1.1 feet.
