**Assessment and Design Report
Soil-Cement Condition Assessment and Design Project
Manatee Plant Cooling Pond Dam
Parrish, Florida
Project Number 300906**

To: Mr. Lewis Rounds, P.E.
FPL Manatee Plant

Date: June 2015

From: Jeff Beriswill
Amec Foster Wheeler Environment & Infrastructure, Inc.

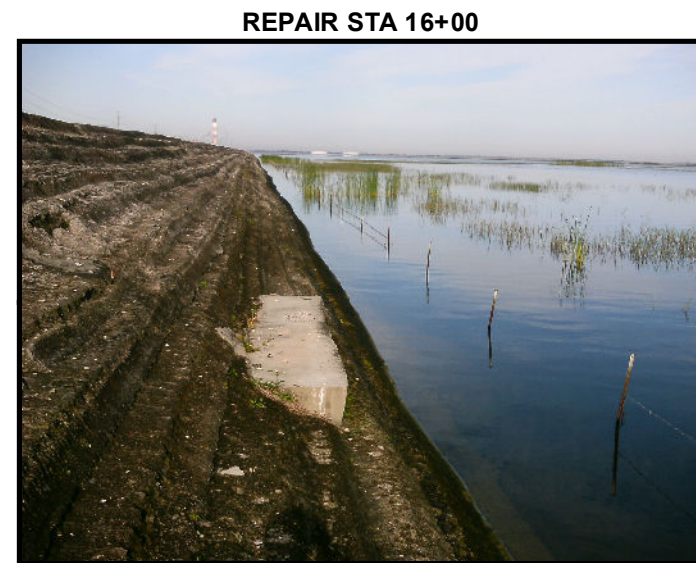
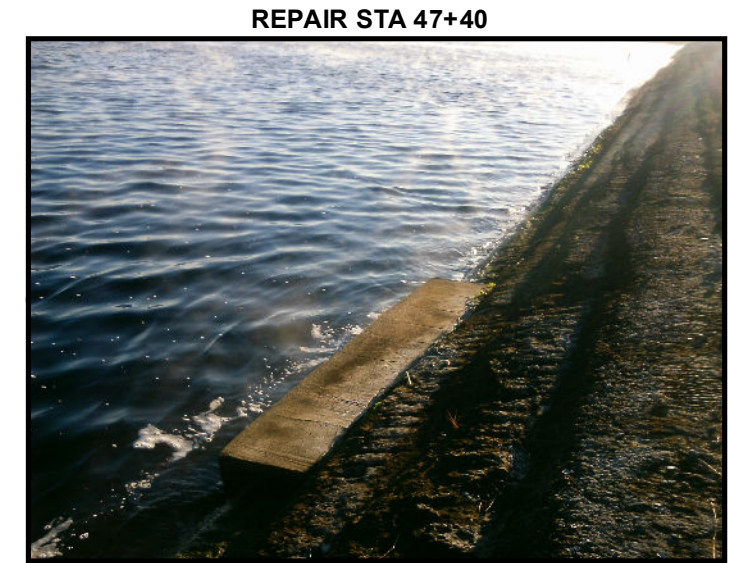
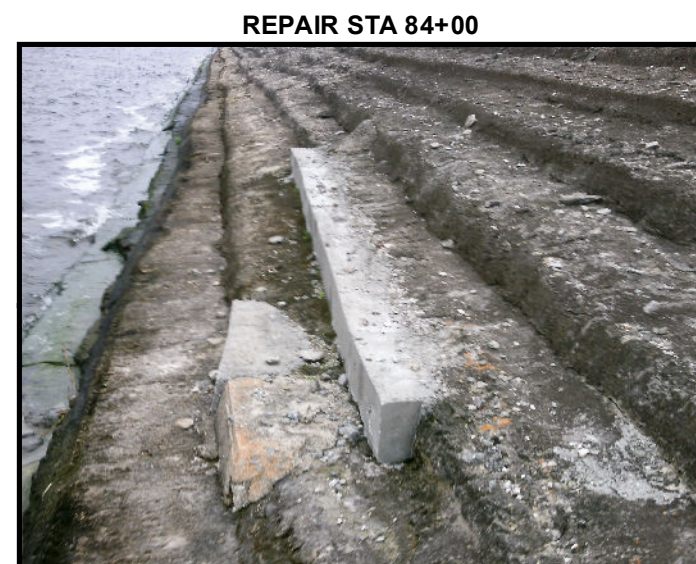
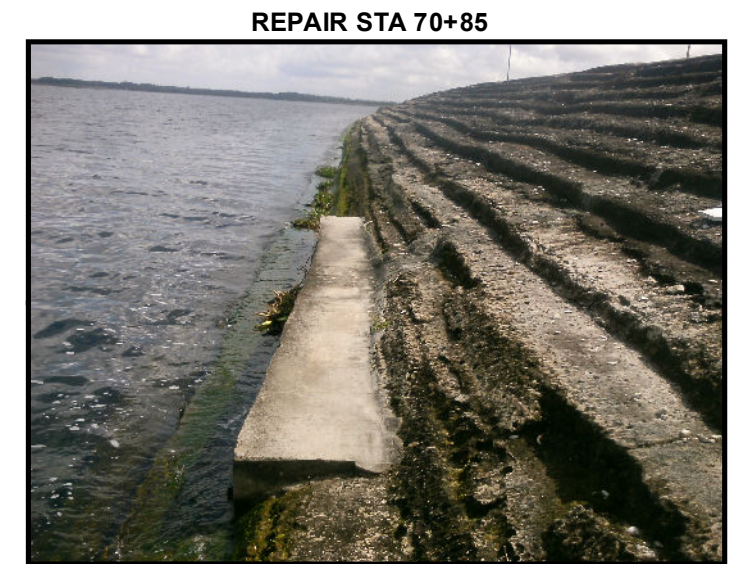
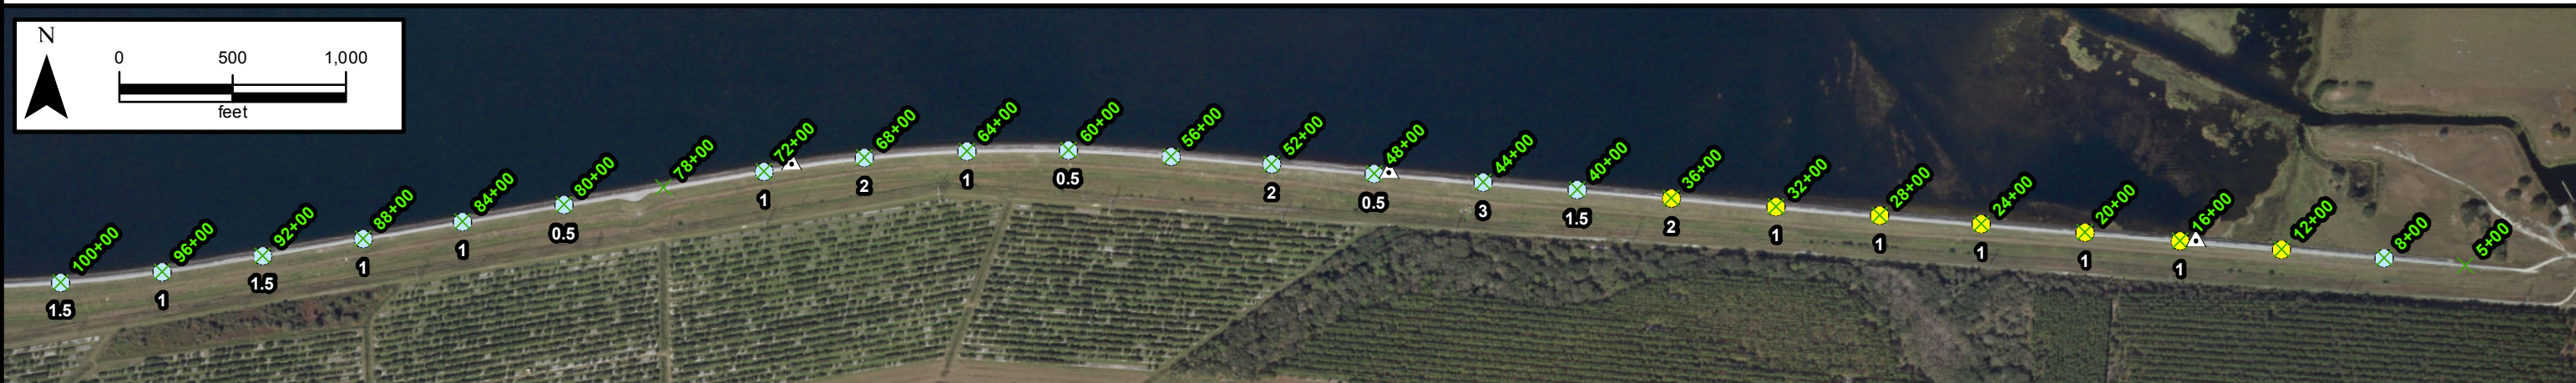
Figure 2A
Summary Plan of Visual Inspections
Stations 5+00 to 100+00
Manatee Plant Cooling Pond
Manatee County, Florida

STA	Visual Inspection								
	Typical Transvers Crack Spacing (ft)	Typical Transvers Crack Width (in)	# of Soft Steps	# of Moderate Steps	# of Hard Steps	# of Eroded Steps	Pitting Observed	Vegetation Observed	Repairs Observed
5+69			0	1	4	1	No	No	No
8+00			3	1	3	2	Yes	Yes	No
12+00			5	3	3	5	Yes	Yes	No
16+00	15	1	5	4	4	8	Yes	Yes	Yes
20+00	20	1	5	6	2	6	Yes	Yes	No
24+00	20	1	3	7	3	5	Yes	Yes	No
28+00	15	1	4	6	3	5	Yes	Yes	No
32+00	15	1	4	7	3	6	Yes	Yes	No
36+00	20	2	5	6	2	5	Yes	Yes	No
40+00	17	1.5	0	2	8	3	Yes	No	No
44+00	18	3	1	4	4	0	Yes	No	No
48+00	11	0.5	5	4	2	3	Yes	Yes	No
52+00	14	2	1	2	9	3	Yes	Yes	No
56+00			1	1	11	1	Yes	No	No
60+00	20	0.5	1	1	10	3	Yes	No	No
64+00	25	1	1	2	9	4	No	Yes	No
65+00						1			No
68+00	19	2	0	2	11	3	Yes	Yes	No
70+85									Yes
72+00	18	1	0	3	10	2	Yes	Yes	No
76+00			0	0	12	1	No	No	No
80+00	10	0.5	0	2	9	3	Yes	No	No
84+00	20	1	0	1	10	1	No	No	Yes
88+00	14	1	0	3	8	2	Yes	Yes	No
92+00	12	1.5	1	1	9	2	No	No	No

96+00	12	1	0	3	8	0	Yes	No	No
100+00	20	1.5	2	1	8	3	Yes	No	No

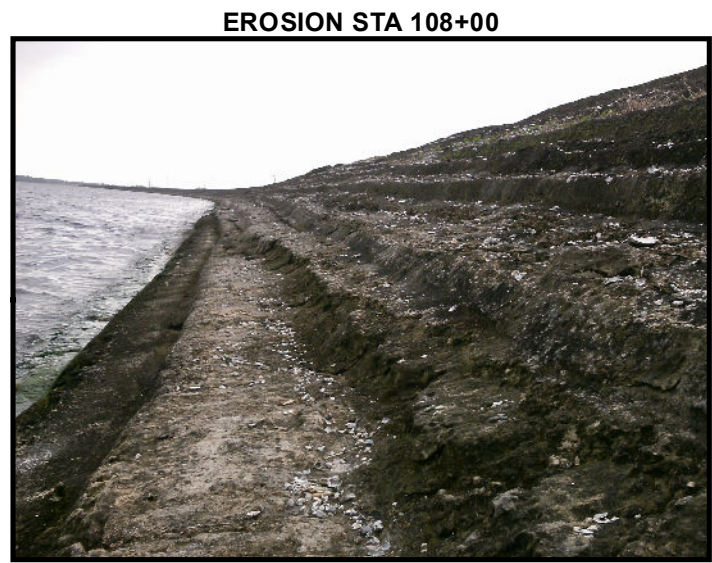
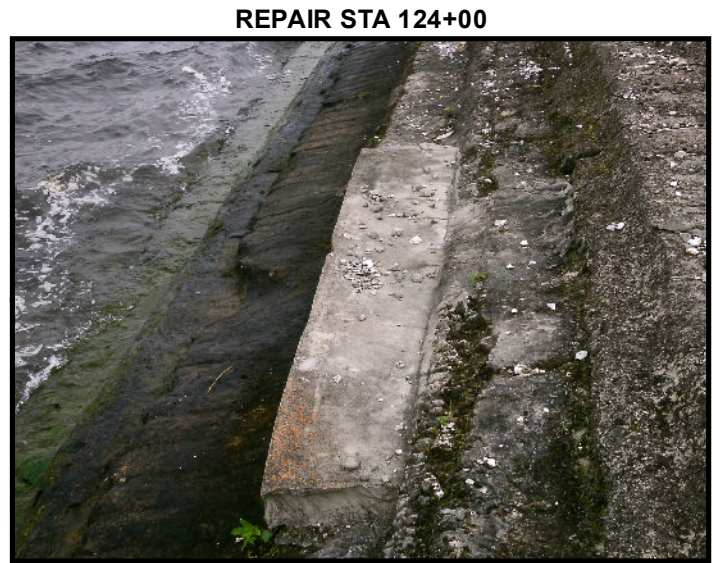
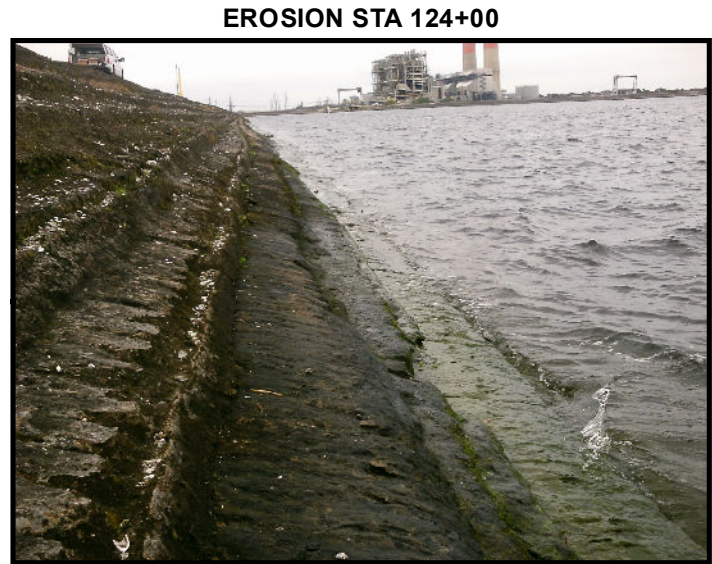
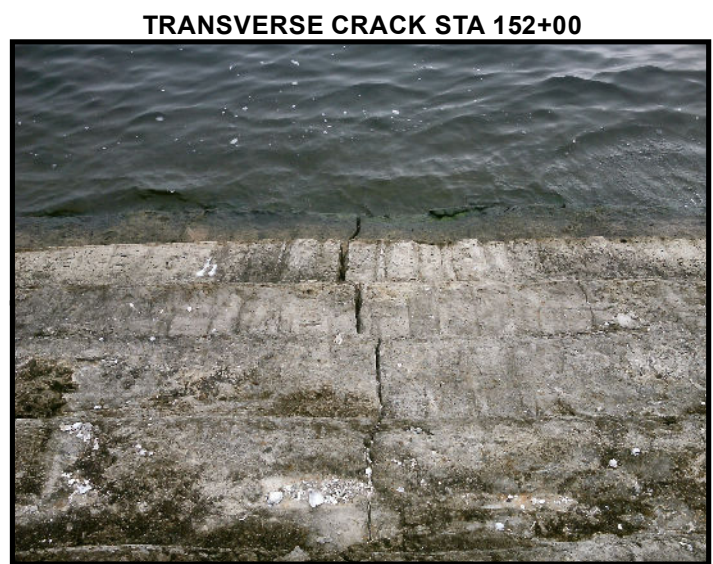
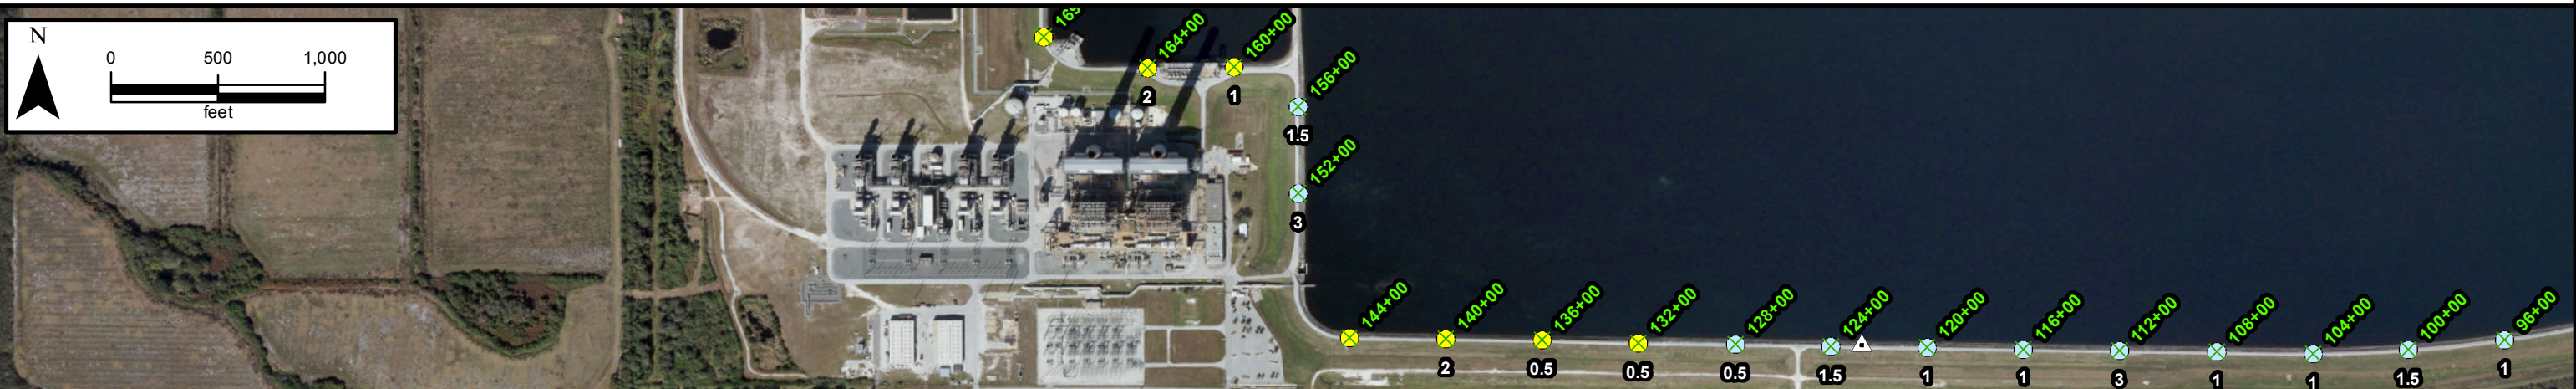
Figure 2B
Summary Plan of Visual Inspections
Stations 100+00 to 164+00
Manatee Plant Cooling Pond
Manatee County, Florida

STA	Visual Inspection								
	Typical Transvers Crack Spacing (ft)	Typical Transvers Crack Width (in)	# of Soft Steps	# of Moderate Steps	# of Hard Steps	# of Eroded Steps	Pitting Observed	Vegetation Observed	Repairs Observed
100+00	20	1.5	2	1	8	3	Yes	No	No
104+00	20	1	3	1	6	2	No	No	No
108+00	20	1	1	3	6	2	Yes	Yes	No
112+00	10	3	1	3	6	2	Yes	No	No
116+00	10	1	4	2	5	4	Yes	Yes	No
120+00	10	1	7	6	1	4	Yes	No	No
122+80									Yes
124+00	12	1.5	1	3	7	4	Yes	Yes	No
128+00	10	0.5	4	2	5	3	Yes	Yes	No
132+00	15	0.5	5	3	2	5	Yes	Yes	Yes
136+00	12	0.5	7	2	2	8	Yes	Yes	No
137+25							Yes		
139+00							Yes		
140+00	15	2	6	1	5	7	Yes	Yes	No
144+00			4	1	7	7	Yes	Yes	No
148+00		0.5	0	0	13	2	Yes	No	No
152+00	10	3	0	1	12	2	Yes	No	No
155+00							Yes		No
155+20									Yes
156+00	12	1.5	0	1	12	4	Yes	No	Yes
160+00	20	1	0	0	13	6	Yes	Yes	No
164+00	20	2	2	7	2	8	Yes	No	No

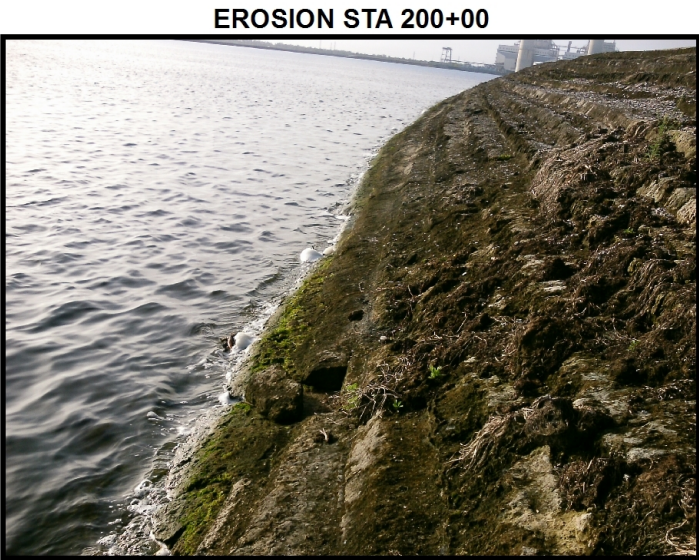
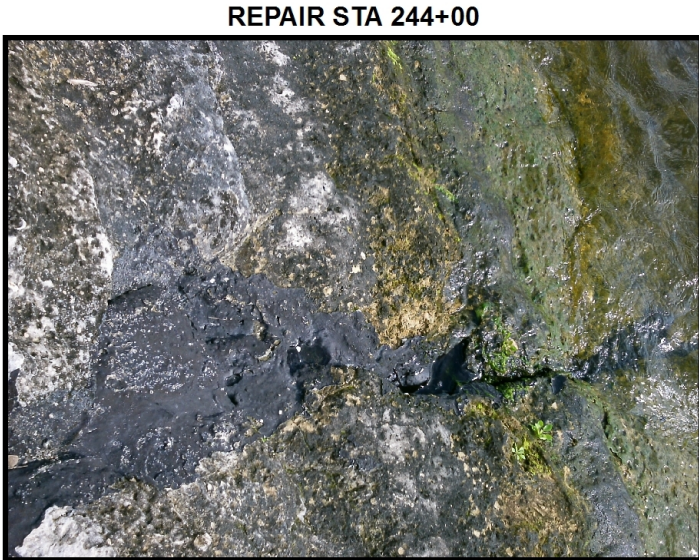
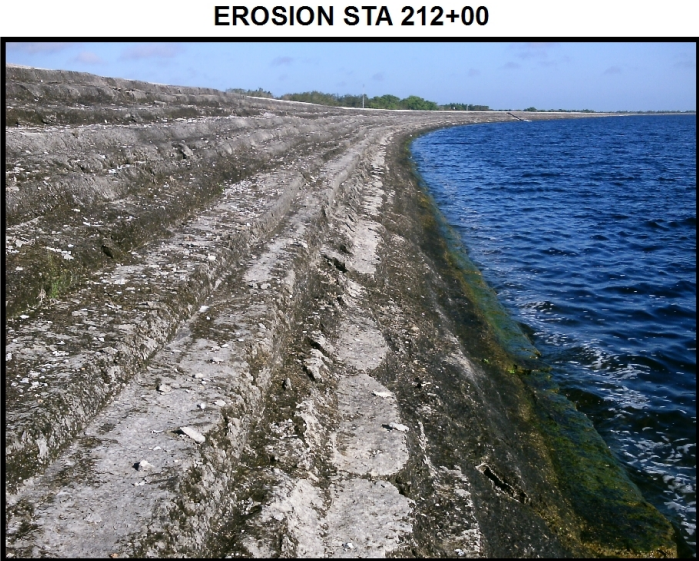
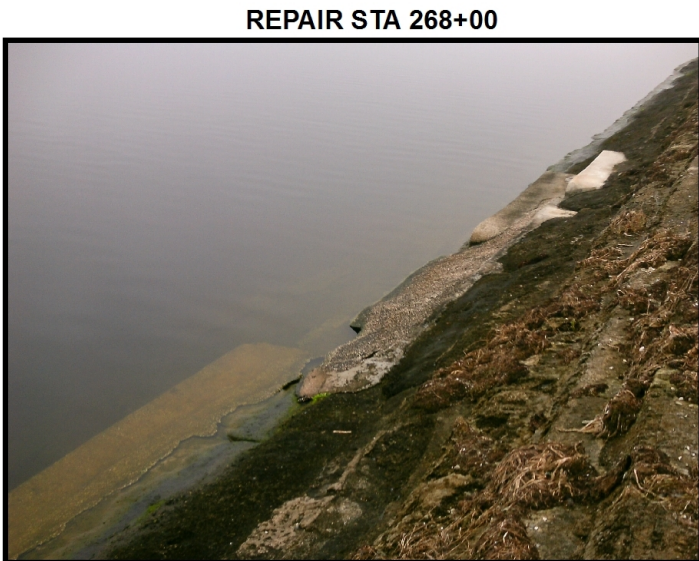
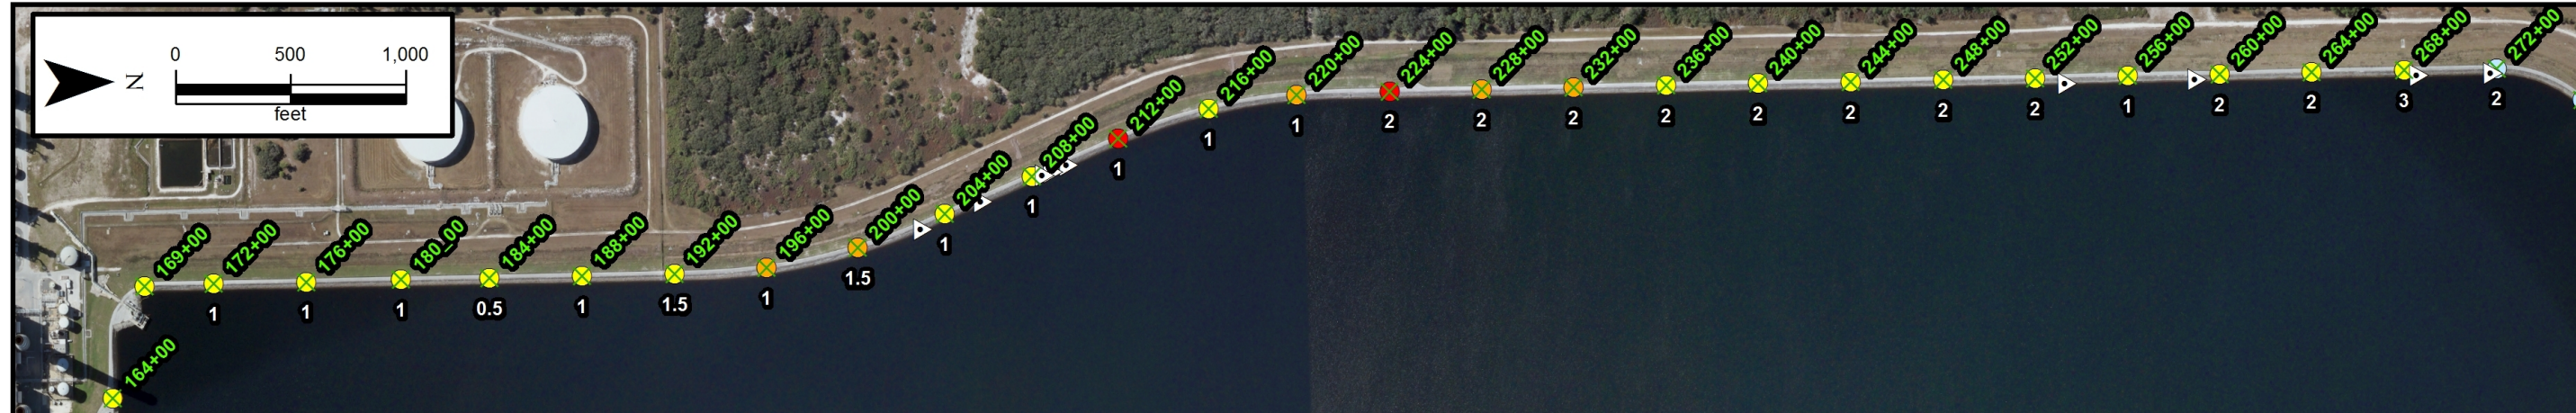
Figure 2C
Summary Plan of Visual Inspections
Stations 164+00 to 272+00
Manatee Plant Cooling Pond
Manatee County, Florida

STA	Visual Inspection								
	Typical Transvers Crack Spacing (ft)	Typical Transvers Crack Width (in)	# of Soft Steps	# of Moderate Steps	# of Hard Steps	# of Eroded Steps	Pitting Observed	Vegetation Observed	Repairs Observed
164+00	20	2	2	7	2	8	Yes	No	No
169+00			3	8	1	8	Yes	Yes	No
172+00	20	1	8	2	2	6	Yes	Yes	No
176+00	15	1	9	0	3	8	Yes	Yes	No
180+00	10	1	9	3	0	6	Yes	Yes	No
184+00	10	0.5	11	2	0	8	Yes	Yes	No
188+00	15	1	6	3	3	7	Yes	Yes	No
192+00		1.5	4	5	3	8	Yes	Yes	No
196+00	15	1	5	3	4	12	Yes	No	No
200+00	30	1.5	4	6	2	12	Yes	Yes	Yes
203+00									Yes
204+00	20	1	7	3	3	8	Yes	Yes	No
205+75									Yes
208+00	20	1	7	3	3	8	No	No	No
212+00	12	1	5	6	2	13	Yes	Yes	No
216+00	15	1	4	5	4	7	Yes	Yes	No
220+00	15	1	6	4	3	10	Yes	Yes	No
224+00	10	2	5	6	2	13	Yes	No	No
228+00	15	2	6	5	2	12	Yes	Yes	No
232+00	15	2	3	7	3	12	Yes	Yes	No
236+00	12	2	4	7	2	6	Yes	Yes	No
240+00	12	2	4	6	3	6	Yes	No	No
244+00	10	2	5	4	4	6	Yes	No	No
248+00	10	2	4	3	5	5	Yes	Yes	No

252+00	15	2	4	4	5	6	Yes	Yes	No
253+35									Yes
256+00	15	1	3	3	7	5	Yes	Yes	No
259+25									Yes
260+00	20	2	2	6	4	8	Yes	No	No
264+00	20	2	3	6	4	5	Yes	No	No
268+00	10	3	4	6	3	5	Yes	No	No
268+60									Yes
272+00	20	2	4	4	5	4	Yes	Yes	No

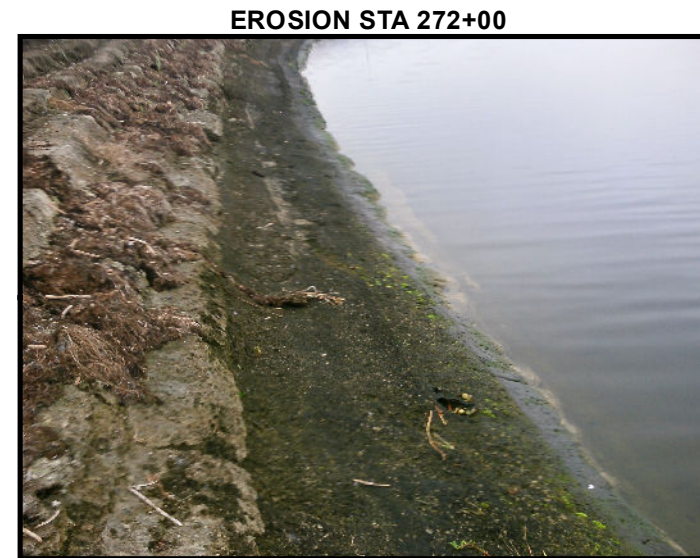
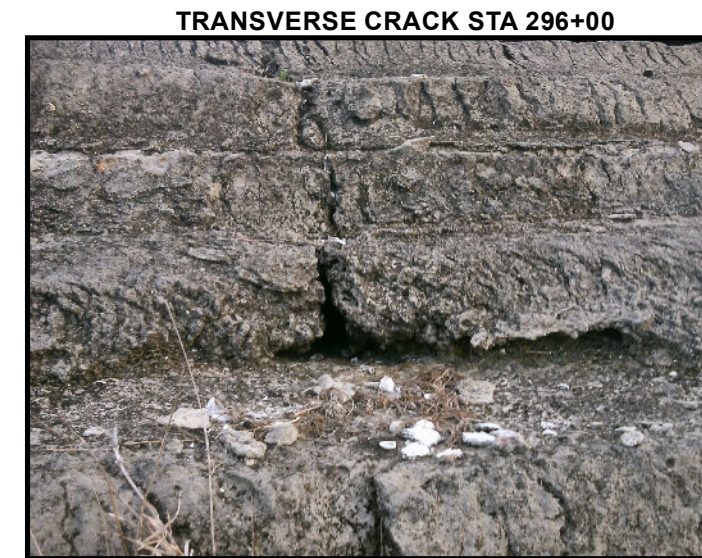
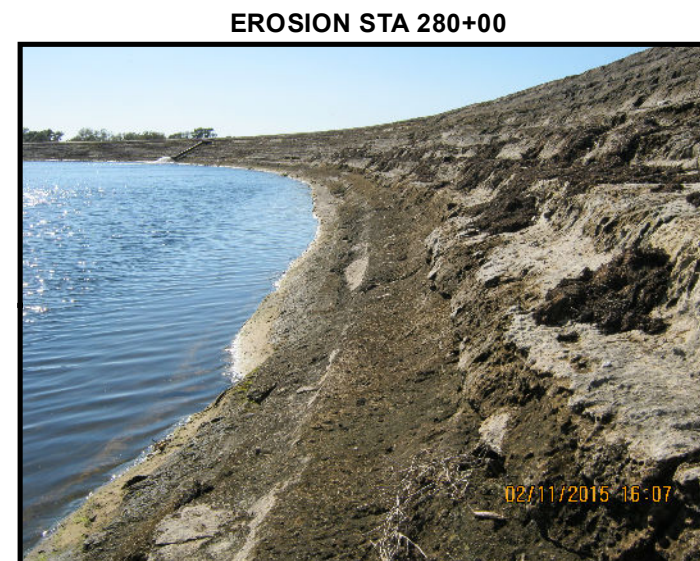
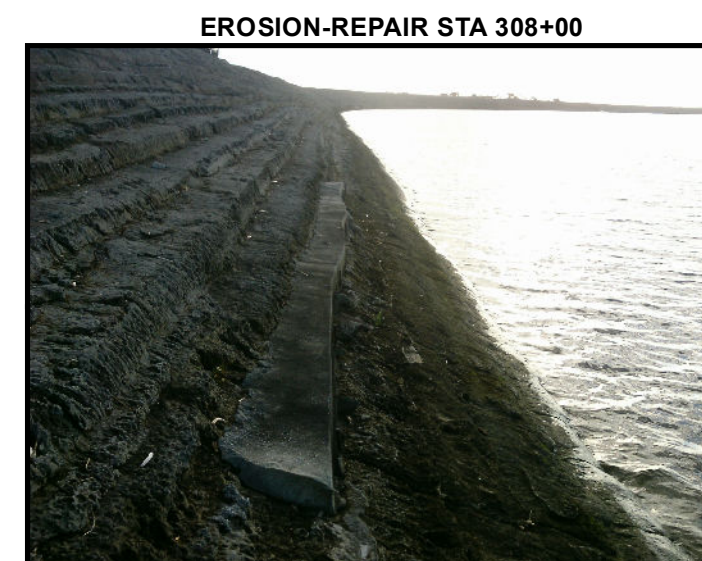
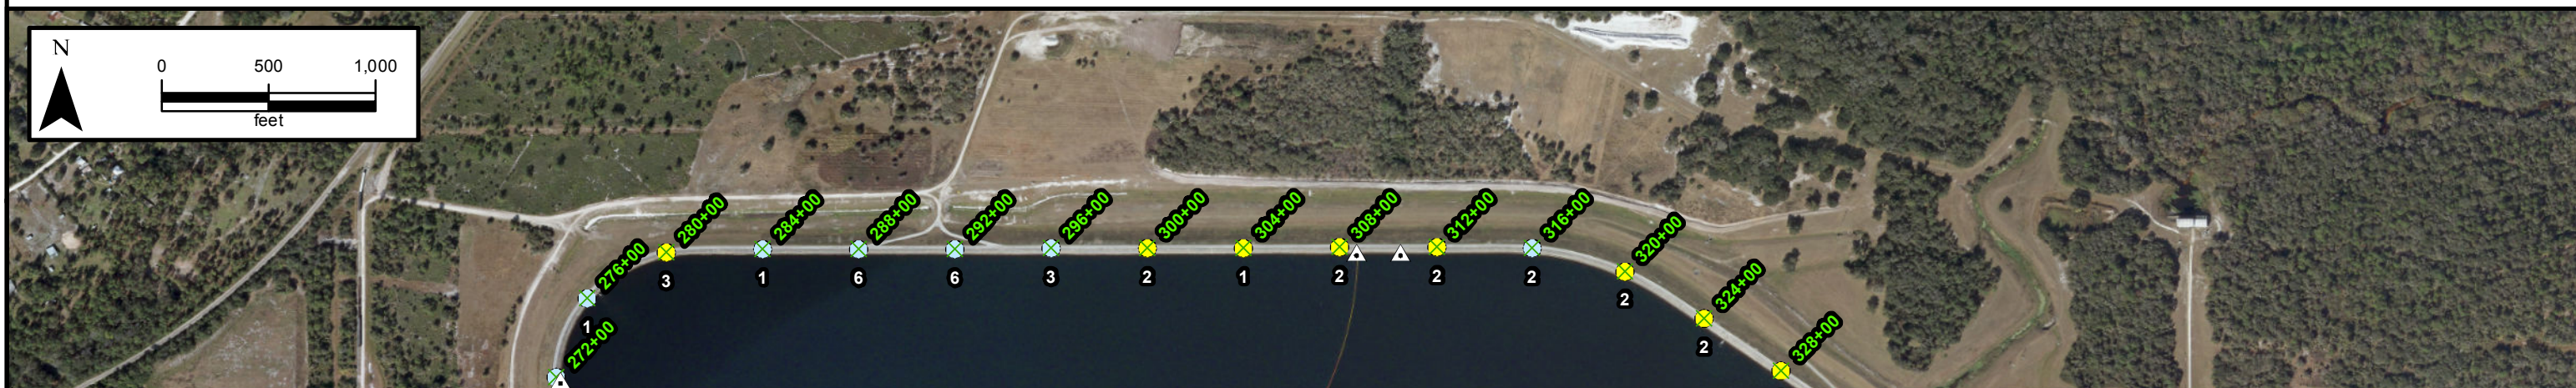
Figure 2D
Summary Plan of Visual Inspections
Stations 272+00 to 328+00
Manatee Plant Cooling Pond
Manatee County, Florida

STA	Visual Inspection								
	Typical Transvers Crack Spacing (ft)	Typical Transvers Crack Width (in)	# of Soft Steps	# of Moderate Steps	# of Hard Steps	# of Eroded Steps	Pitting Observed	Vegetation Observed	Repairs Observed
272+00	20	2	4	4	5	4	Yes	Yes	No
276+00	20	1	3	4	6	4	Yes	No	No
280+00	20	3	7	5	1	6	Yes	Yes	No
284+00	15	1	3	3	8	4	Yes	No	Yes
288+00	20	6	2	3	11	4	Yes	Yes	No
292+00	15	6	3	3	10	4	Yes	No	No
296+00	15	3	3	3	10	4	Yes	No	No
300+00	15	2	3	3	10	6	Yes	Yes	No
304+00	10	1	3	3	10	5	Yes	No	No
308+00	15	2	3	2	12	5	Yes	No	No
308+50									Yes
310+65									Yes
312+00	15	2	4	3	11	6	Yes	No	No
316+00	10	2	3	3	10	4	Yes	No	No
320+00	15	2	5	4	8	7	Yes	No	No
324+00	15	2	5	7	6	5	Yes	No	No
328+00	20	2	5	5	7	5	Yes	No	No

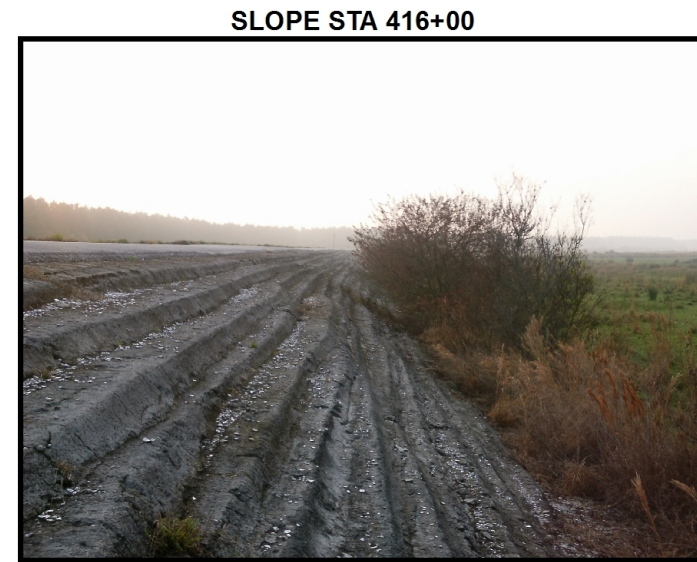
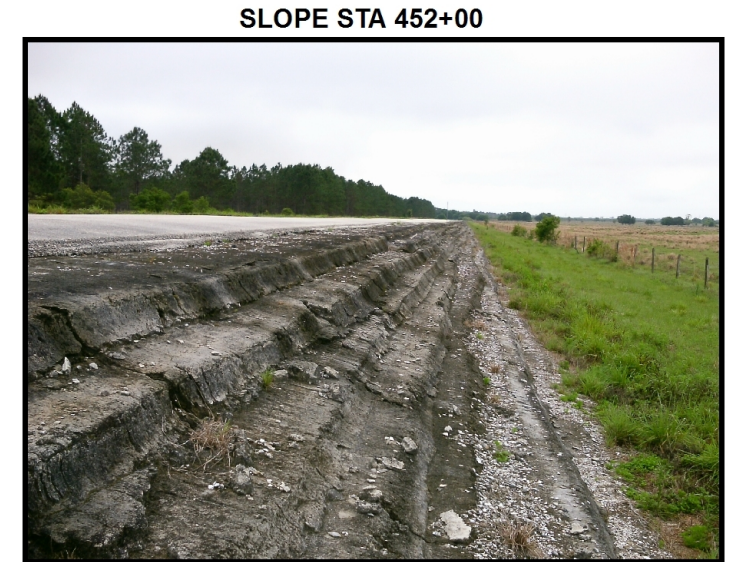
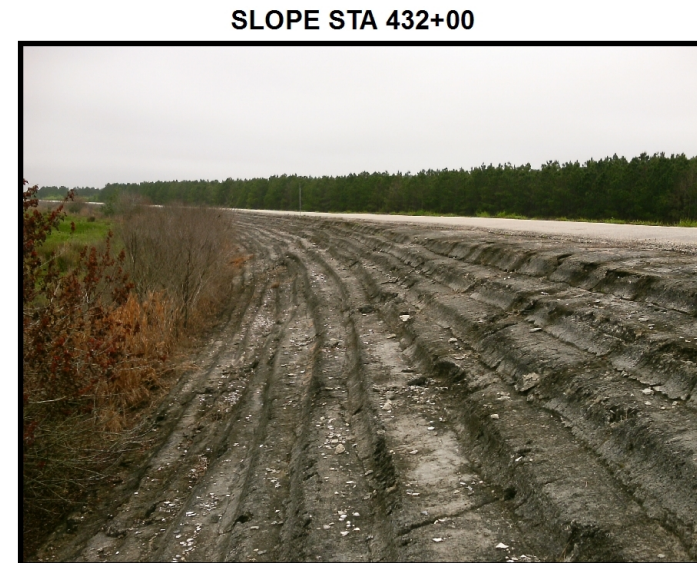
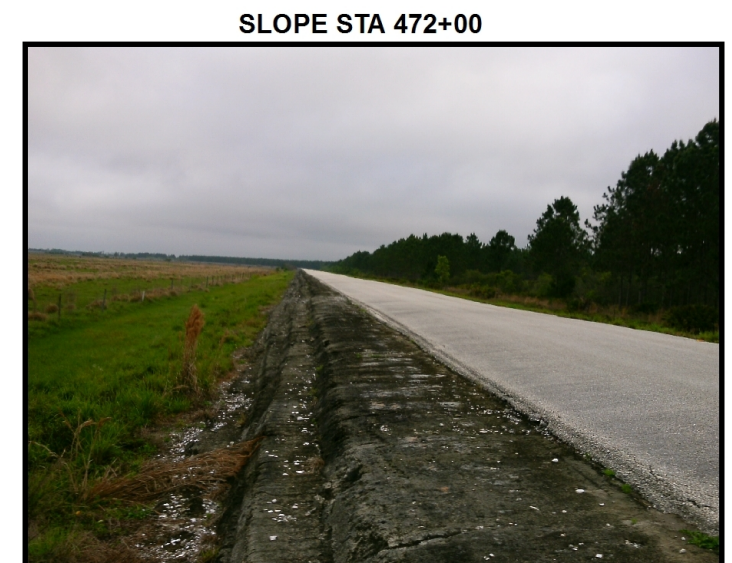
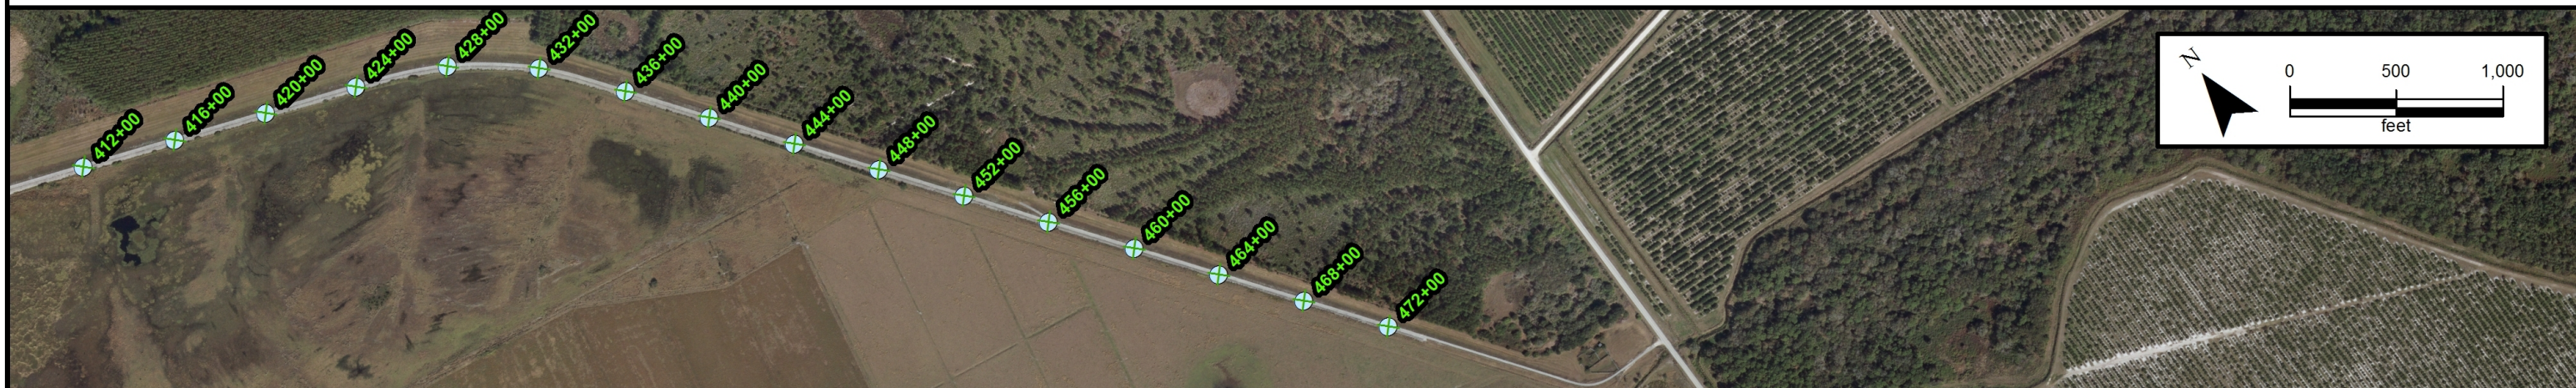
Figure 2E
Summary Plan of Visual Inspections
Stations 328+00 to 412+00
Manatee Plant Cooling Pond
Manatee County, Florida

STA	Visual Inspection								
	Typical Transvers Crack Spacing (ft)	Typical Transvers Crack Width (in)	# of Soft Steps	# of Moderate Steps	# of Hard Steps	# of Eroded Steps	Pitting Observed	Vegetation Observed	Repairs Observed
412+00			0	7	5	4	No	No	No
416+00			0	4	6	2	No	Yes	No
420+00			0	5	7	4	Yes	No	No
424+00			2	6	4	1	No	No	No
428+00			2	6	4	1	No	No	No
432+00			3	6	3	4	No	No	No
436+00			4	6	2	4	No	No	No
440+00			6	5	1	1	No	No	No
444+00			6	4	0	1	No	No	No
448+00			3	4	2	3	No	Yes	No
452+00			0	4	2	1	No	No	No
456+00			0	6	0	2	No	Yes	No
460+00			0	4	2	2	No	No	No
464+00			0	3	2	1	No	No	No
468+00			0	3	2	3	No	No	No
472+00			0	2	2	1	No	No	No

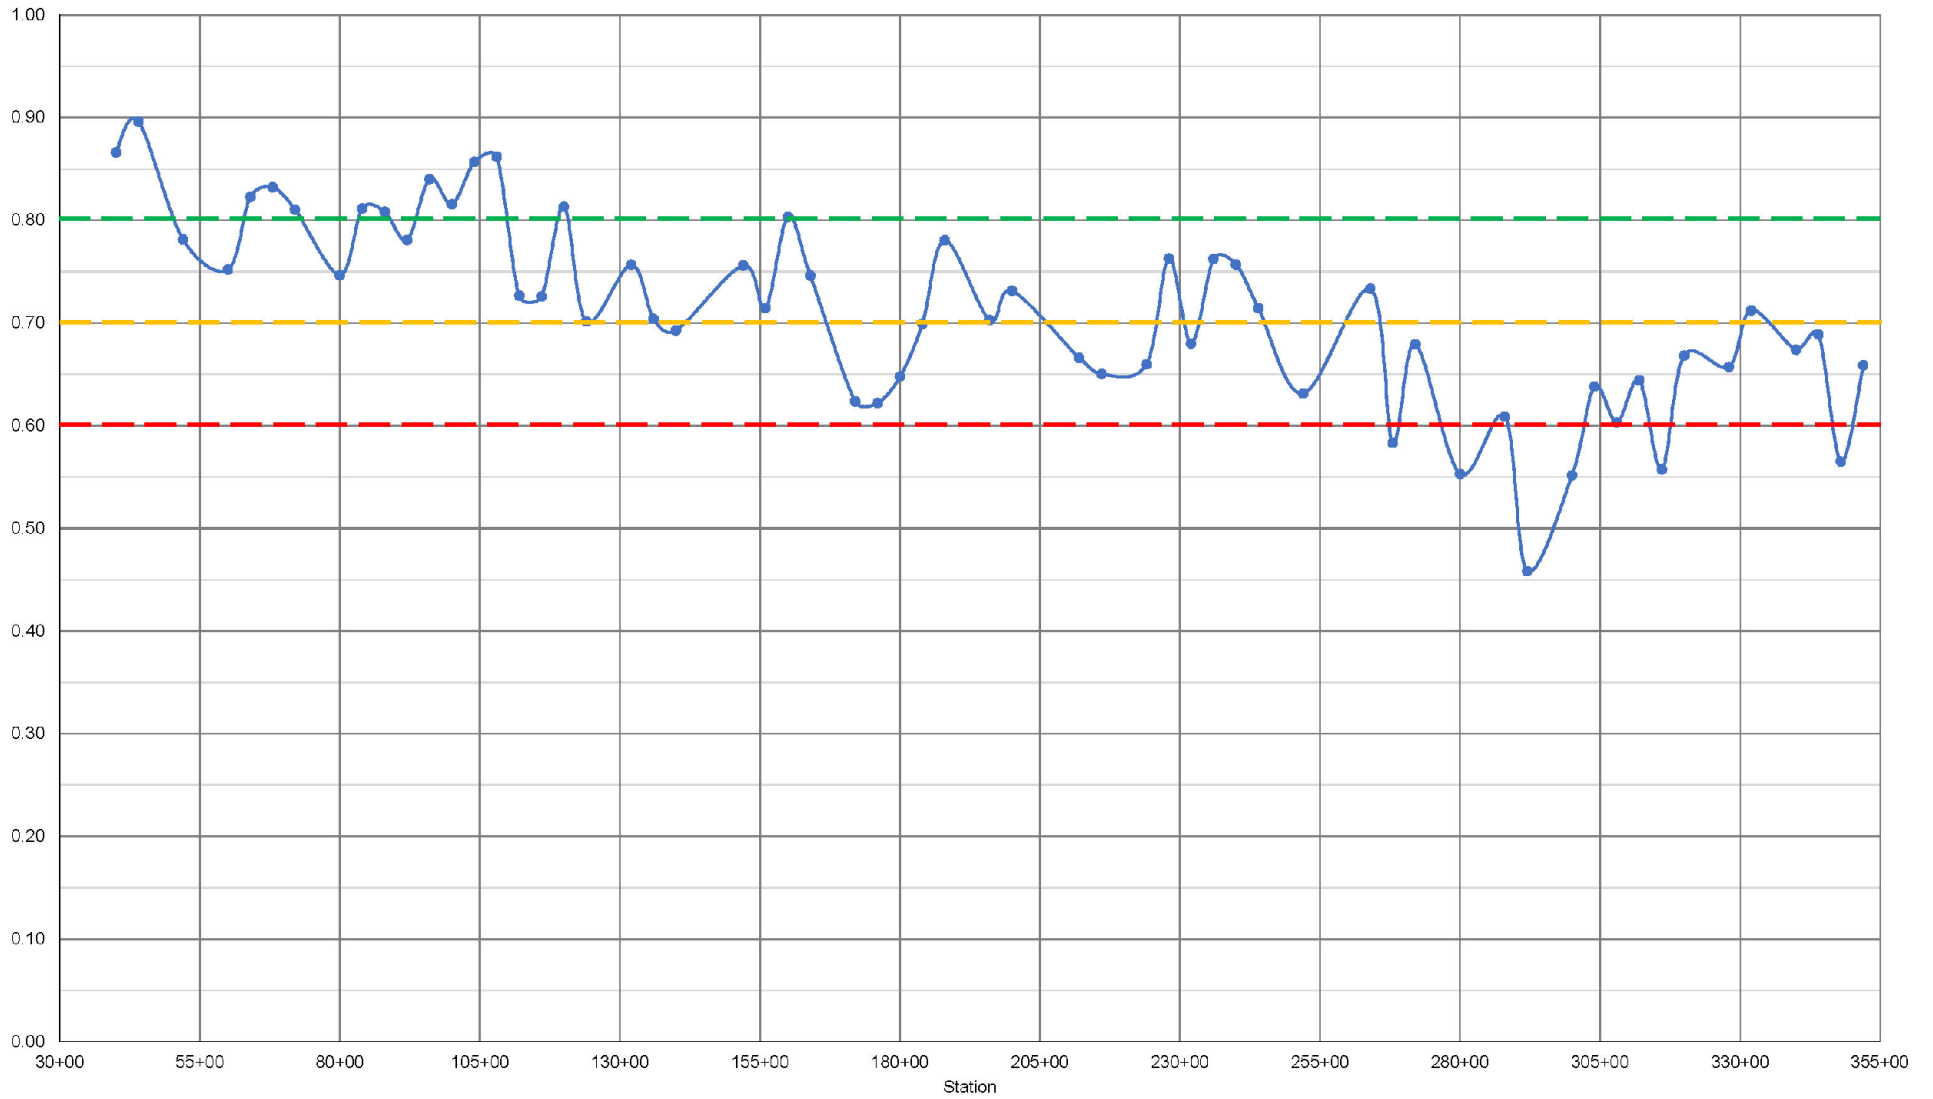
Figure 6
Condition Assessment Factor Profiles
Manatee Plant - Cooling Pond
Manatee County, Florida

The resulting profile of CAFs shown on **Figure 6** was used to determine the condition of the soil-cement along the embankment alignment. A CAF below 0.6 is considered to be a value at which the soil-cement should be repaired. The CAFs generally match the historical observations of the FPL dam inspection personnel.

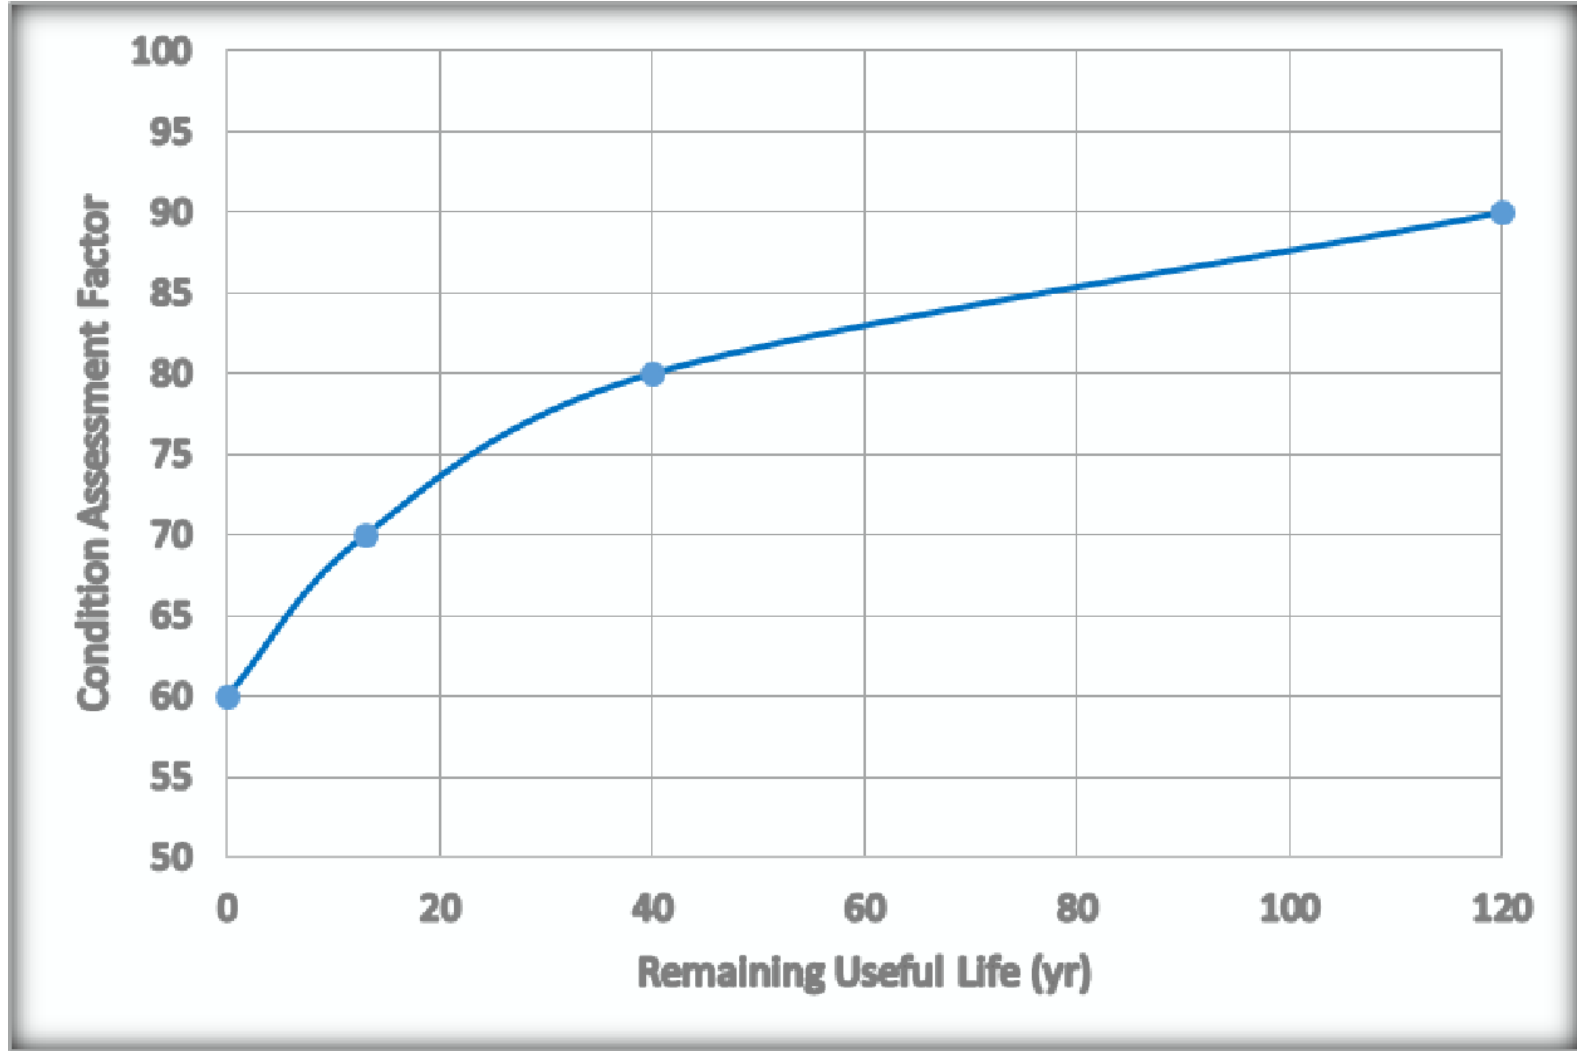
Figure 7
Relationship of RUL to CAF
Manatee Plant Cooling Pond
Manatee County, Florida

Using these simplifying assumptions, the estimated time for the soil-cement to degrade to a CAF of 0.6 for various existing values of CAF is provided in **Table 3**. The estimated repair length of soil-cement over time is also provided in Table 3 and shown graphically on **Figure 7**.

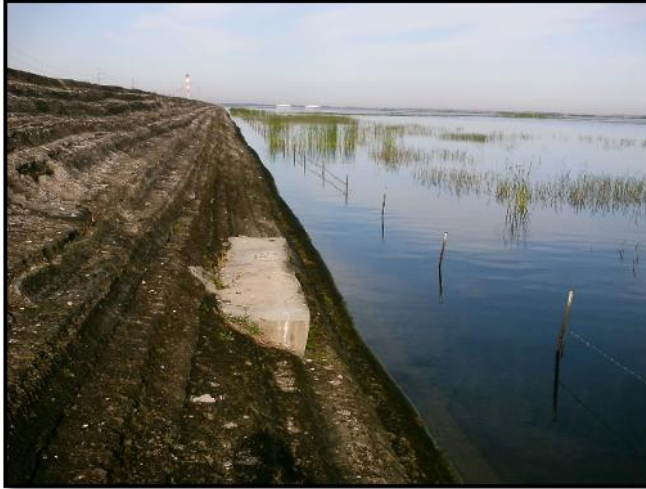
Location: STA 15+65

Description: A repair to steps 9 and 10 was observed at STA 15+65.

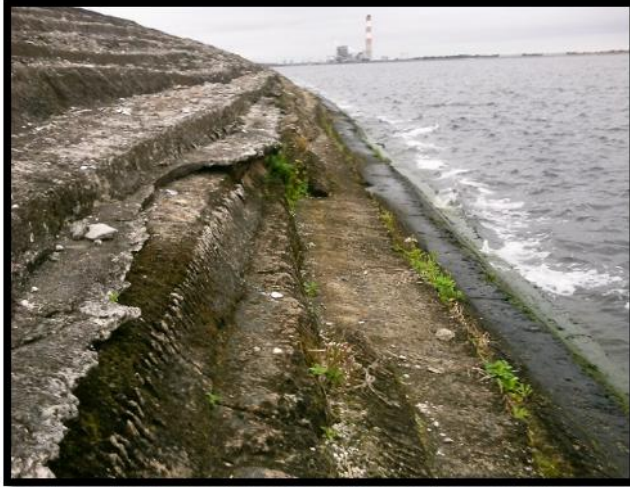
Location: STA 65+00

Description: Severe erosion, weathering, and very soft at step 9, STA 65+00. Moderate vegetation also noted.

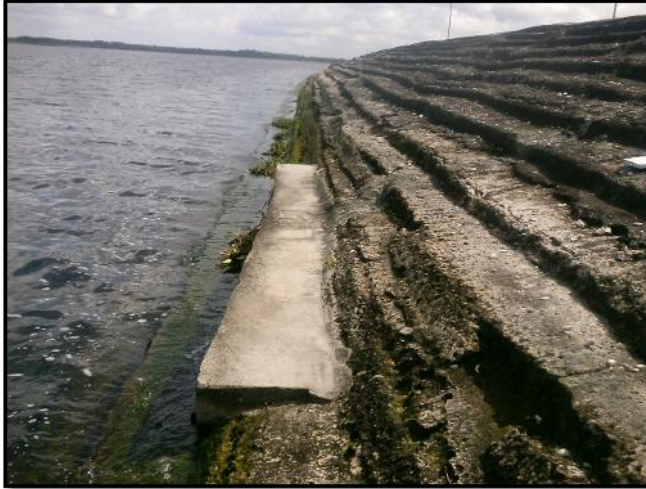
Location: STA 70+85

Description: A repair to the soil-cement slope was observed at STA 70+85. The repair was observed at step 12.

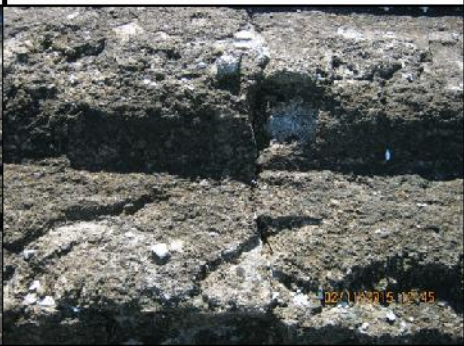
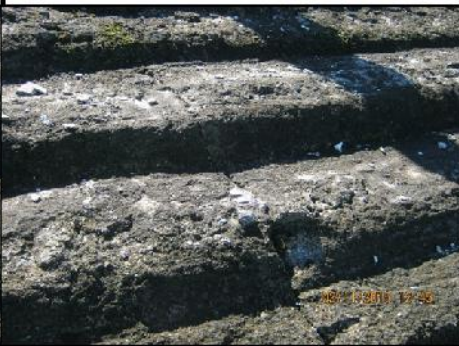
Description: Down view	Description: Transverse crack	Description: Transverse crack

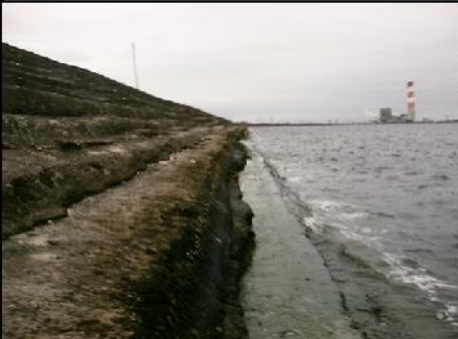
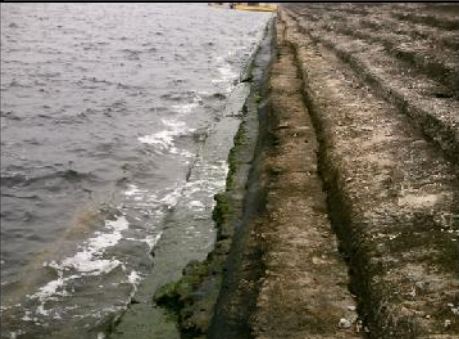
<u>Description:</u> Step 11 erosion and weathering looking West	<u>Description:</u> Step 11 erosion and weathering looking East	<u>Description:</u> General view looking West

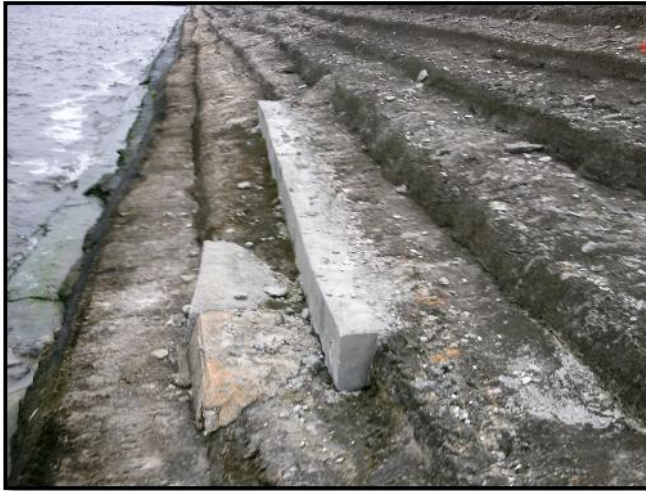
Location: STA 84+00

Description: A repair to the soil-cement slope was observed at STA 84+00 step 8 and 9.

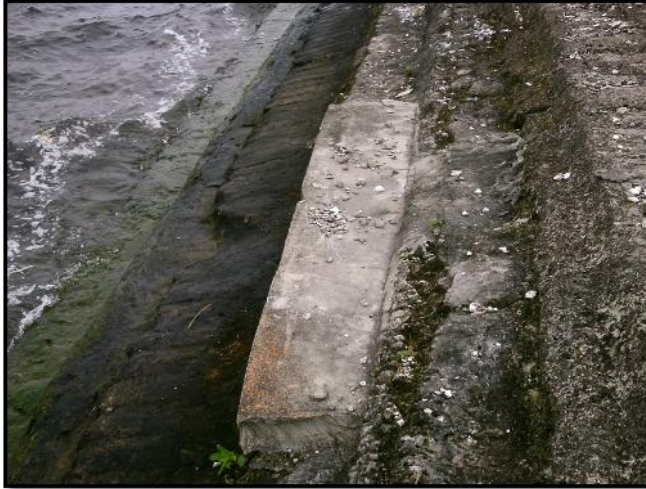
Location: STA 122+80

Description: A repair to the soil-cement slope was observed at STA 122+80 at step 8.

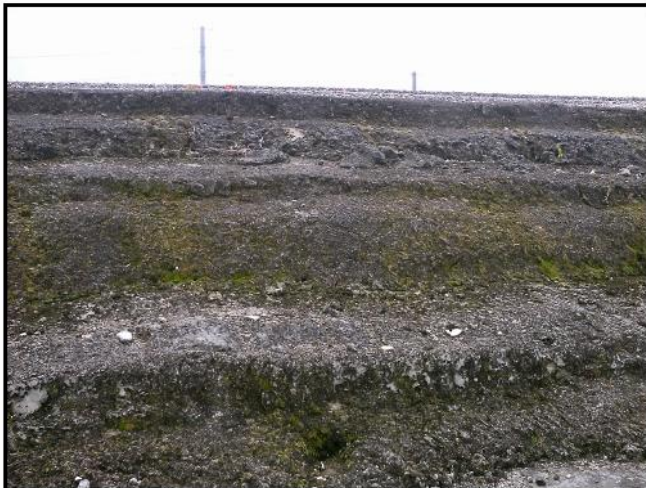
Location: STA 122+80

Description: Severe erosion and weathering on steps 2 and 3 was observed at STA 122+80.

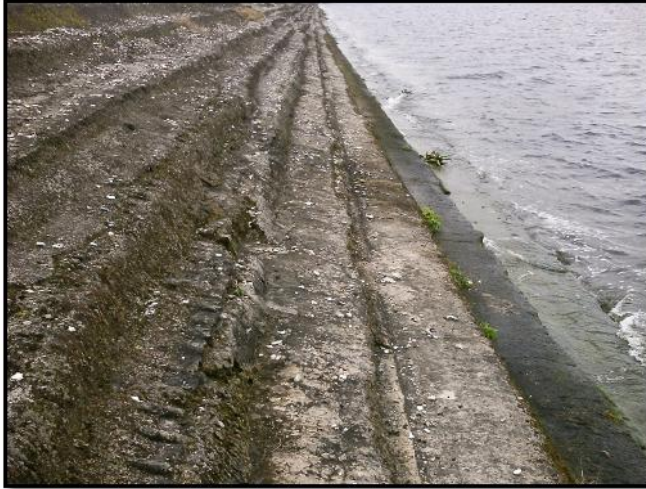
Location: STA 122+80

Description: Severe erosion and weathering was noted on steps 8 through 10 at STA 122+80.

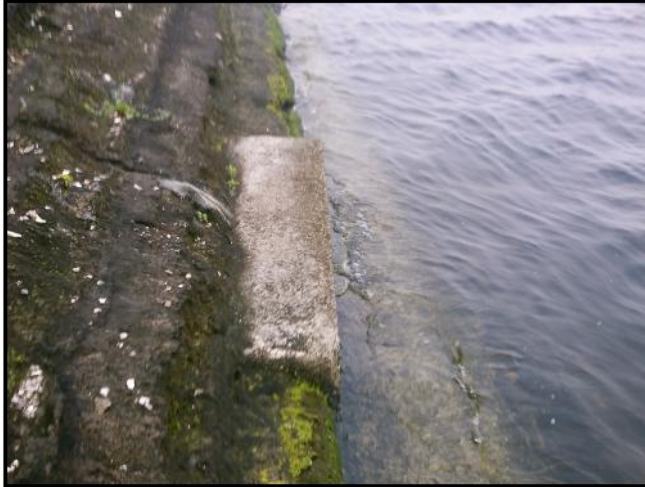
Location: STA 132+00

Description: A repair to the soil-cement slope was observed at STA 132+00.

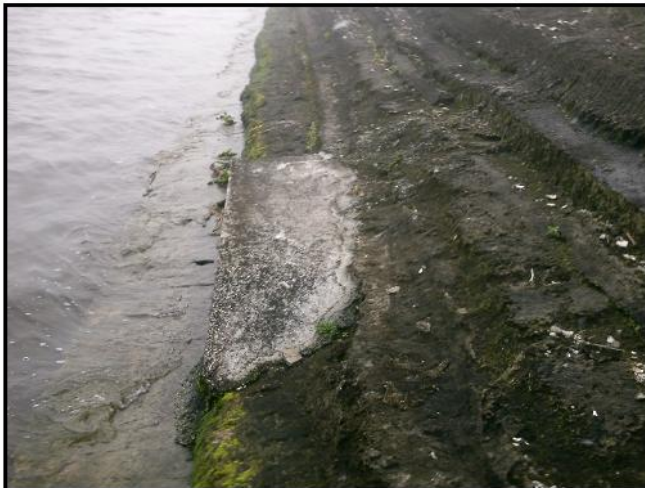
Location: STA 132+00

Description: A repair to the soil-cement slope was observed at STA 132+00.

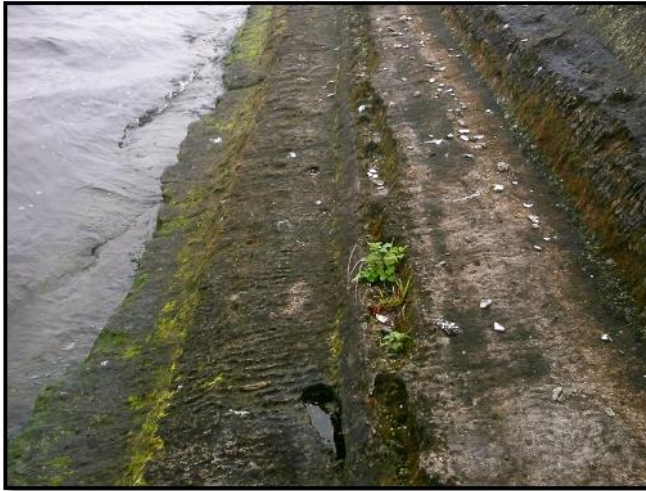
Location: STA 137+25

Additional Damage or Repair Observations		
Station	Step #	Description
137+25	11 and 12	Step 11 has a 6 in lateral void, step 12 severe under cutting
139+00	11	Severely pitted, eroded with missing sections.
Notes:

Description: Step 11 and 12 looking East showing a small void and under cutting of steps 11 and 12 at STA 137+25.

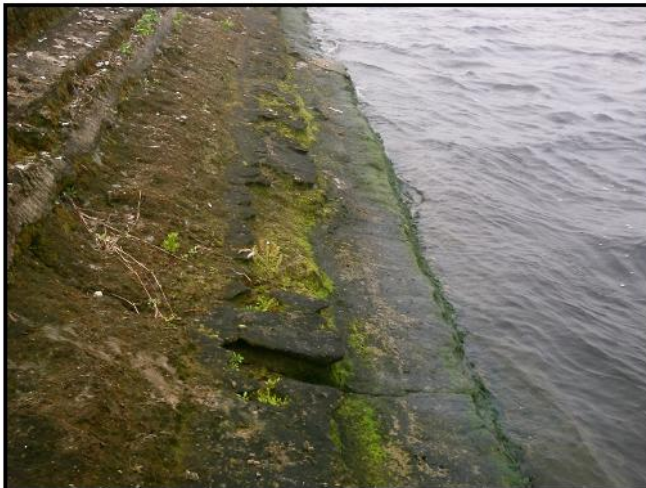
Location: STA 139+00

Description: Severe pitting, erosion, and missing sections of step 11 observed at STA 139+00.
