**Assessment and Design Report
Soil-Cement Condition Assessment and Design Project
Manatee Plant Cooling Pond Dam
Parrish, Florida
Project Number 300906**

To: Mr. Lewis Rounds, P.E.
FPL Manatee Plant

Date: June 2015

From: Jeff Beriswill
Amec Foster Wheeler Environment & Infrastructure, Inc.

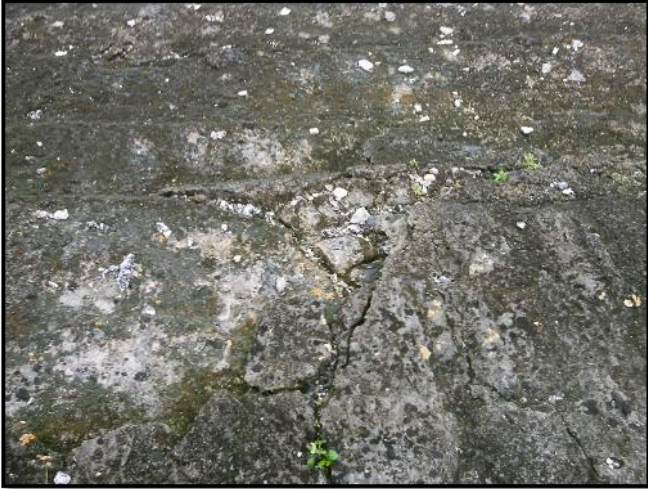
Location: STA 140+00

Step 1 has large area damaged and breaking apart. Steps 2 through 4 variably eroded, weathered, and soft. Step 7 severely eroded, weathered, pitted, and has been under cut. Steps 8 through 10 extreme pitting, erosion, and weathering. Step 11 moderate erosion and under cutting.

Description: Damage to step 1 observed at STA 140+00.

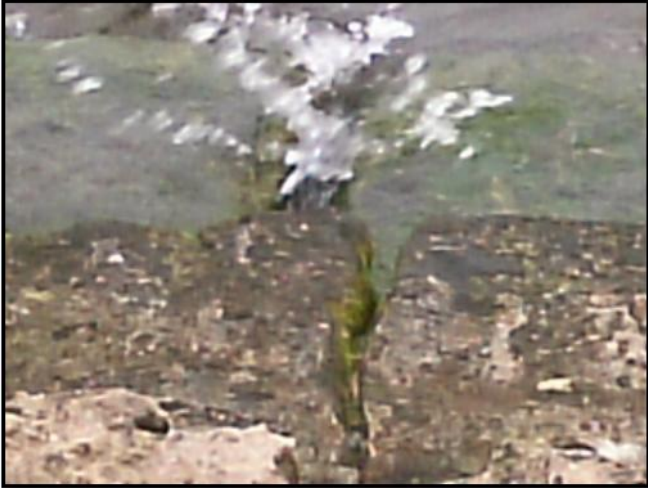
Location: STA 140+00

Spacing (feet)	Step #	Width (inches)	Length (feet)	Depth (inches)	Noted Void Y/N
15	8 through 12	2	10	3	N
Notes: 3 transverse cracks noted with a typical spacing between cracks of approximately 15ft or greater.

Description: A wide transverse crack at STA 140+00 step 12.

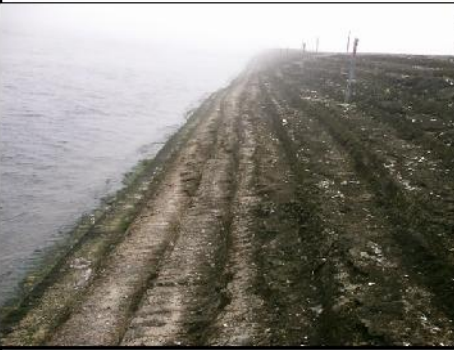
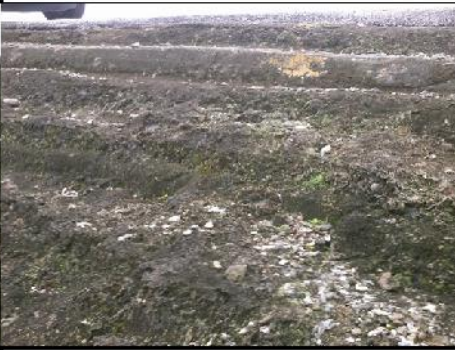
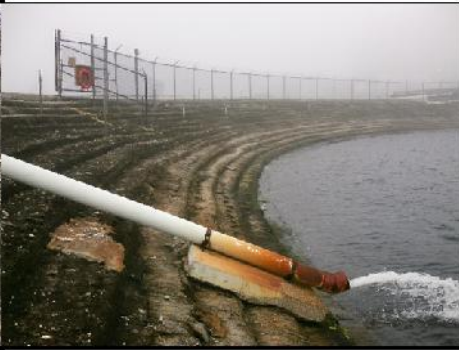
General Photographs of Observations		
1	2	3

<u>Description:</u> Steps 8 through 12	<u>Description:</u> Steps 3 through 6	<u>Description:</u> General view West

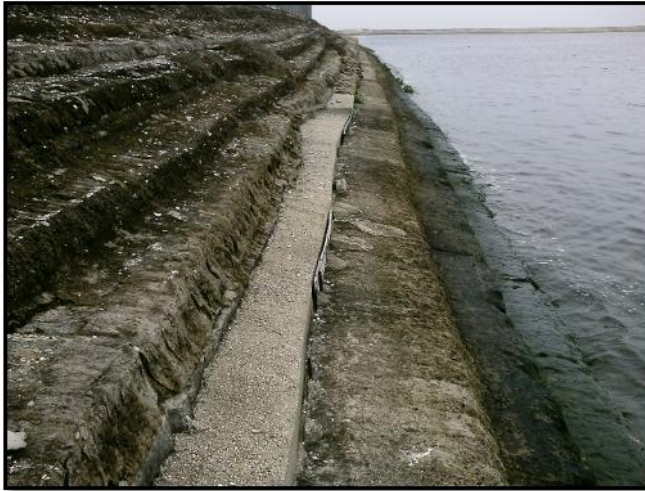
Location: STA 155+20

Description: A repair to the soil-cement slope was observed at STA 155+20.

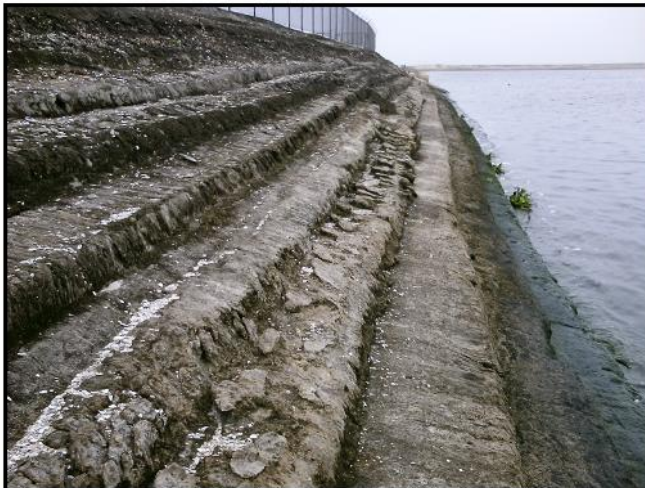
Location: STA 155+00

Description: Extreme pitting of step 10 at STA 155+00.

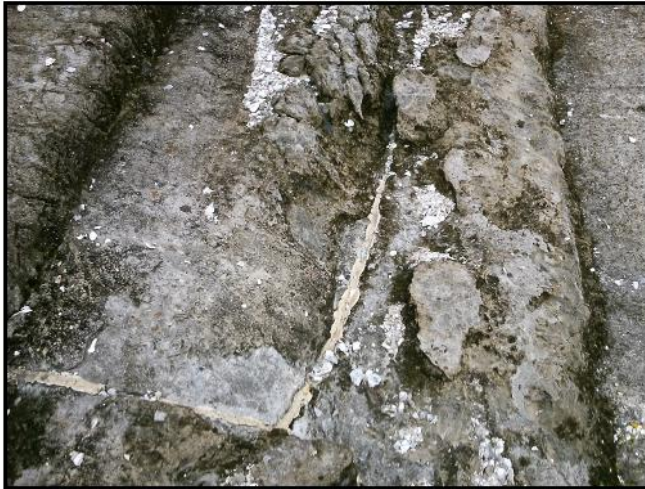
Location: STA 155+20

Description: A caulk repair to a transverse crack at STA 155+20.

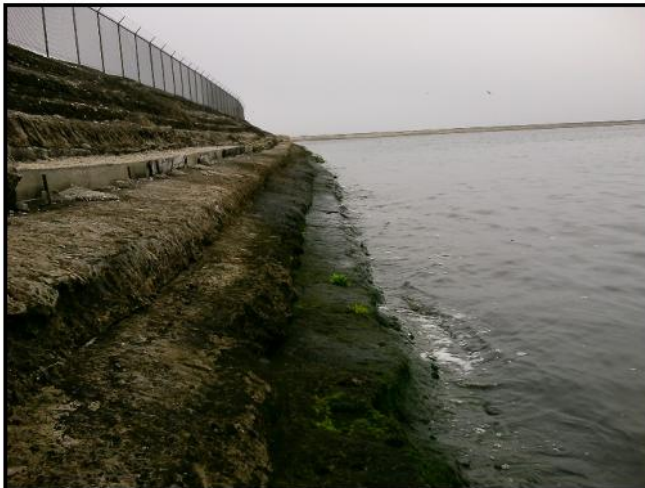
Location: STA 155+20

Description: General view of the erosion and under cutting of step 12 at STA 155+20.

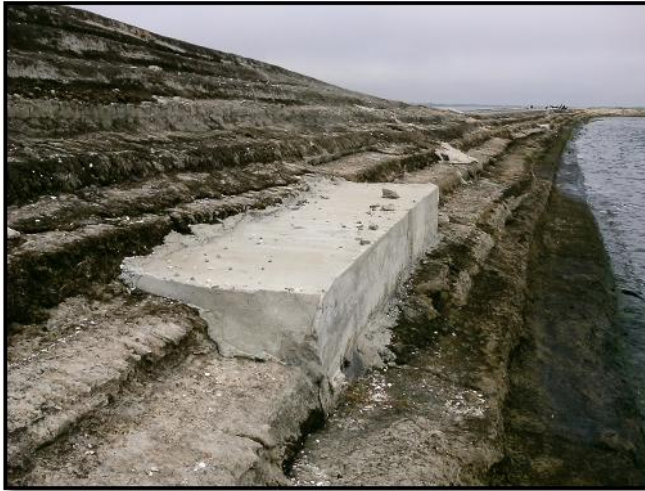
Location: STA 156+00

Description: A repair to the soil-cement steps 8 and 9 was observed at STA 156+00.

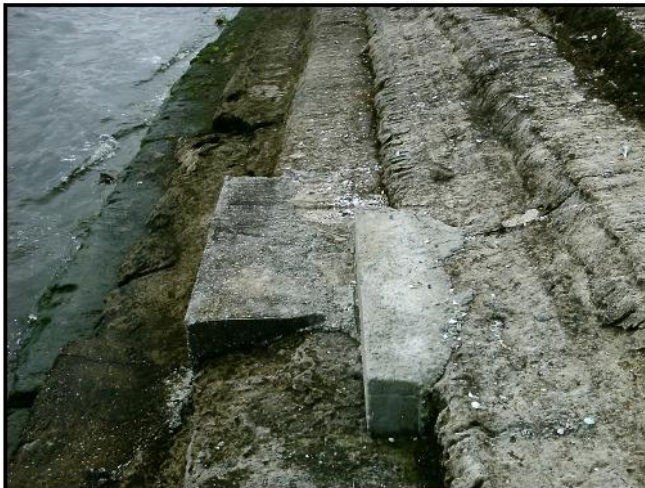
Location: STA 156+00

Description: A repair to the soil-cement steps 8 and 9 was observed at STA 156+00.

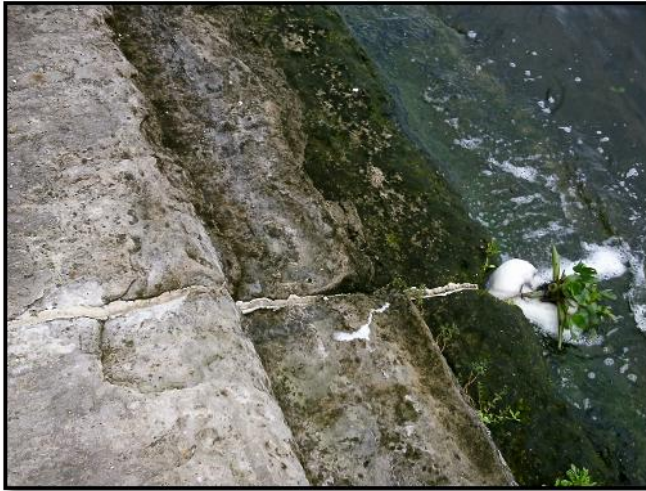
Location: STA 156+00

Description: A caulk repair to a transverse crack at STA 156+00.

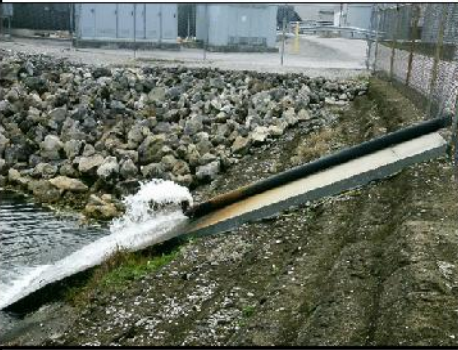
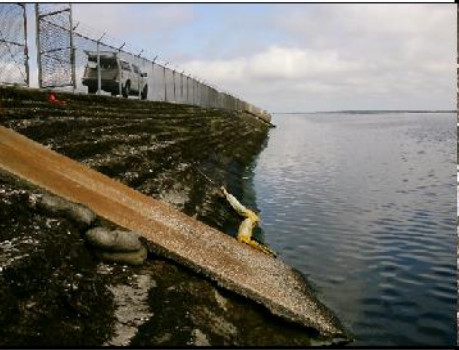
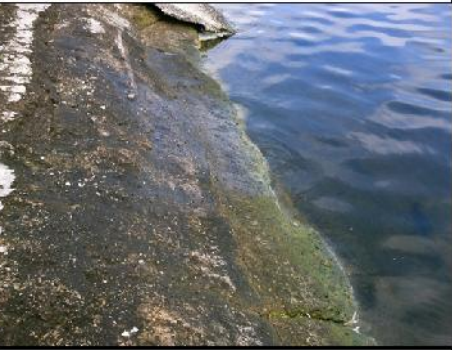
General Photographs of Observations		
1	2	3

Description: Steps 2 through 6	Description: General Erosion of steps 10 through 12 looking North	Description: Steps 10 through 12

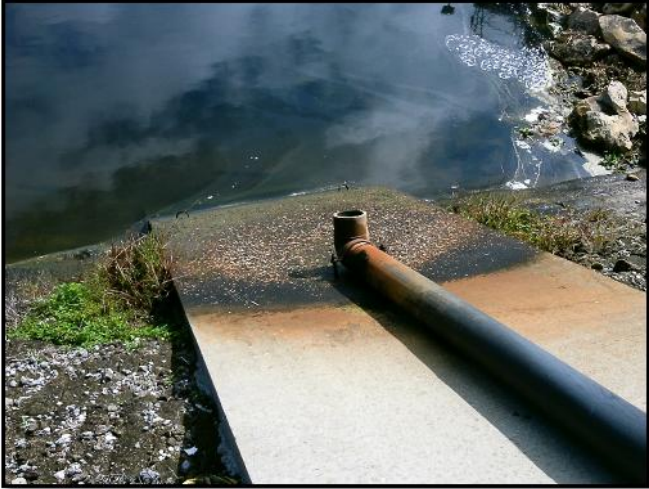
Location: STA 169+00

Additional Damage or Repair Observations		
Station	Step #	Description
169+00		Heavy vegetation around outfall structure D-007
Notes:

Description: Vegetation around outfall D-009 STA 169+00.

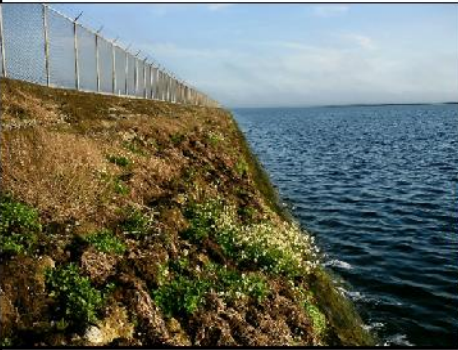
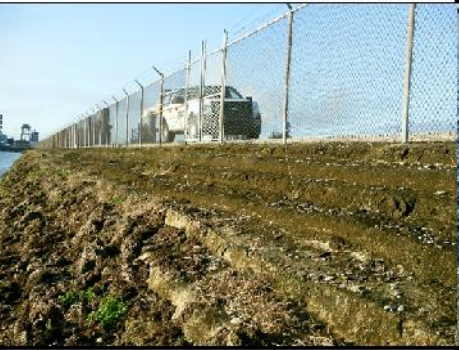
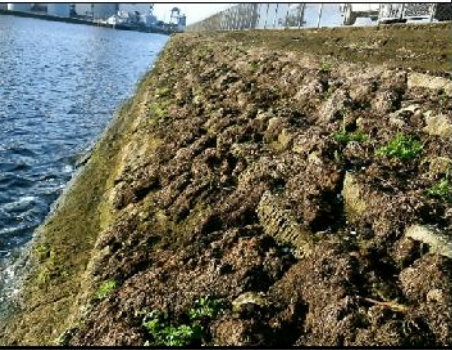
General Photographs of Observations		
1	2	3

<u>Description:</u> decaying vegetation and new growth	<u>Description:</u> Steps 1 through 4 looking South	<u>Description:</u> Steps 9 through 12

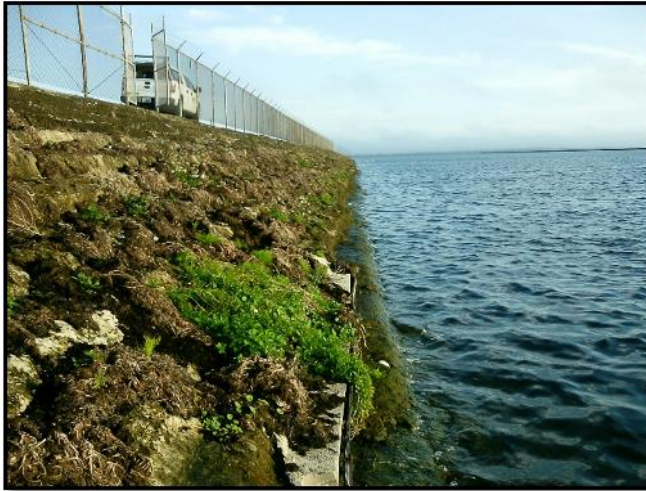
Location: STA 184+00

Description: A repair to the soil-cement slope was observed at STA 184+00.

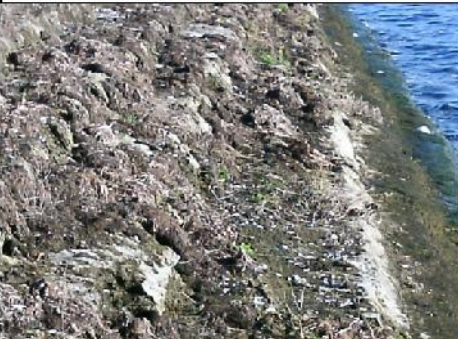
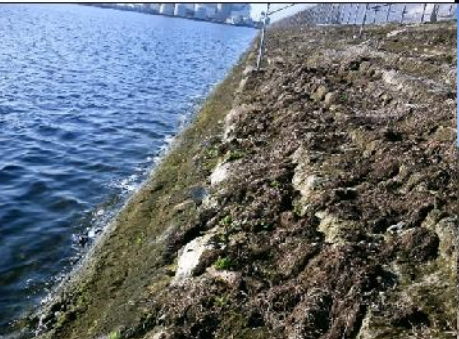
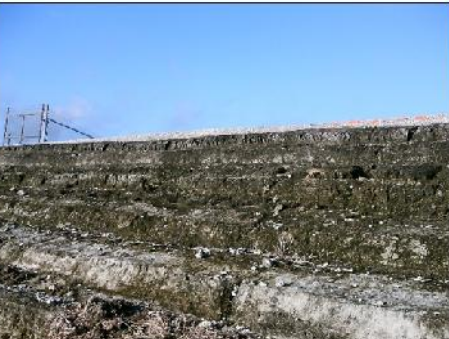
General Photographs of Observations		
1	2	3

<u>Description:</u> Steps 8 through 12Ste	<u>Description:</u> Decaying vegetation with moderate new growth	<u>Description:</u> Steps 1 through 4

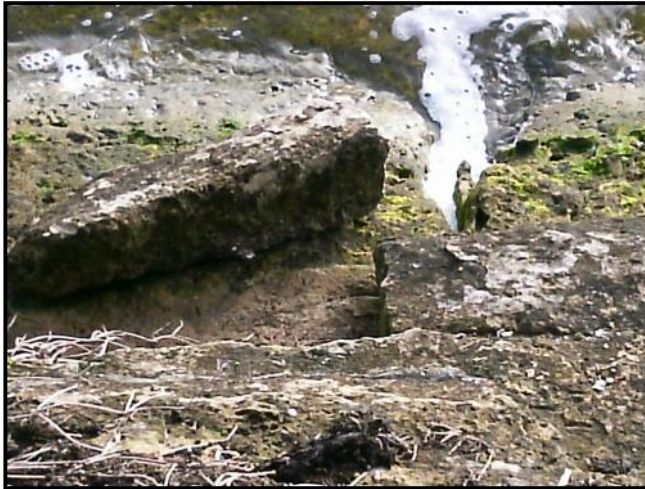
Location: STA 200+00

Description: A large section of step 11 is dislodged and step 12 has severe erosion and under cutting.

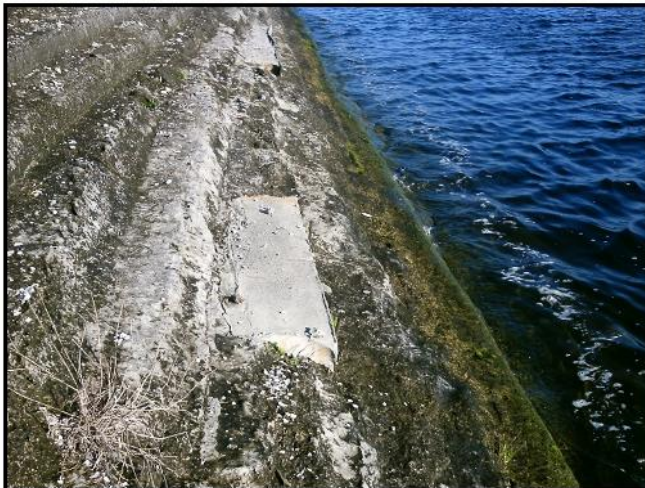
Location: STA 203+00

Description: A repair to the soil-cement slope was observed at STA 203+00 step 11.

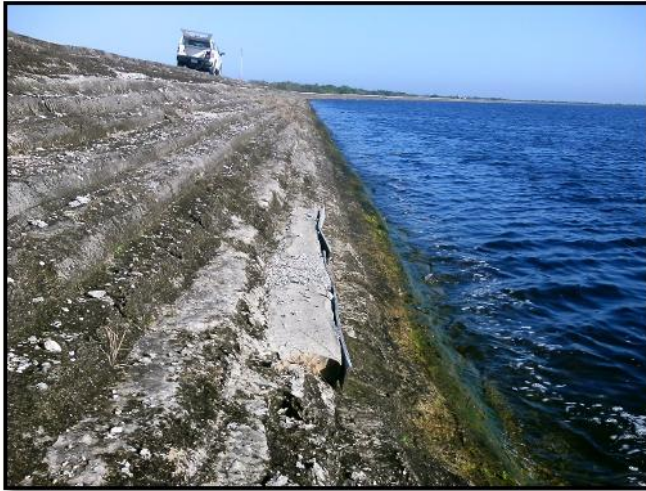
Location: STA 203+00

Description: A repair to the soil-cement slope was observed at STA 203+00 step 11.

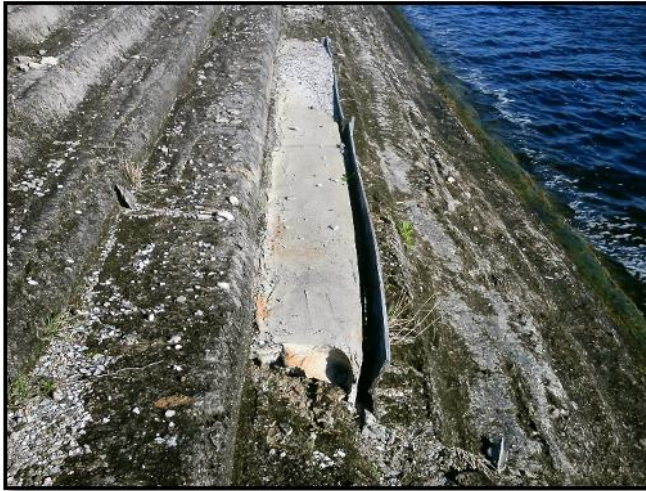
Location: STA 205+75

Description: A repair to the soil-cement slope was observed at STA 205+75.

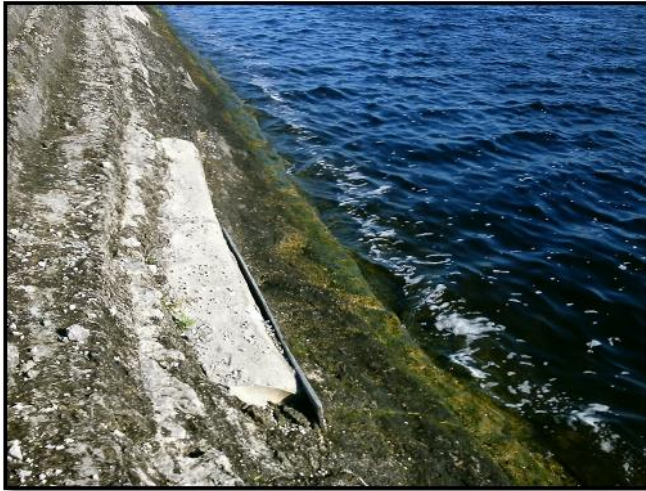
Location: STA 209+00

Description: A repair to the soil-cement slope was observed at STA 209+00 step 11.

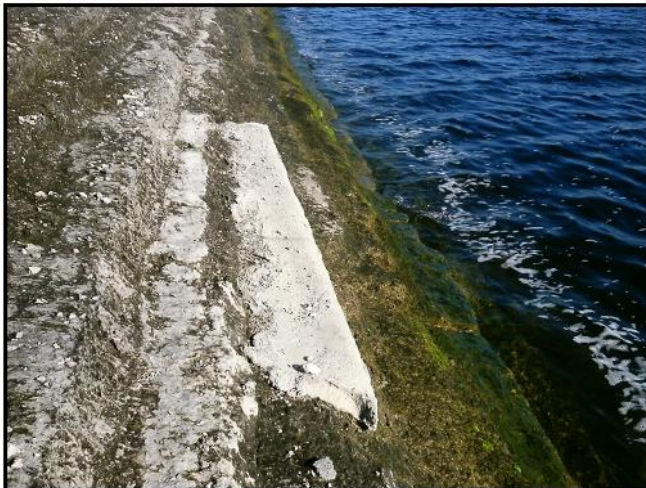
Location: STA 209+50

Description: A repair to the soil-cement slope was observed at STA 209+50 step 11.

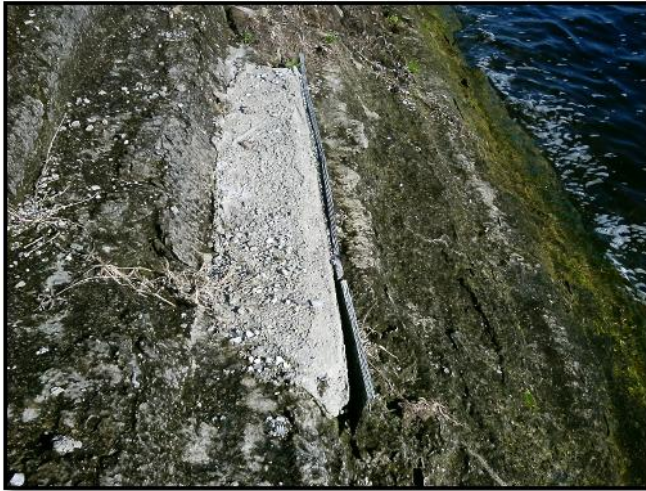
Location: STA 209+90

Description: A repair to the soil-cement slope was observed at STA 209+50 step 9.

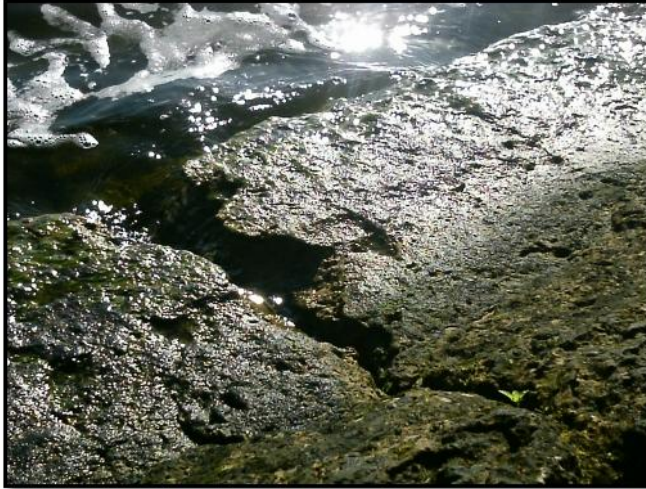
Location: STA 212+00

Description: Large transverse crack at STA 212+00.

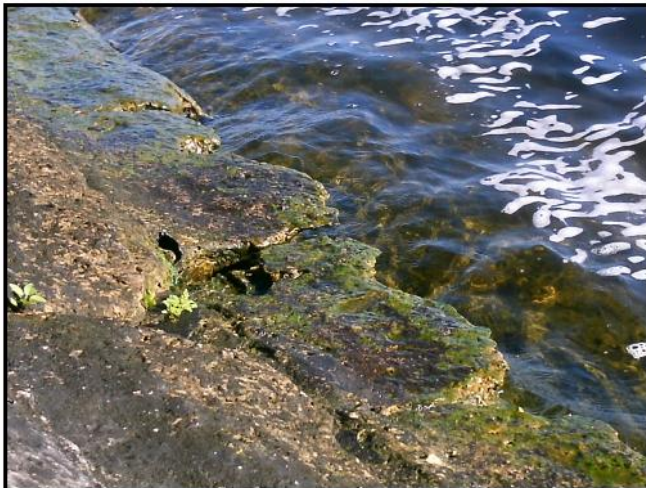
Location: STA 212+00

Description: Under cutting of step 13 at STA 212+00.

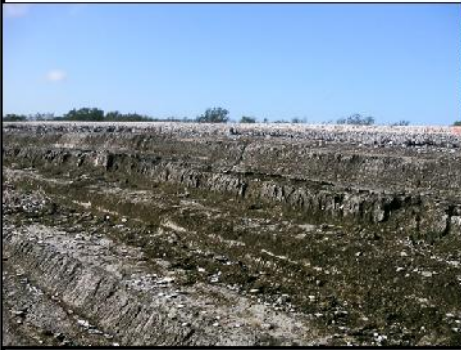
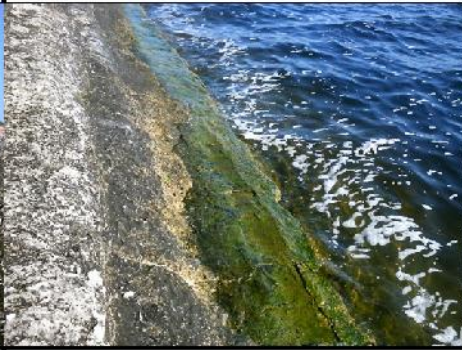
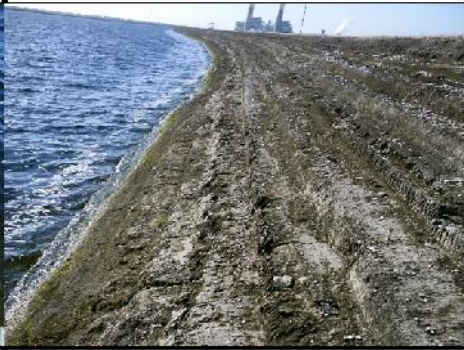
1	2	3

<u>Description:</u> Steps 1 and 2 showing erosion	<u>Description:</u> Sections of step 13 missing	<u>Description:</u> Steps 9 and 10

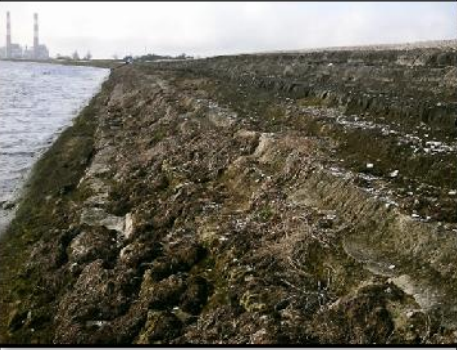
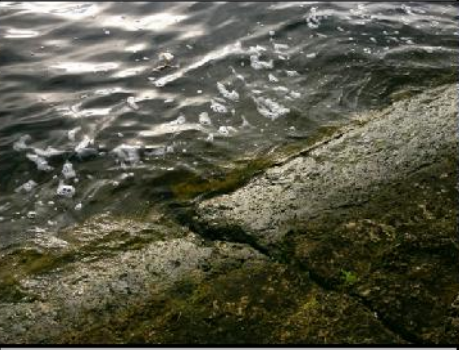
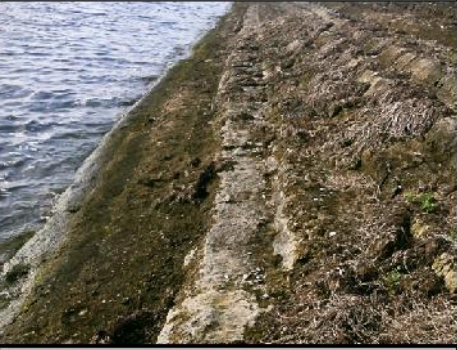
1	2	3

Description: Decaying and new vegetation	Description: Typical transverse crack	Description: Steps 8 and 9 looking South

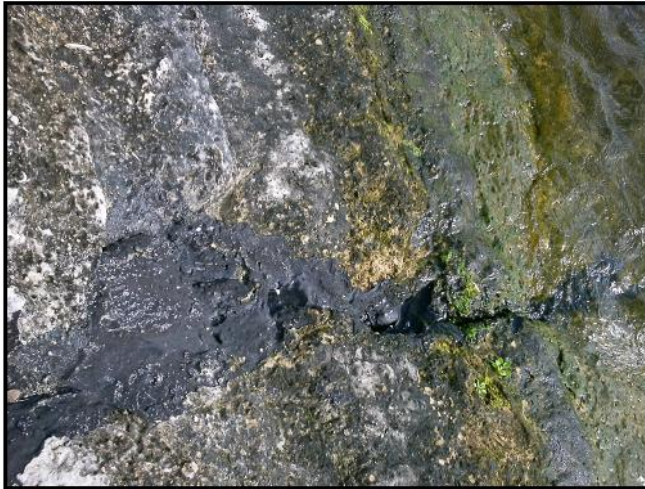
Location: STA 244+00

Additional Damage or Repair Observations		
Station	Step #	Description
244+00	7 through 13	A bituminous caulk repair was noted.
244+00	10	A one foot laterally measured cavity was noted.
Notes:

Description: A repair to the soil-cement slope with a bituminous type caulk applied to a transverse crack from step 7 to the waterline at STA 244+00.

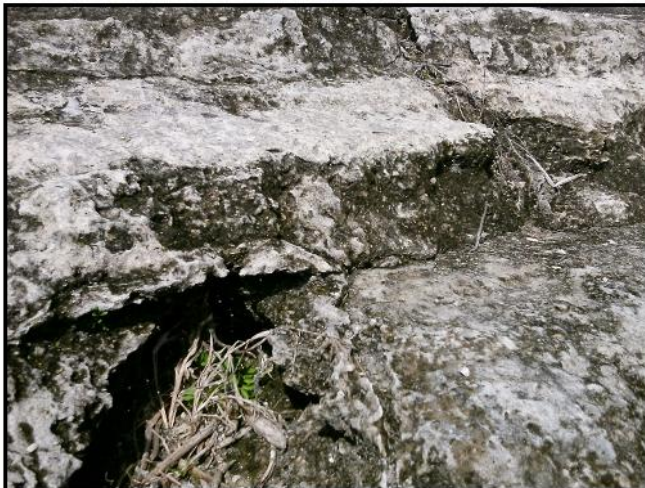
Location: STA 244+00

Description: A cavity under step 10 measured one foot laterally was observed at STA 244+00.

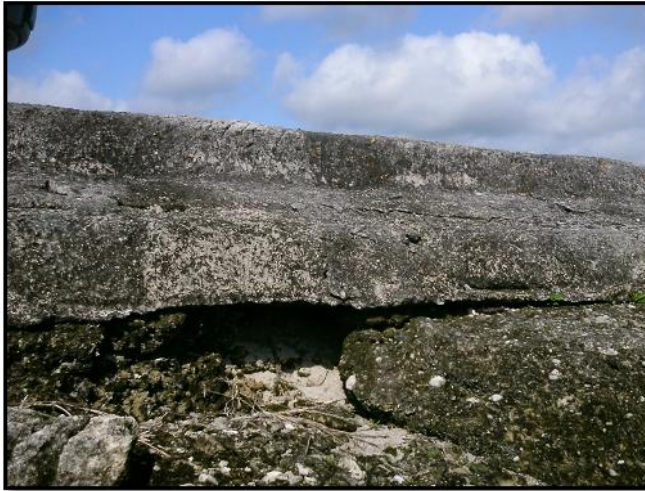
Location: STA 248+00

Station	Step #	Description
248+00	2	Cavity under step 2 created by washout or animal.
248+00	13	3 voids noted just below waterline in step 13.
Notes:

Description: A cavity under step 2 at STA 248+00.

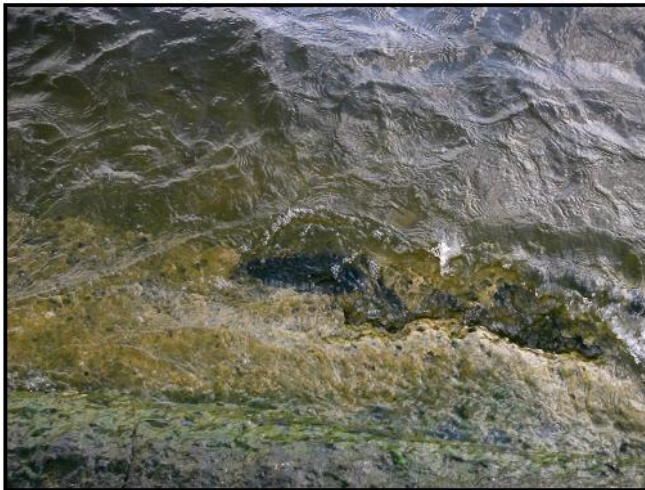
Location: STA 248+00

Description: One of several voids noted just under the water at STA 248+00.

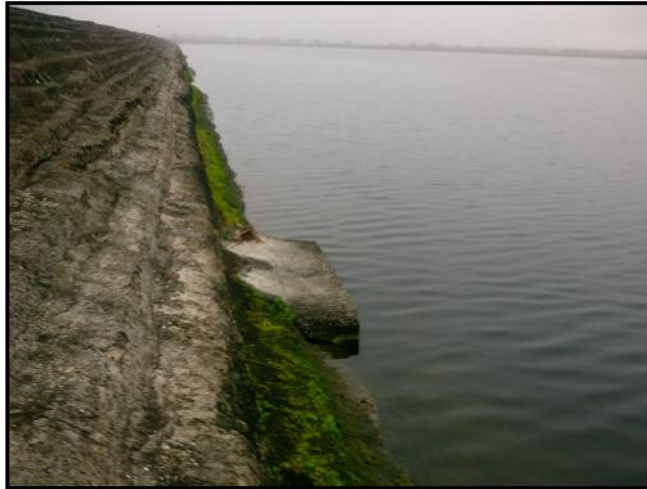
Location: STA 253+35

Additional Damage or Repair Observations		
Station	Step #	Description
253+35	13	8 ft. X 3 ft. X 1 ft. step repair
Notes:

Description: A repair to the soil-cement slope was observed on step 13 at STA 235+35.

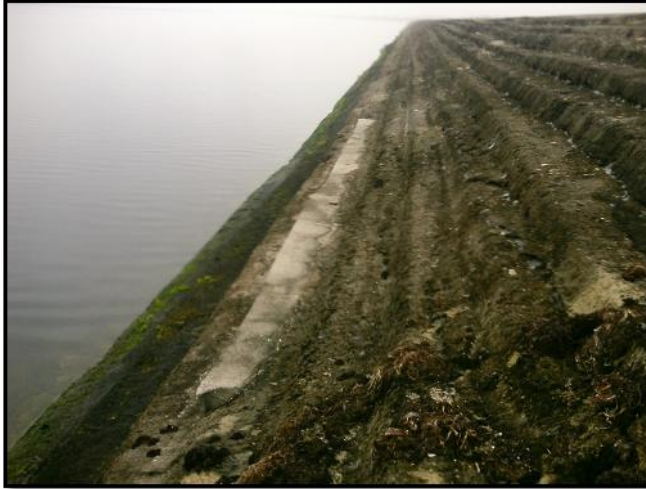
Location: STA 259+25

Additional Damage or Repair Observations		
Station	Step #	Description
259+25	9	45 ft. X 1 ft. X 0.5 ft. step repair
Notes:

Description: A repair to the soil-cement slope was observed at step 9 STA 259+25.

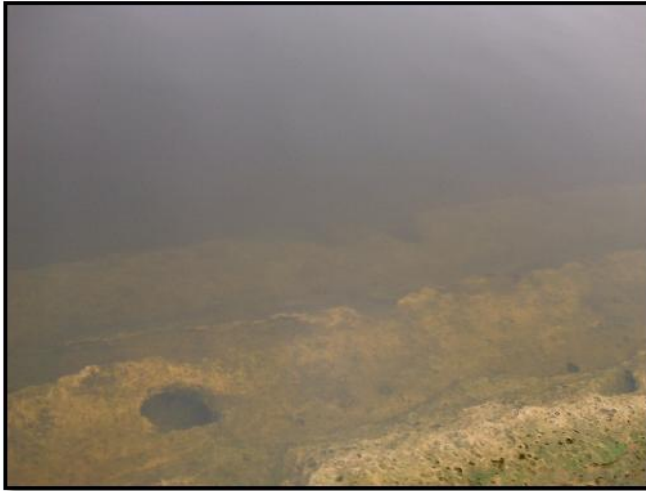
Location: STA 264+00

Steps 8 through 10 moderately to severely eroded and pitted. Steps 11 through 13 extremely eroded and well rounded. Slight under cutting of step 11. Up to 6 voids observed with an average diameter of 6 inches located just below the waterline.

Description: Numerous small voids/potholes noted just below the waterline at STA 264+00.

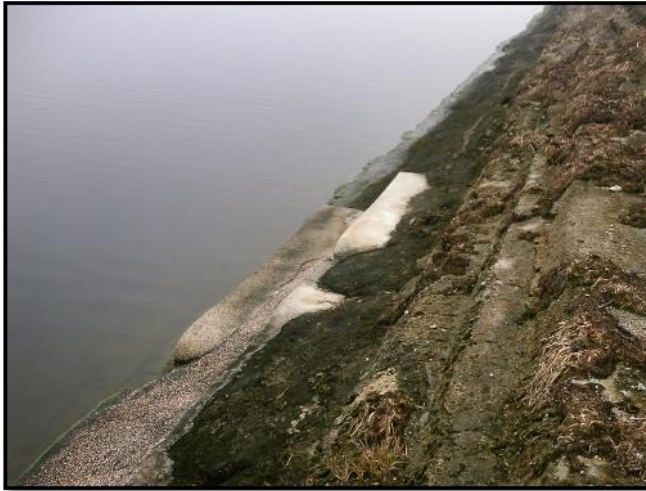
Location: STA 268+60

Additional Damage or Repair Observations		
Station	Step #	Description
268+60	10 through underwa	3 types of repairs noted; step repair on 11 through 13
		Concrete slurry ramp on steps 11 through 13, sections broken away
		Underwater shelf type extension of step 13
Notes: No additional damage or repairs observed.

Description: A repair to the soil-cement slope was observed at steps 11 through 13 at STA 268+60.

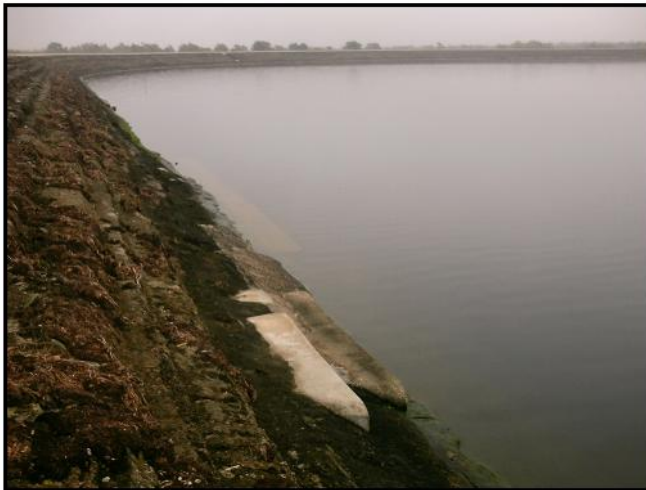
Location: STA 268+60

Description: A concrete slurry repair was made to steps 11 through 13 at STA 268+60.

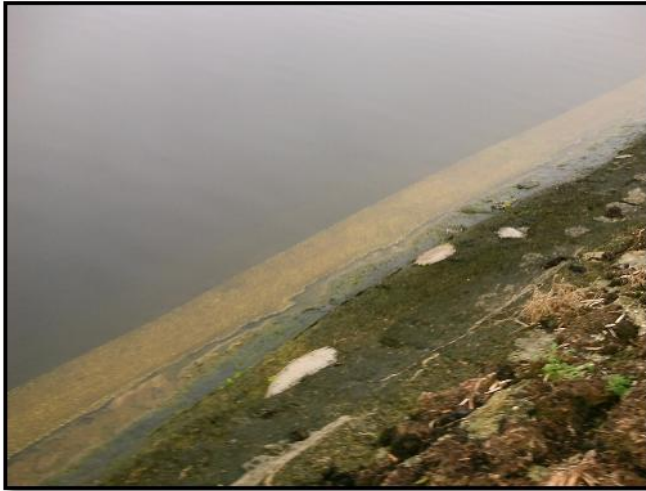
Location: STA 268+60

Description: A shelf extension was made to step 13 at STA 268+60.

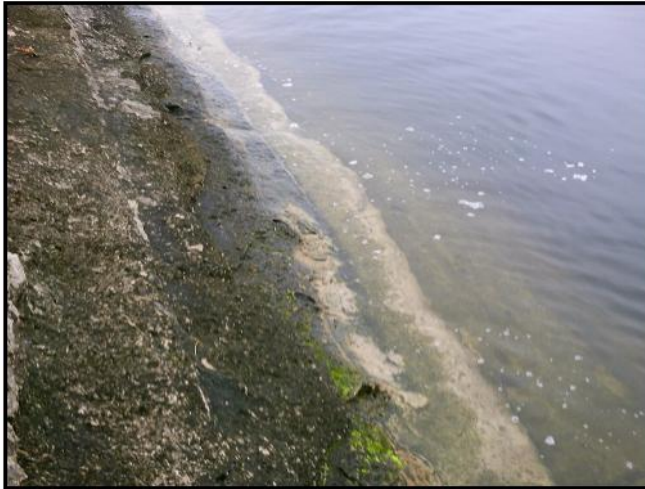
Location: STA 280+00

Description: Steps 11 through 13 extremely eroded and well-rounded at STA 280+00.

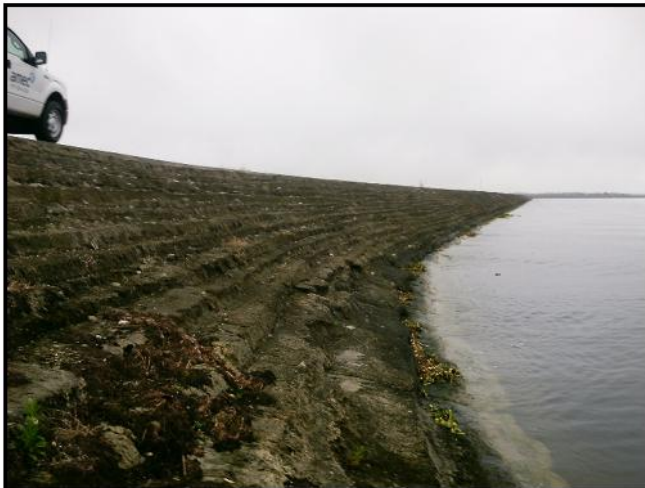
Location: STA 280+00

Description: Large sections of step 11 observed to be missing at STA 280+00.

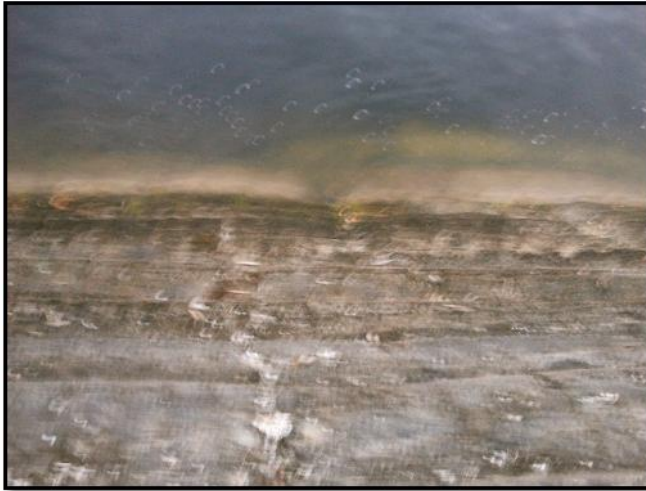
Location: STA 284+00

Description: A repair to a transverse crack was observed at STA 284+00.

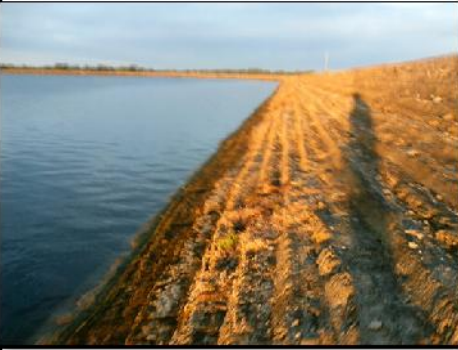
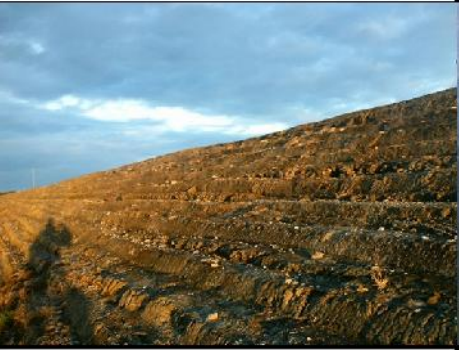
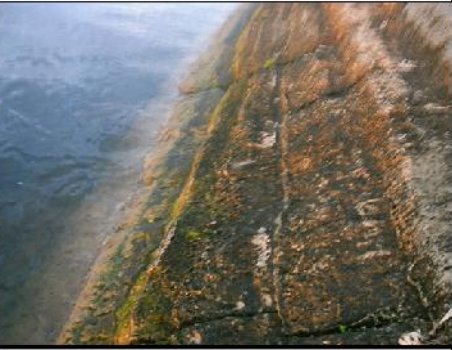
General Photographs of Observations		
1	2	3

<u>Description:</u> steps 12 through 14	<u>Description:</u> General profile of steps 3 through 10	<u>Description:</u> Steps 14 through 16

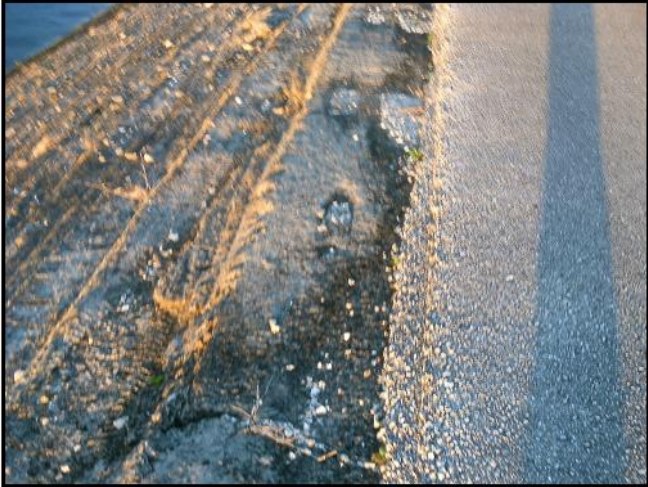
Location: STA 292+00

Description: Step 1 at STA 292+00 showing multiple cracks and breaks.

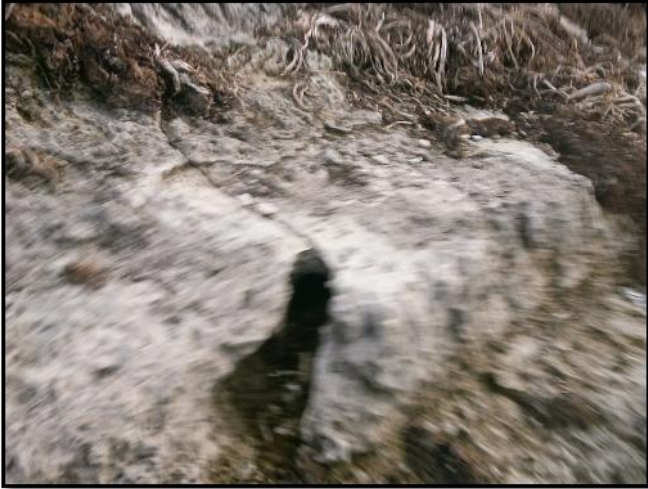
Location: STA 296+00

Description: A 6 inch deep lateral void measured at STA 296+00 step 12.

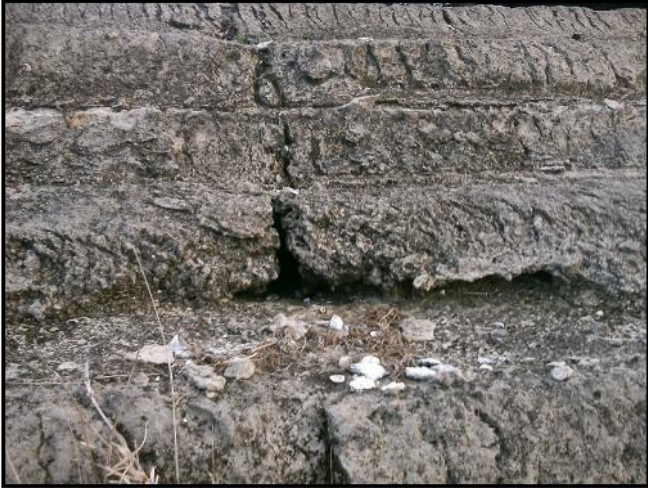
Location: STA

Description: A 6 inch deep lateral void measured at STA 296+00 step 9.

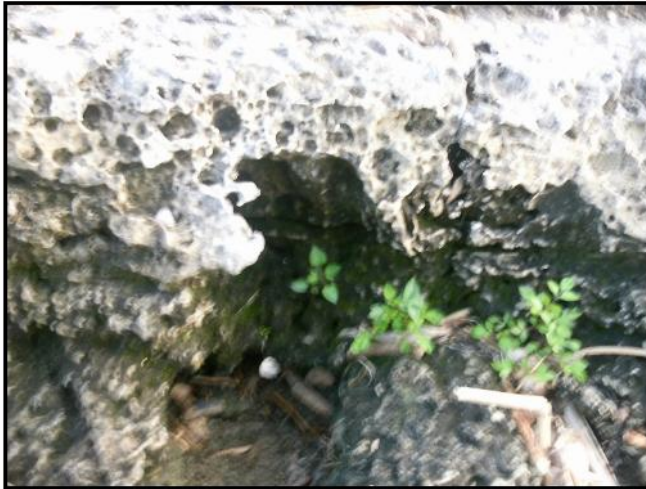
Location: STA 300+00

Description: Extreme erosion and under cutting of step 13 was noted at STA 300+00.

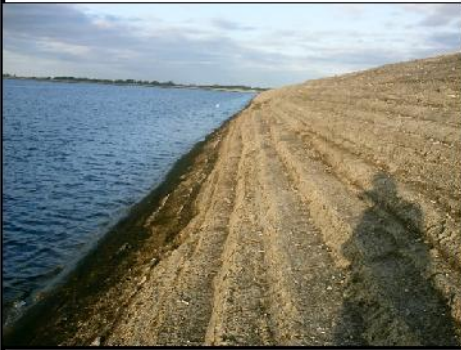
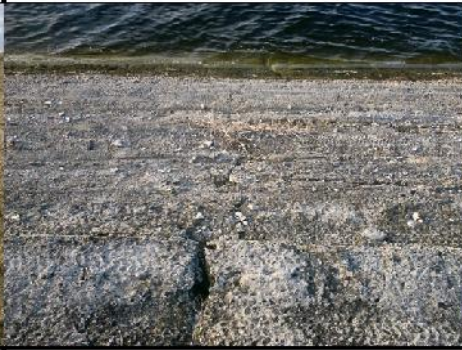
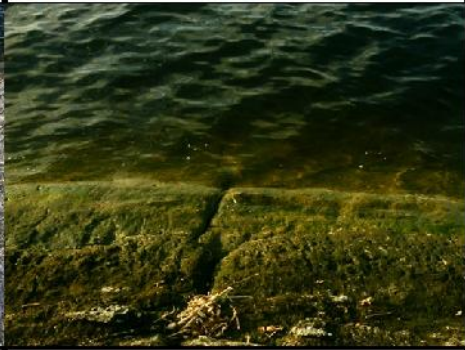
General Photographs of Observations		
1	2	3

<u>Description:</u> Steps 12 through 17	<u>Description:</u> Transverse crack from 12 through 17 into water	<u>Description:</u> Transverse crack into water

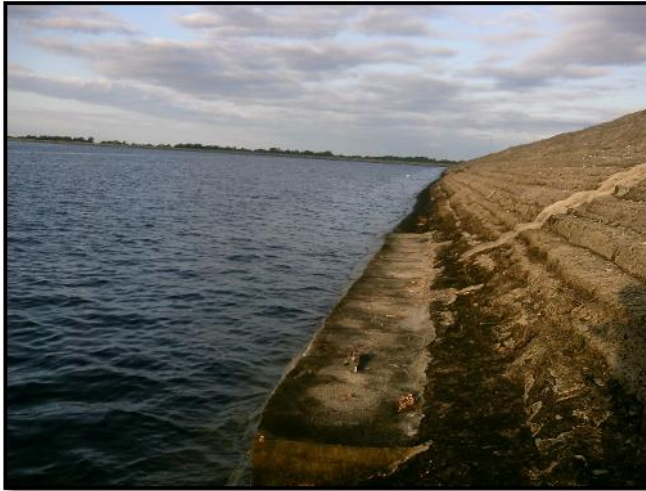
Location: STA 308+50

Description: A repair to the soil-cement slope was observed at STA 308+50 steps 16 and 17.

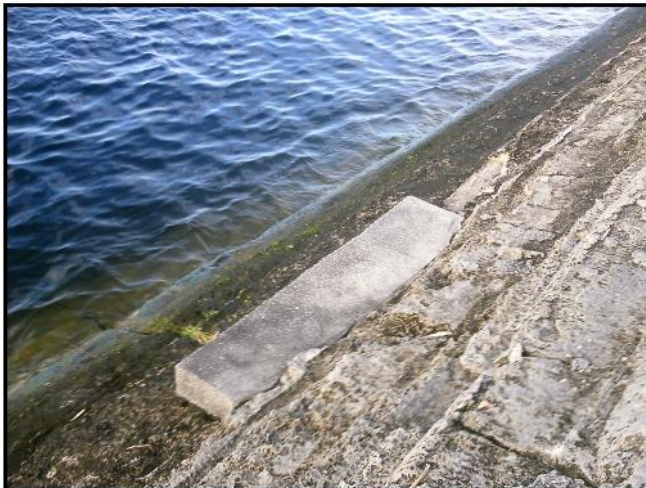
Location: STA 310+65

Description: A repair to the soil-cement slope was observed at STA 310+65 step 13.

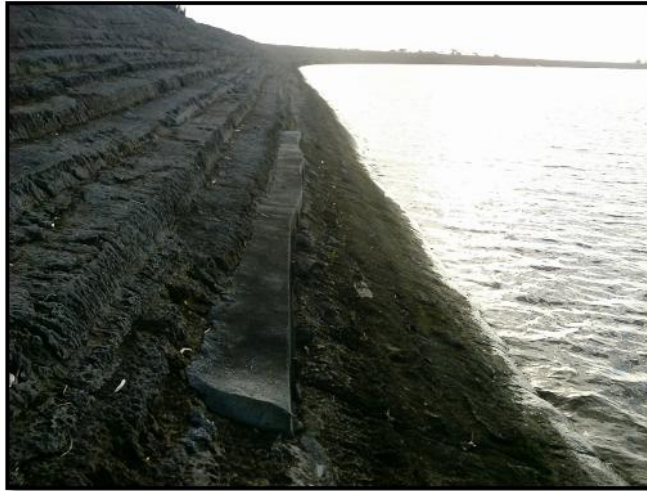
Location: STA 310+65

Description: A repair to the soil-cement slope was observed at STA 310+65 step 12.

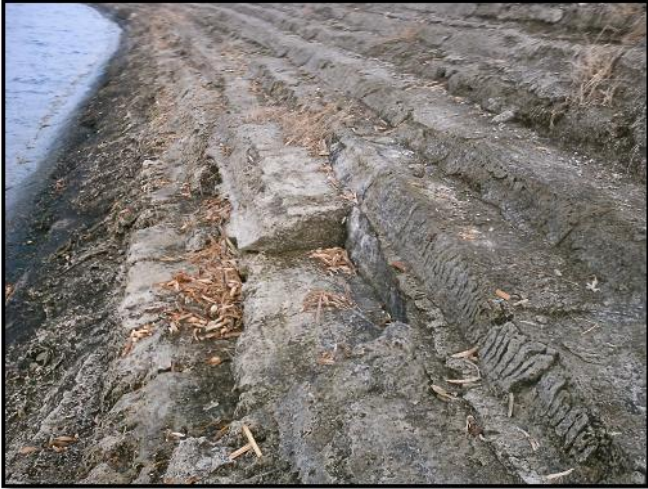
Location: STA 320+00

Description: Large sections from step 14 noted missing at STA 320+00.

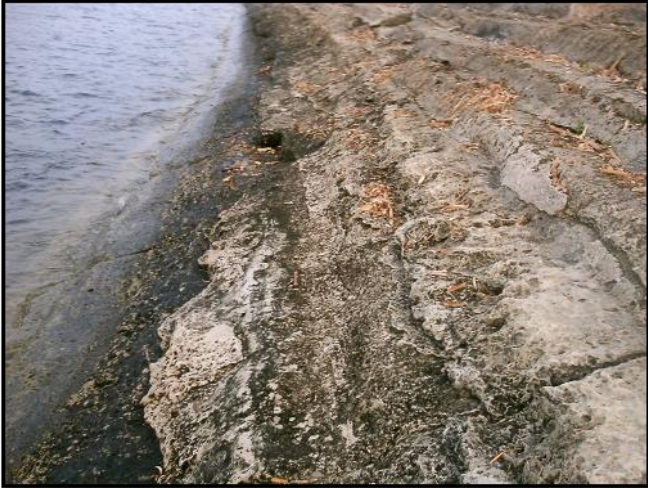
Location: STA 320+00

Description: Large sections from step 14 noted missing at STA 320+00.

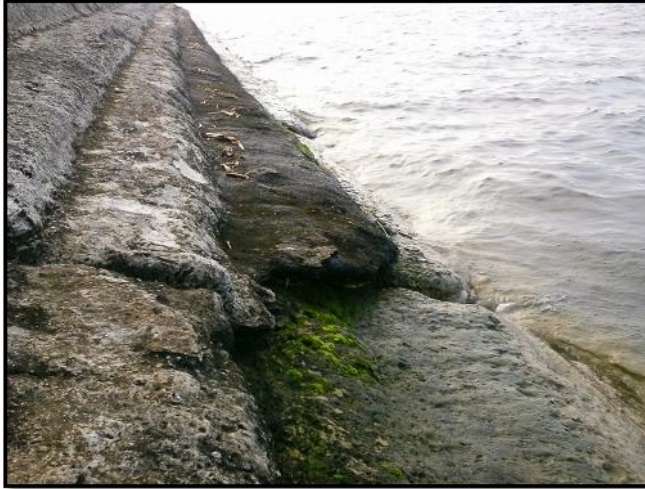
Location: STA 324+00

Description: Large sections of step 16 noted missing at STA 324+00.

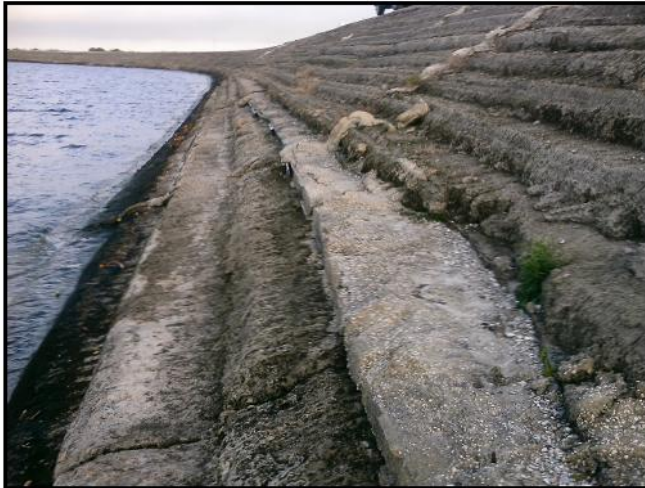
Location: STA 324+00 to STA 327+00

Description: A repair to the soil-cement slope was observed at step 13 STA 324+00 to STA 327+00.

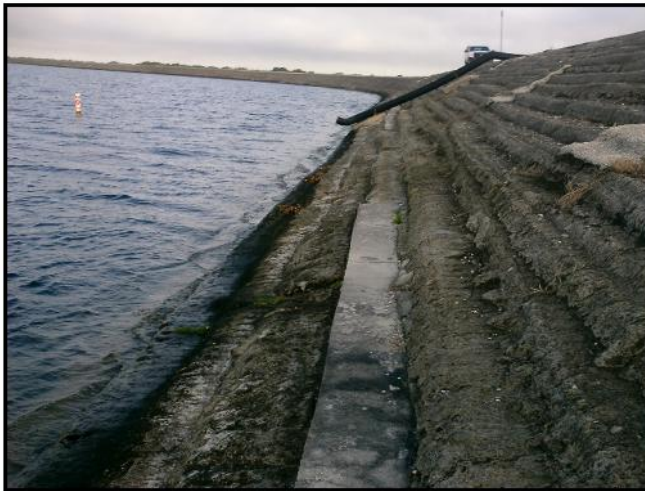
Location: STA 324+00 to STA 327+00

Description: A repair to the soil-cement slope was observed at step 13 STA 324+00 to STA 327+00.

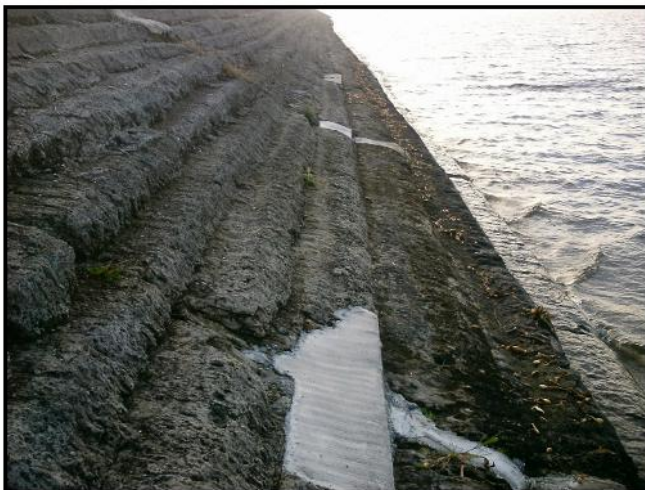
Location: STA STA 324+00 to STA 327+00

Description: A repair to the soil-cement slope was observed at step 13 STA 324+00 to STA 327+00.

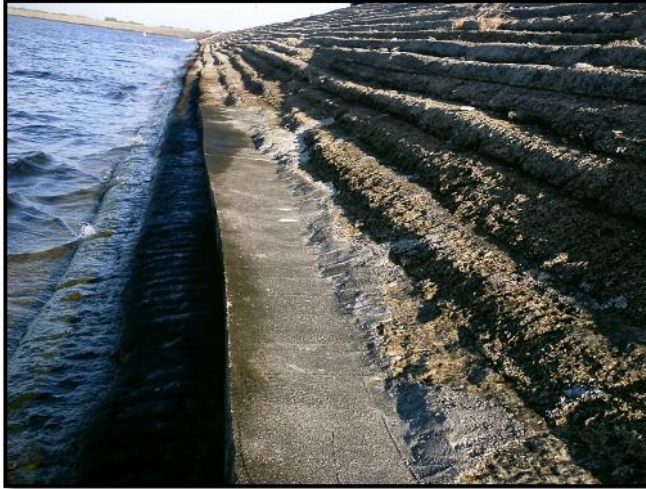
Location: STA 333+15

Description: A repair to the soil-cement slope was observed at step 15 STA 333+15

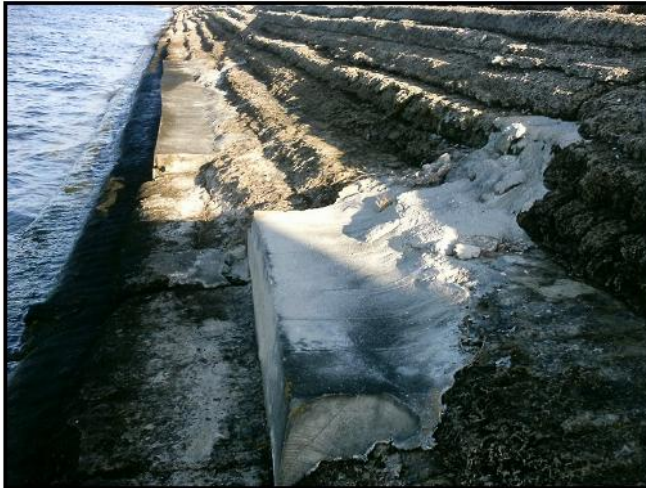
Location: STA 333+15

Description: A repair to the soil-cement slope was observed at step 15 STA 333+15.

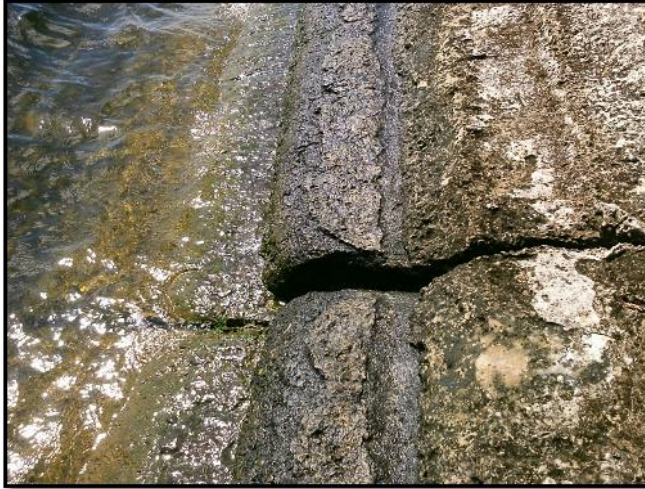
Location: STA 340+00

Description: A large transverse crack noted at STA 340+00.

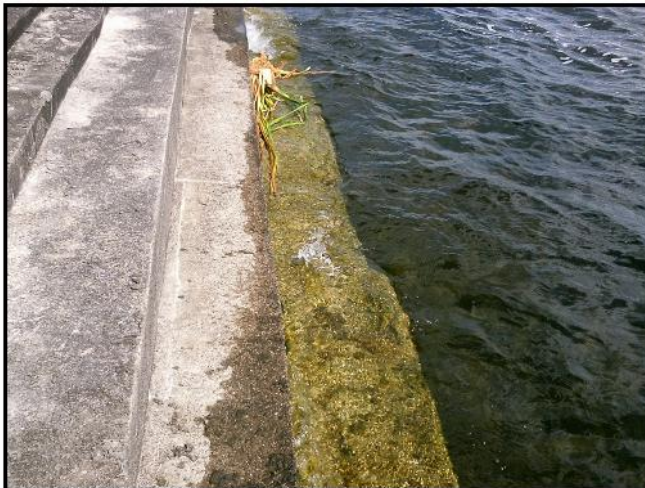
Location: STA 341+45

Description: A repair to the soil-cement slope was observed at STA 341+45.

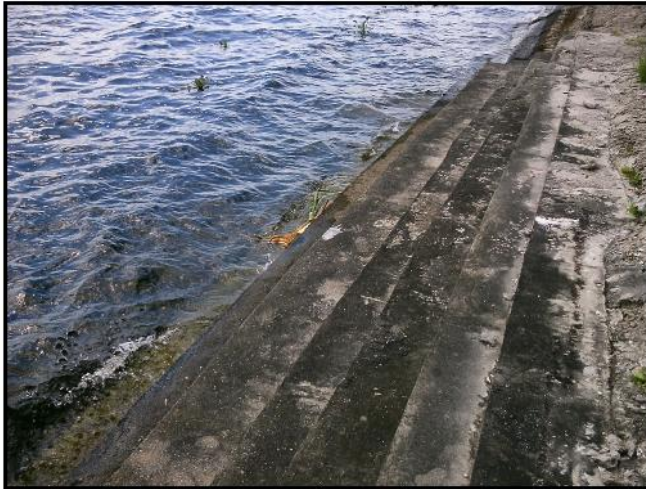
Location: STA 341+45

Description: A repair to the soil-cement slope was observed at STA 341+45.

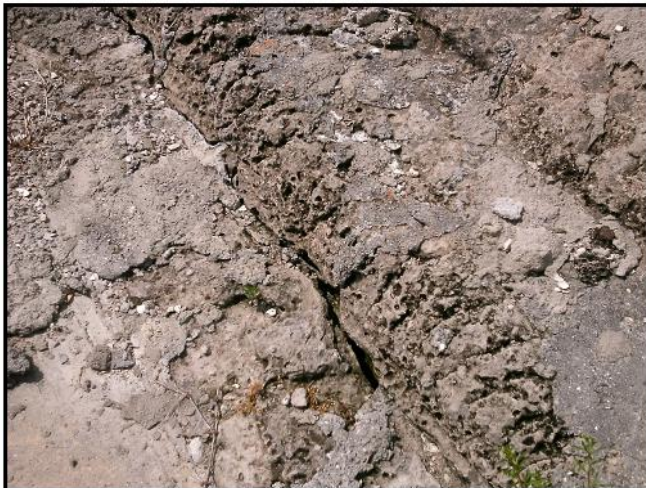
Description: A separation crack was observed from the repair and step 15 at STA 341+45.

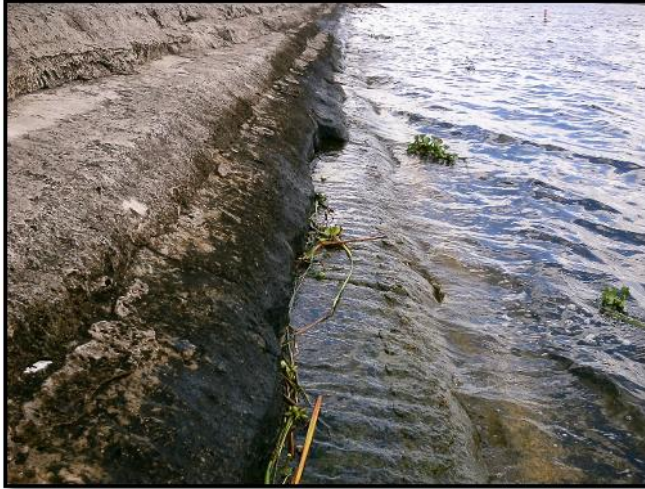
Location: STA 344+00

Description: Under cutting of steps 16 and 17 observed at STA 344+00.
