**Assessment and Design Report
Soil-Cement Condition Assessment and Design Project
Manatee Plant Cooling Pond Dam
Parrish, Florida
Project Number 300906**

To: Mr. Lewis Rounds, P.E.
FPL Manatee Plant

Date: June 2015

From: Jeff Beriswill
Amec Foster Wheeler Environment & Infrastructure, Inc.

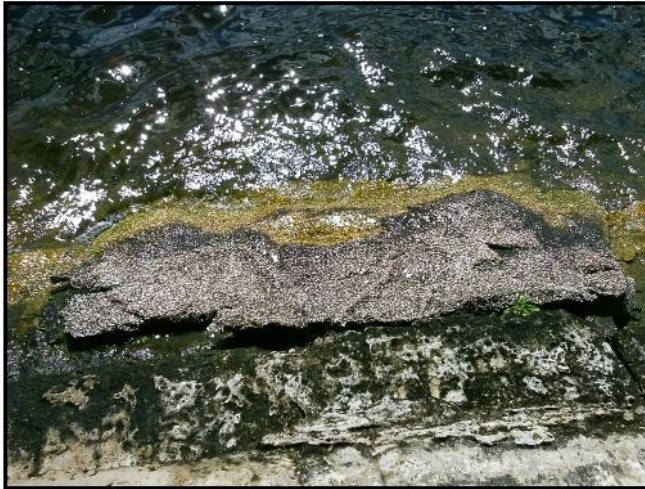
Location: STA 352+00

Description: A concrete slurry repair to the soil-cement slope was observed at step 17 STA 352+00.

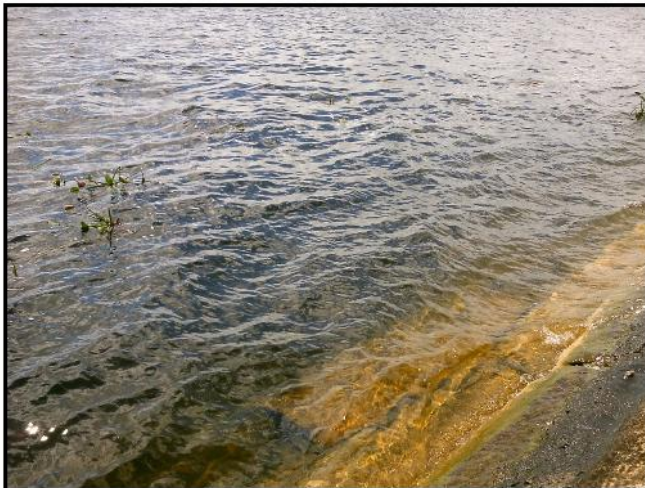
Location: STA 352+00

Description: An underwater repair to the soil-cement slope was observed at STA 352+00. The repair was observed just below the water level.

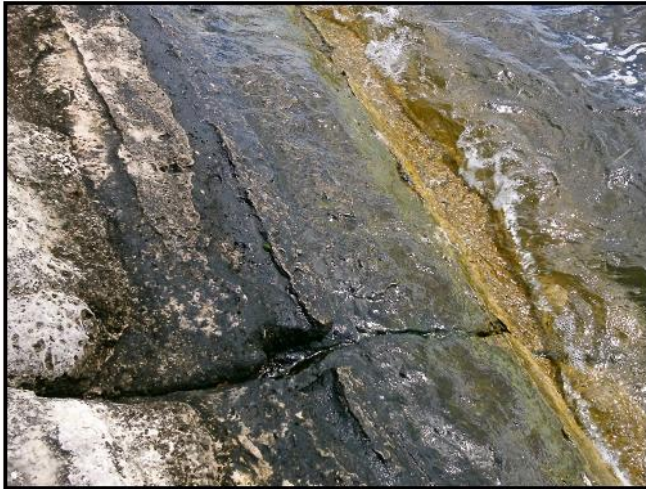
Location: STA 360+00

Description: Extreme erosion of steps 15 and 16 at STA 360+00.

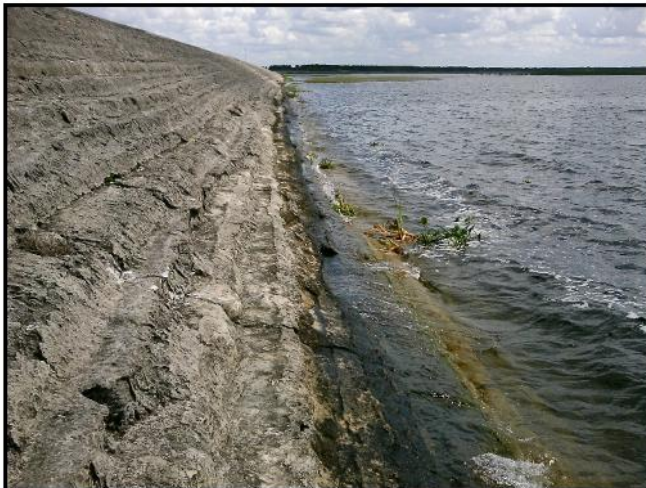
Location: STA 360+00

Description: Multiple sections missing from step 15 at STA 360+00.

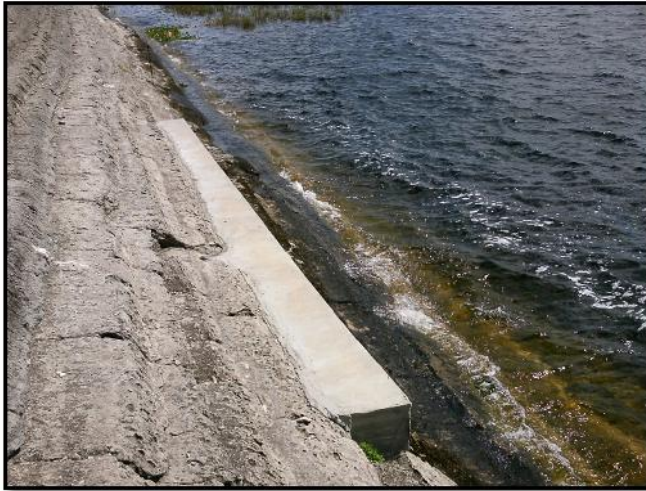
Location: STA 364+00

Description: A repair to the soil-cement slope was observed at step 14 STA 364+00.

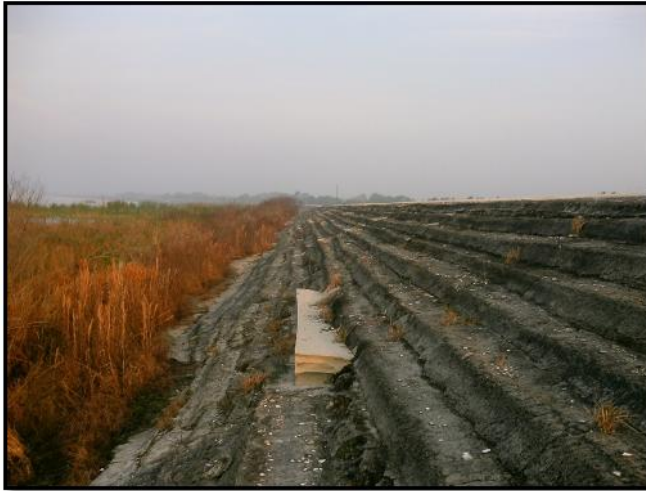
Location: STA 408+00

Description: A repair to the soil-cement slope was observed at STA 408+00 step 8.

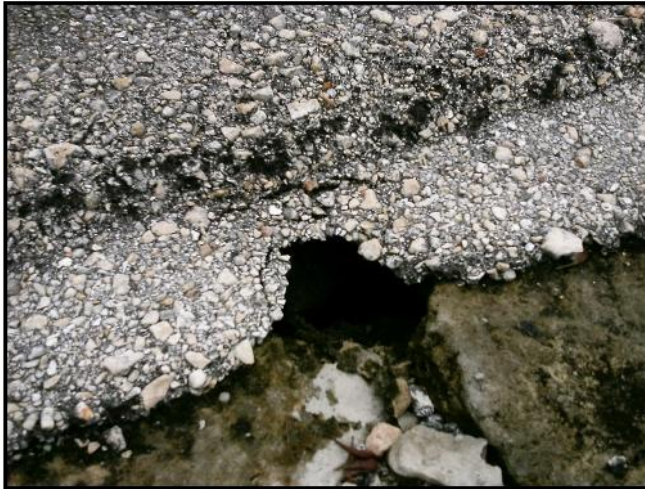
Location: STA 444+00

Description: A small hole/void at least 30 inches deep vertical and lateral under step 1 from edge of asphalt embankment road base.

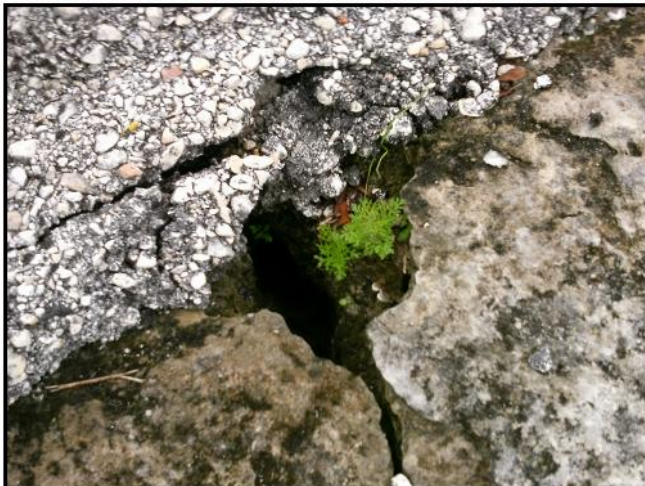
Location: STA 445+20

Description: A small hole/void at least 30 inches deep vertical and lateral under step 1 from edge of asphalt embankment road base.

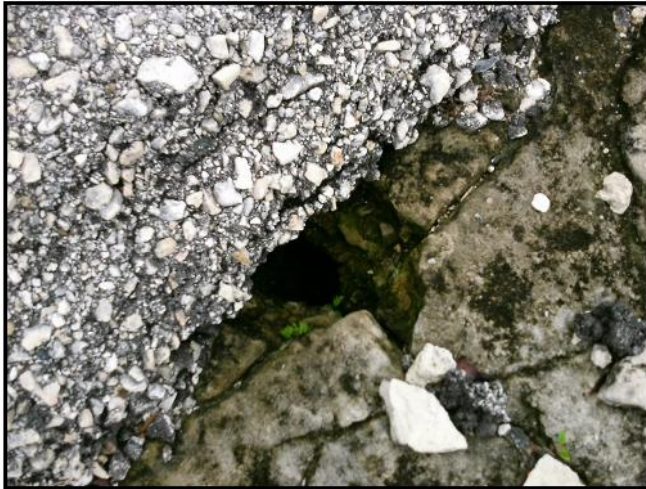
Location: STA 446+45

Description: A small hole/void at least 30 inches deep vertical and lateral under step 1 from edge of asphalt embankment road base.

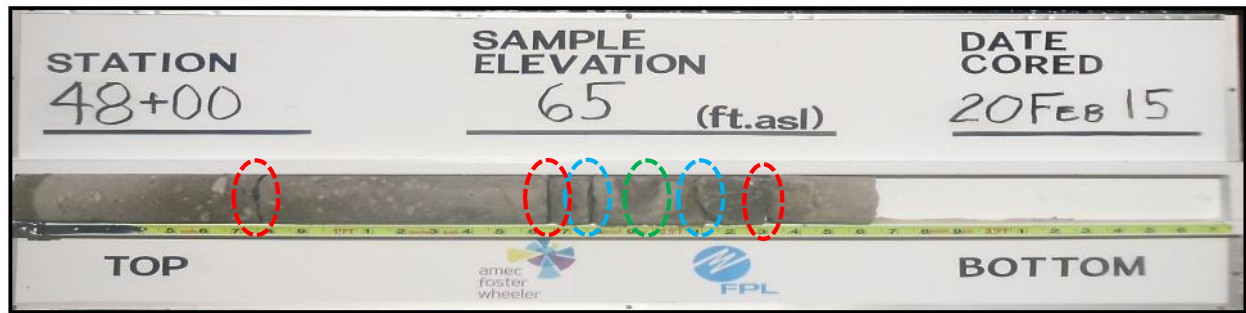
Location: STA 48+00

Core ID:	48+00 (top)	Date Cored:	2/20/15
Core Elevation:	65' ASL	Date Photographed:	2/22/15
Recovered Length (ft):	2.6	SC Thickness (ft):	2.6
RQD (%):	76	Void Depth (ft):	N/A
Notes:	Plant material in core at 1.75 to 2.1 feet

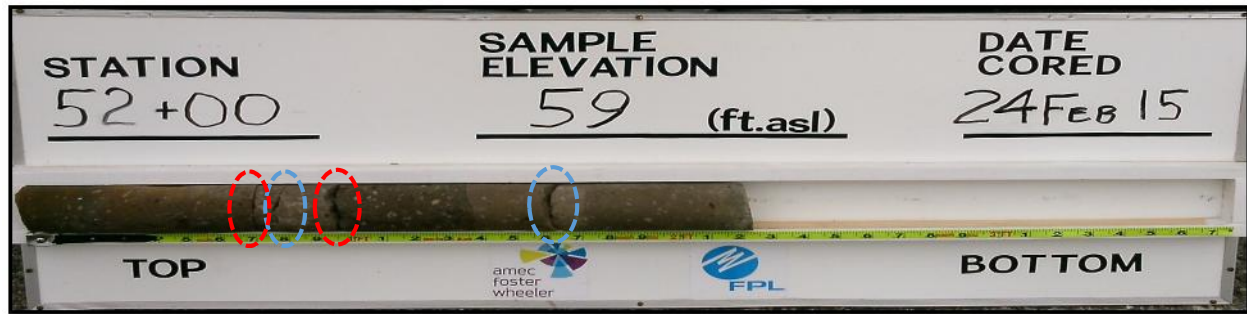
Location: STA 52+00

Core ID:	52+00 (bottom)	Date Cored:	2/20/15
Core Elevation:	59' ASL	Date Photographed:	2/22/15
Recovered Length (ft):	2.22	SC Thickness (ft):	2.92
RQD (%):	87	Void Depth (ft):	0.70
Notes:

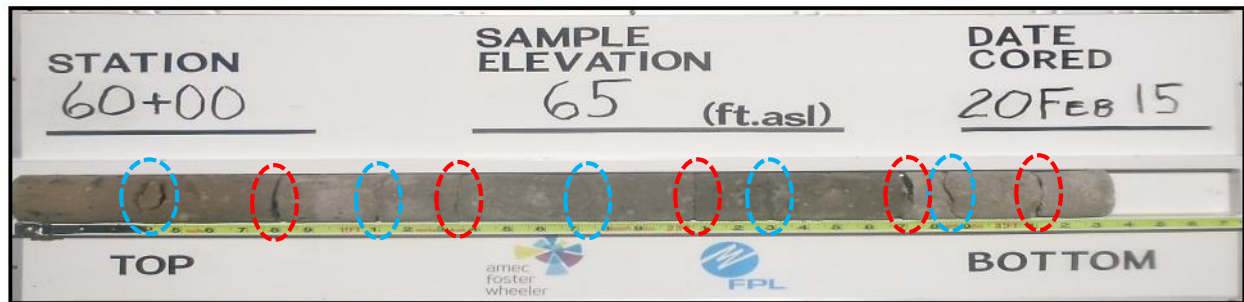
Location: STA 60+00

Core ID:	60+00 (top)	Date Cored:	2/20/15
Core Elevation:	65' ASL	Date Photographed:	2/22/15
Recovered Length (ft):	3.3	SC Thickness (ft):	3.3
RQD (%):	48	Void Depth (ft):	N/A
Notes:	Small void observed at first fracture from top

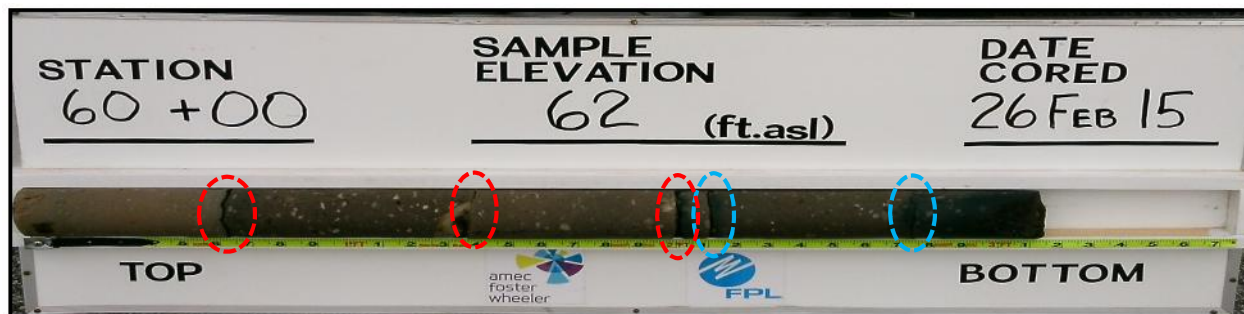
Location: STA 60+00

Core ID:	60+00 (middle)	Date Cored:	2/20/15
Core Elevation:	62' ASL	Date Photographed:	2/22/15
Recovered Length (ft):	3.15	SC Thickness (ft):	3.15
RQD (%):	97	Void Depth (ft):	N/A
Notes:	Void observed at second mechanical break from top

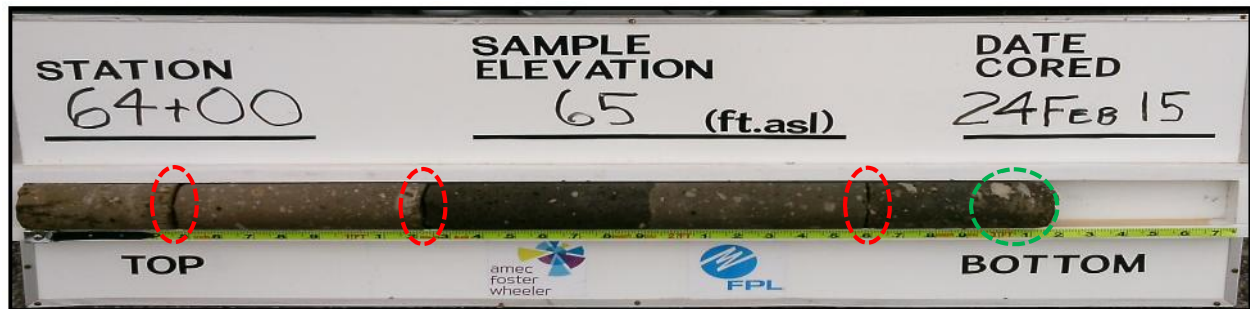
Location: STA 64+00

Core ID:	64+00 (top)	Date Cored:	2/24/15
Core Elevation:	65' ASL	Date Photographed:	2/25/15
Recovered Length (ft):	3.15	SC Thickness (ft):	3.15
RQD (%):	100	Void Depth (ft):	N/A
Notes:	Clay nodules observed at bottom of core

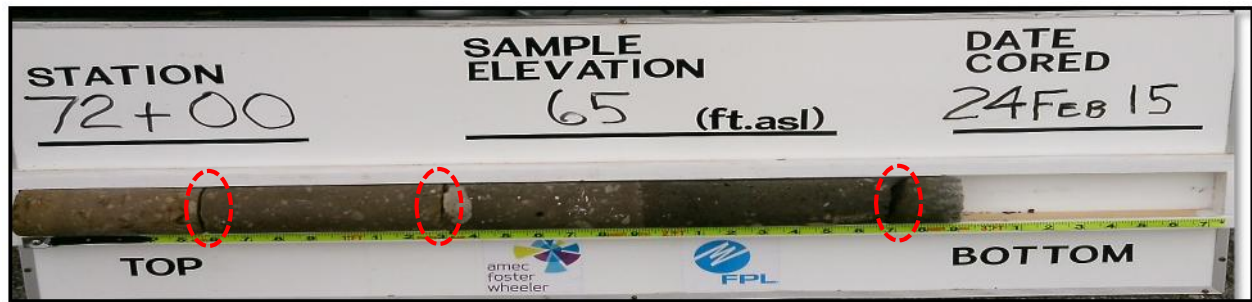
Location: STA 72+00

Core ID:	72+00 (top)	Date Cored:	2/24/15
Core Elevation:	65' ASL	Date Photographed:	2/25/15
Recovered Length (ft):	2.9	SC Thickness (ft):	2.9
RQD (%):	91	Void Depth (ft):	N/A
Notes:	Clay nodule located below second mechanical break from top

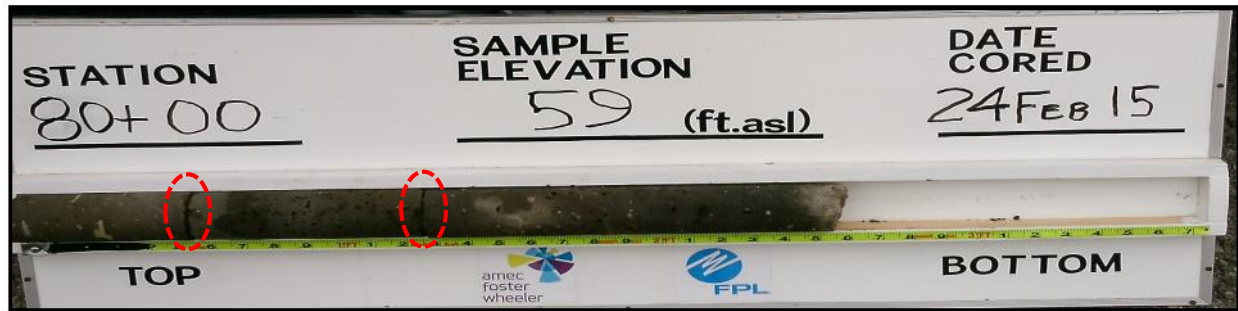
Location: STA 80+00

Core ID:	80+00 (bottom)	Date Cored:	2/24/15
Core Elevation:	59' ASL	Date Photographed:	2/25/15
Recovered Length (ft):	2.55	SC Thickness (ft):	3.08
RQD (%):	100	Void Depth (ft):	N/A
Notes:

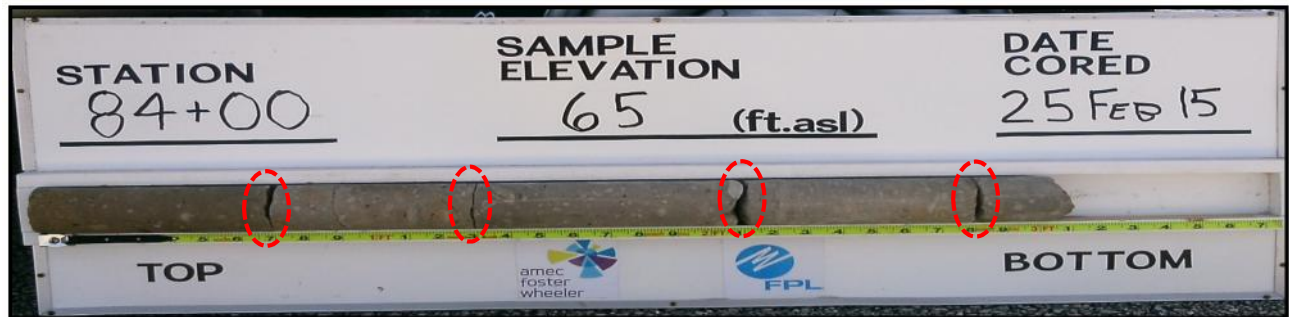
Location: STA 84+00

Core ID:	84+00 (top)	Date Cored:	2/25/15
Core Elevation:	65' ASL	Date Photographed:	3/4/15
Recovered Length (ft):	3.1	SC Thickness (ft):	3.1
RQD (%):	94	Void Depth (ft):	N/A
Notes:

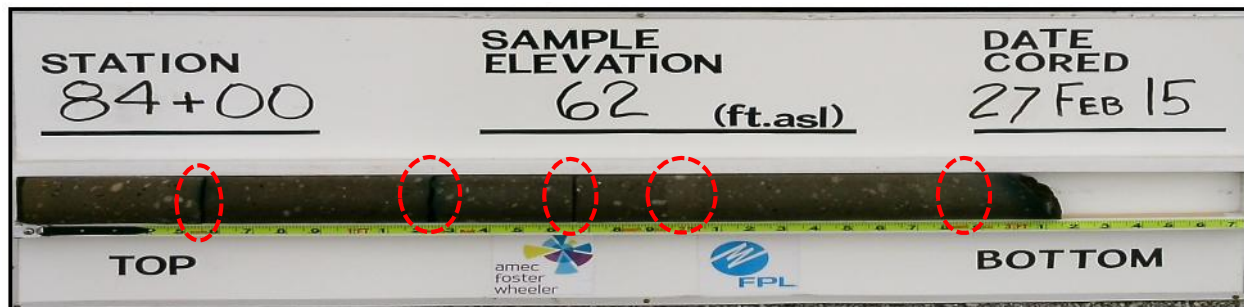
Location: STA 84+00

Core ID:	84+00 (middle)	Date Cored:	2/27/15
Core Elevation:	62' ASL	Date Photographed:	3/4/15
Recovered Length (ft):	3.15	SC Thickness (ft):	3.15
RQD (%):	90	Void Depth (ft):	N/A
Notes:

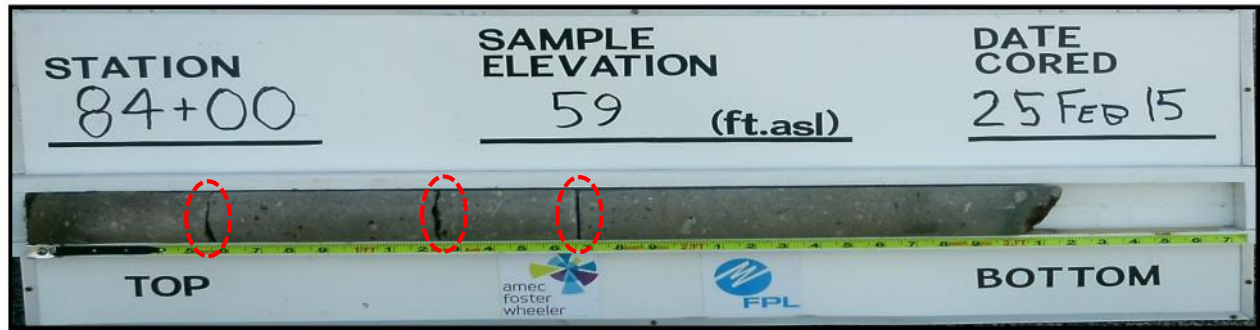
Location: STA 84+00

Core ID:	84+00 (bottom)	Date Cored:	2/25/15
Core Elevation:	59' ASL	Date Photographed:	3/4/15
Recovered Length (ft):	3.1	SC Thickness (ft):	3.1
RQD (%):	100	Void Depth (ft):	N/A
Notes:

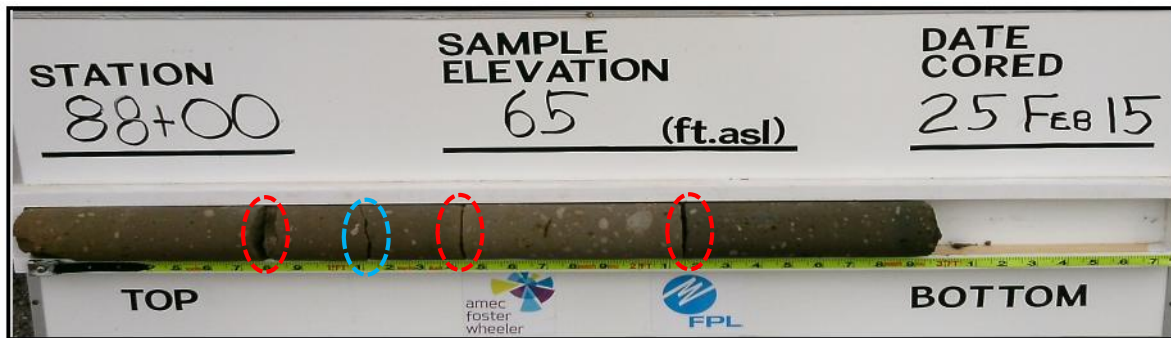
Location: STA 88+00

Core ID:	88+00 (top)	Date Cored:	2/25/15
Core Elevation:	65' ASL	Date Photographed:	2/25/15
Recovered Length (ft):	2.95	SC Thickness (ft):	2.96
RQD (%):	100	Void Depth (ft):	N/A
Notes:

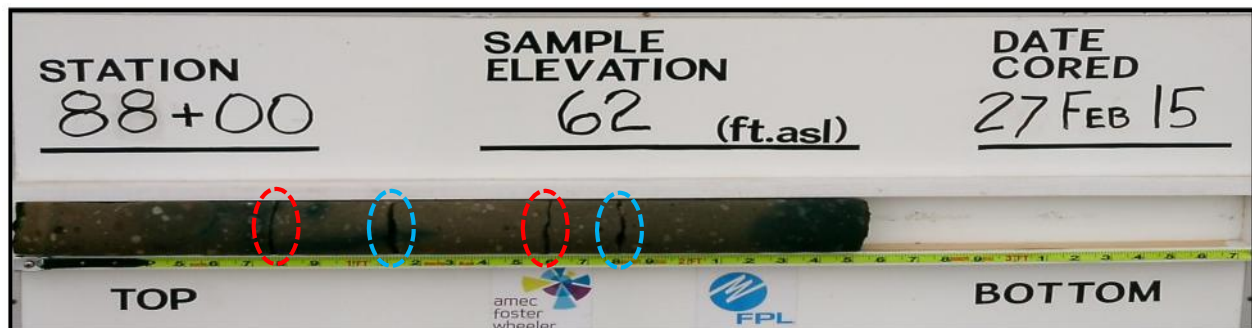
Location: STA 88+00

Core ID:	88+00 (middle)	Date Cored:	2/27/15
Core Elevation:	62' ASL	Date Photographed:	2/27/15
Recovered Length (ft):	2.51	SC Thickness (ft):	2.51
RQD (%):	92	Void Depth (ft):	N/A
Notes:

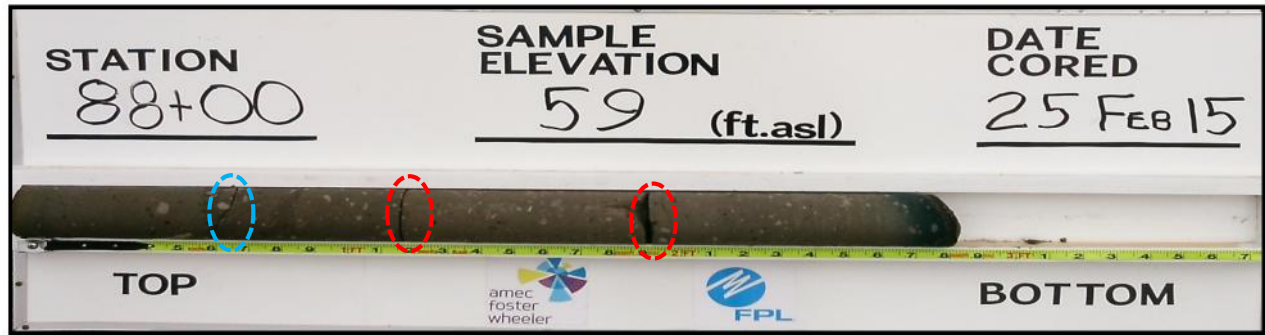
Location: STA 88+00

Core ID:	88+00 (bottom)	Date Cored:	2/25/15
Core Elevation:	59' ASL	Date Photographed:	2/25/15
Recovered Length (ft):	2.8	SC Thickness (ft):	2.8
RQD (%):	100	Void Depth (ft):	N/A
Notes:

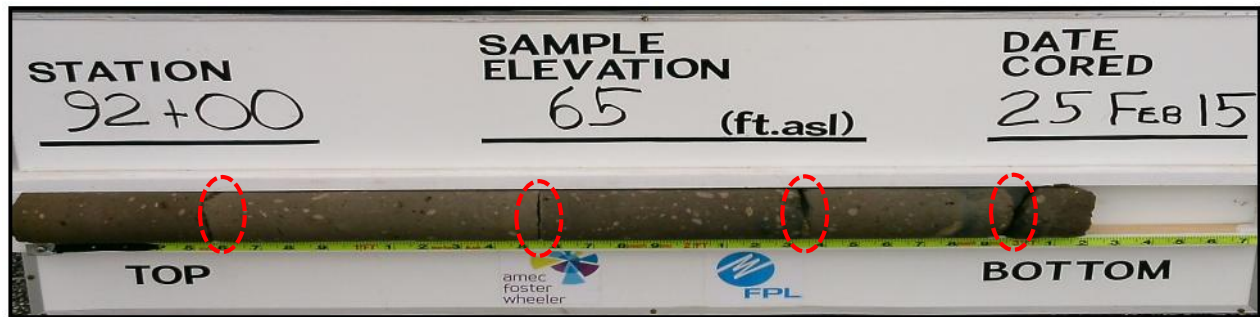
Location: STA 92+00

Core ID:	92+00 (top)	Date Cored:	2/25/15
Core Elevation:	65' ASL	Date Photographed:	2/25/15
Recovered Length (ft):	3.16	SC Thickness (ft):	3.16
RQD (%):	100	Void Depth (ft):	N/A
Notes:

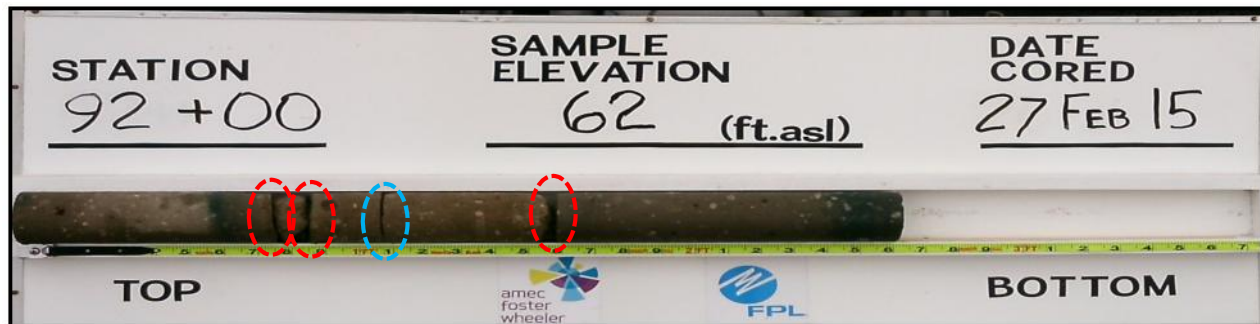
Location: STA 92+00

Core ID:	92+00 (middle)	Date Cored:	2/27/15
Core Elevation:	62' ASL	Date Photographed:	2/27/15
Recovered Length (ft):	2.6	SC Thickness (ft):	2.6
RQD (%):	88	Void Depth (ft):	N/A
Notes:

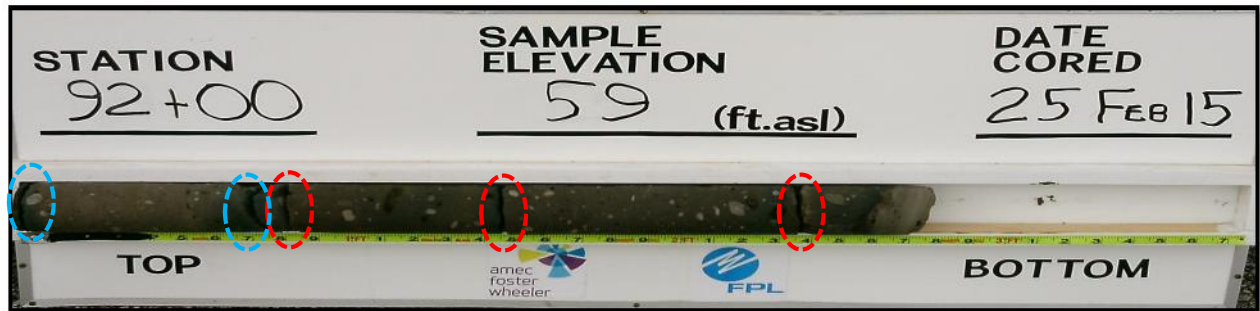
Location: STA 92+00

Core ID:	92+00 (bottom)	Date Cored:	2/25/15
Core Elevation:	59' ASL	Date Photographed:	2/25/15
Recovered Length (ft):	2.73	SC Thickness (ft):	2.73
RQD (%):	95	Void Depth (ft):	N/A
Notes:

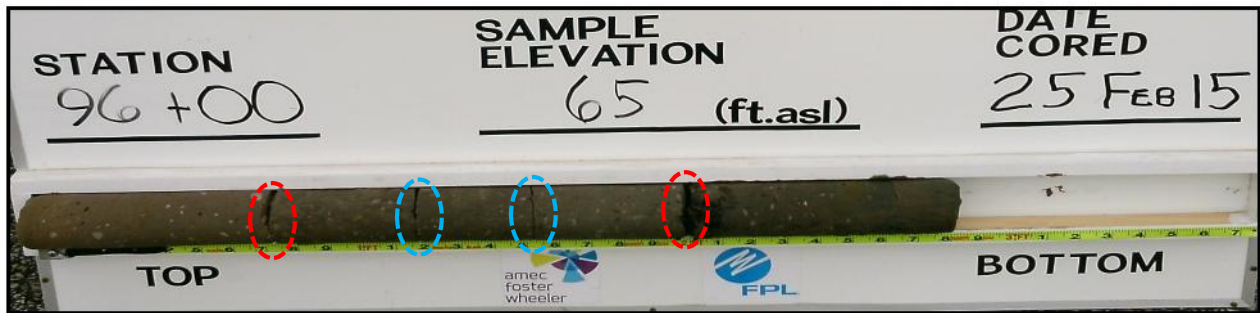
Location: STA 96+00

Core ID:	96+00 (top)	Date Cored:	2/25/15
Core Elevation:	65' ASL	Date Photographed:	2/25/15
Recovered Length (ft):	2.8	SC Thickness (ft):	2.8
RQD (%):	100	Void Depth (ft):	N/A
Notes:

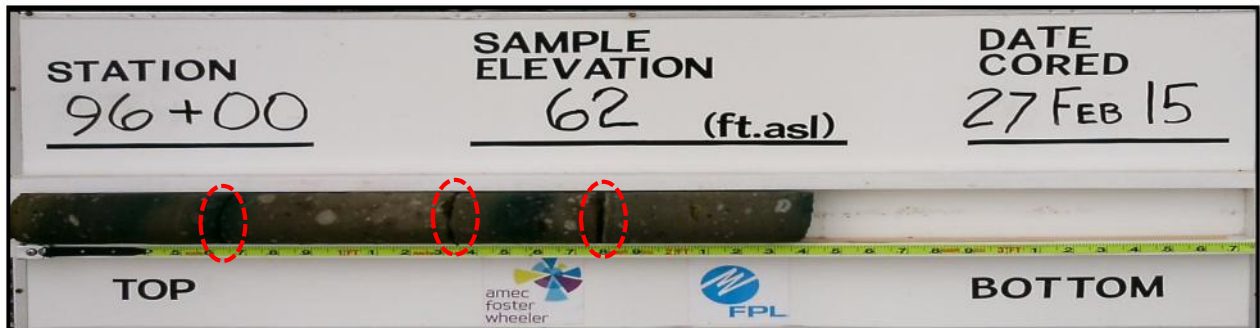
Location: STA 96+00

Core ID:	96+00 (middle)	Date Cored:	2/27/15
Core Elevation:	62' ASL	Date Photographed:	2/27/15
Recovered Length (ft):	2.4	SC Thickness (ft):	2.4
RQD (%):	100	Void Depth (ft):	N/A
Notes:

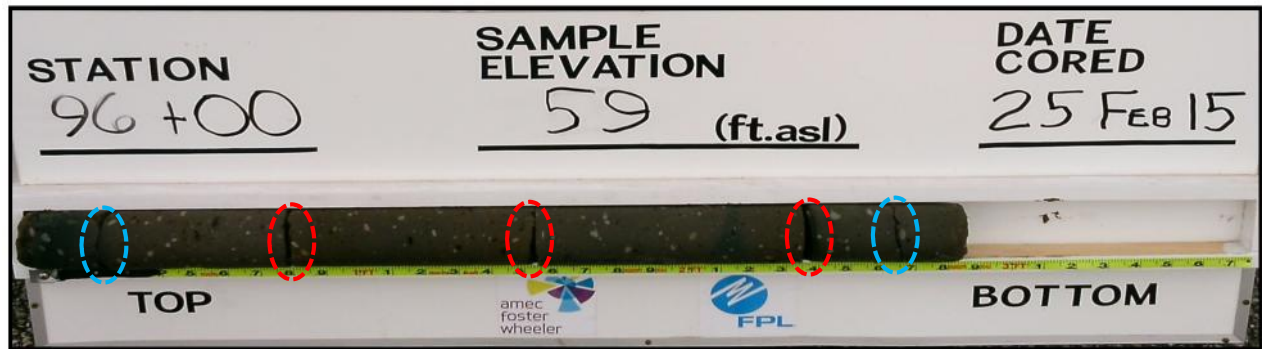
Location: STA 96+00

Core ID:	96+00 (bottom)	Date Cored:	2/25/15
Core Elevation:	59' ASL	Date Photographed:	2/25/15
Recovered Length (ft):	2.82	SC Thickness (ft):	2.82
RQD (%):	74	Void Depth (ft):	N/A
Notes:

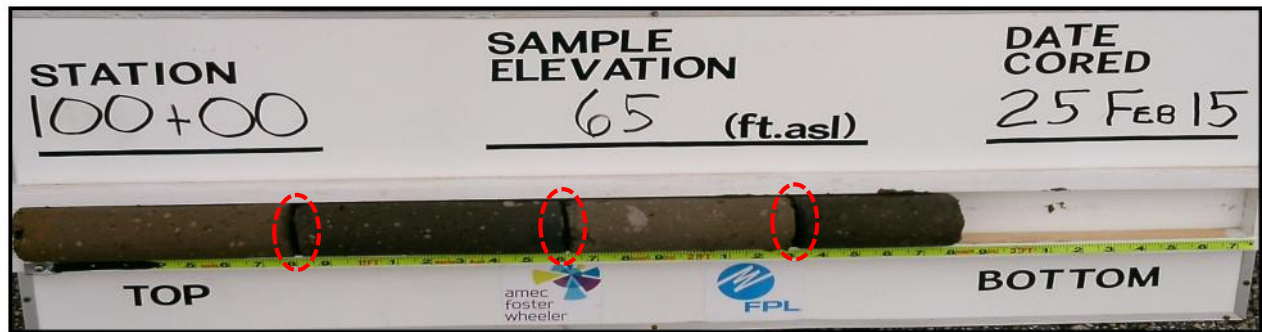
Location: STA 100+00

Core ID:	100+00 (top)	Date Cored:	2/25/15
Core Elevation:	65' ASL	Date Photographed:	2/25/15
Recovered Length (ft):	2.8	SC Thickness (ft):	2.8
RQD (%):	100	Void Depth (ft):	N/A
Notes:

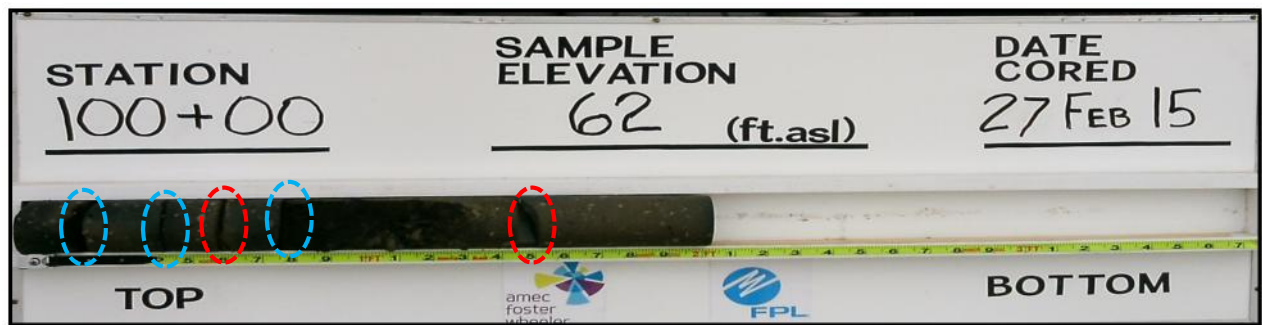
Location: STA 100+00

Core ID:	100+00 (middle)	Date Cored:	2/27/15
Core Elevation:	62' ASL	Date Photographed:	2/27/15
Recovered Length (ft):	2.02	SC Thickness (ft):	2.02
RQD (%):	29	Void Depth (ft):	N/A
Notes:

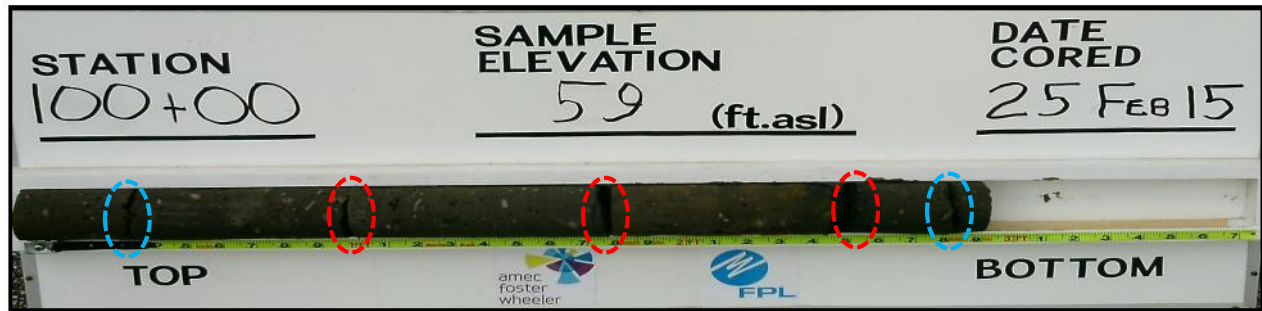
Location: STA 100+00

Core ID:	100+00 (bottom)	Date Cored:	2/25/15
Core Elevation:	59' ASL	Date Photographed:	2/25/15
Recovered Length (ft):	2.9	SC Thickness (ft):	2.9
RQD (%):	97	Void Depth (ft):	N/A
Notes:

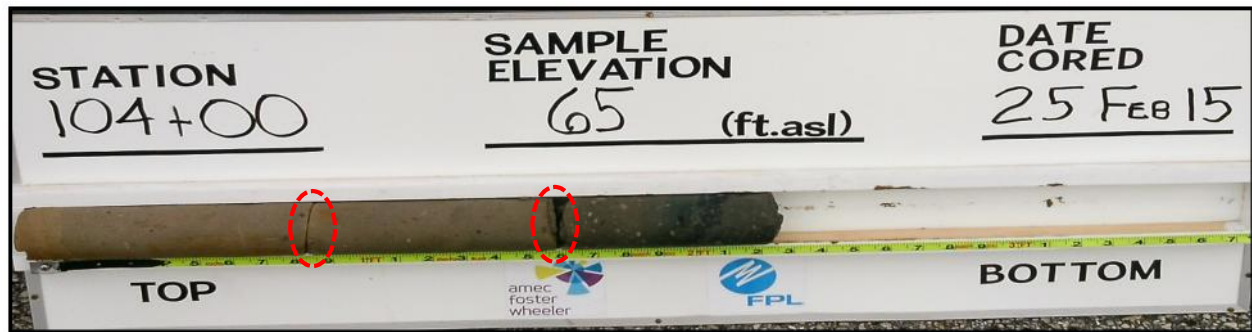
Location: STA 104+00

Core ID:	104+00 (top)	Date Cored:	2/25/15
Core Elevation:	65' ASL	Date Photographed:	2/25/15
Recovered Length (ft):	2.25	SC Thickness (ft):	2.25
RQD (%):	100	Void Depth (ft):	N/A
Notes:

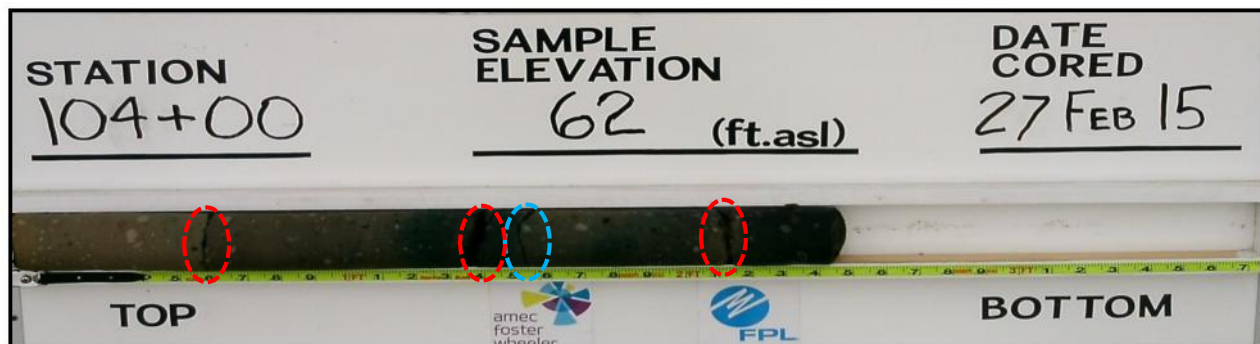
Location: STA 104+00

Core ID:	104+00 (middle)	Date Cored:	2/27/15
Core Elevation:	62' ASL	Date Photographed:	2/27/15
Recovered Length (ft):	2.5	SC Thickness (ft):	2.5
RQD (%):	92	Void Depth (ft):	N/A
Notes:

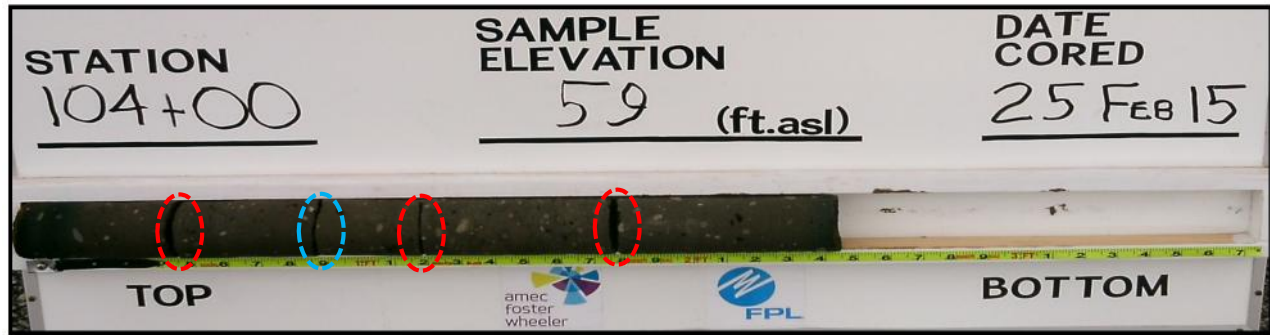
Location: STA 104+00

Core ID:	104+00 (bottom)	Date Cored:	2/25/15
Core Elevation:	59' ASL	Date Photographed:	2/25/15
Recovered Length (ft):	2.45	SC Thickness (ft):	2.83
RQD (%):	100	Void Depth (ft):	N/A
Notes:

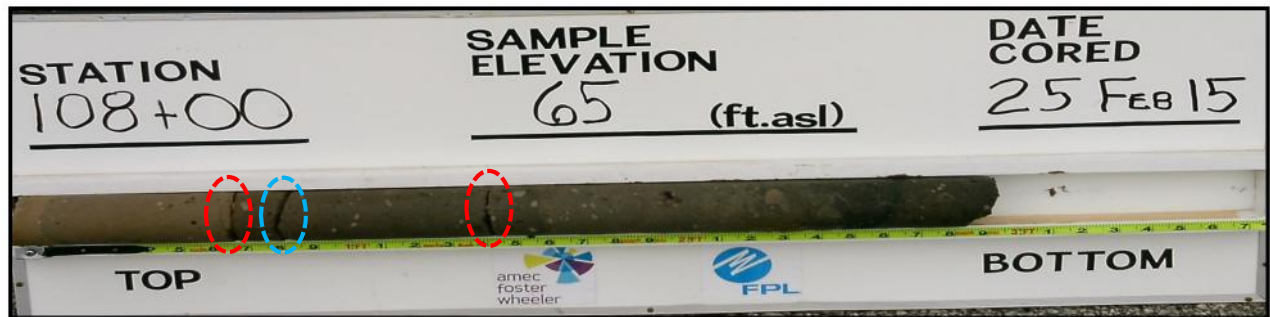
Location: STA 108+00

Core ID:	108+00 (top)	Date Cored:	2/25/15
Core Elevation:	65' ASL	Date Photographed:	2/25/15
Recovered Length (ft):	2.88	SC Thickness (ft):	2.88
RQD (%):	95	Void Depth (ft):	N/A
Notes:

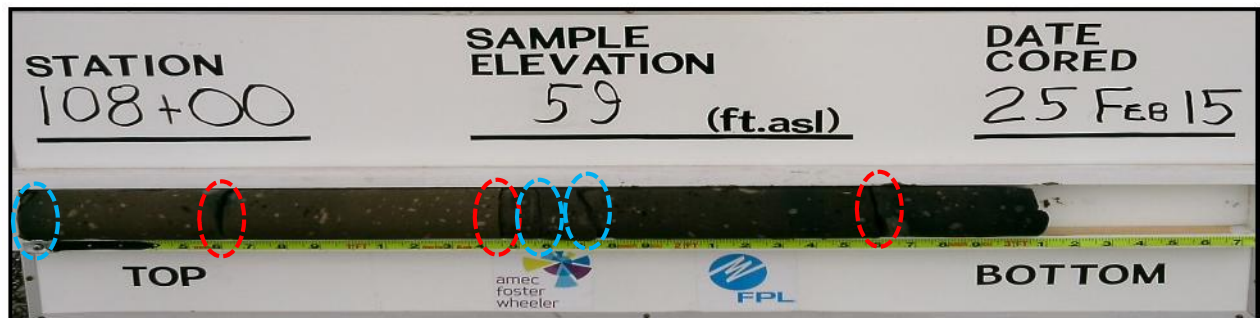
Location: STA 108+00

Core ID:	108+00 (middle)	Date Cored:	2/25/15
Core Elevation:	59' ASL	Date Photographed:	2/25/15
Recovered Length (ft):	3.05	SC Thickness (ft):	3.05
RQD (%):	89	Void Depth (ft):	N/A
Notes:

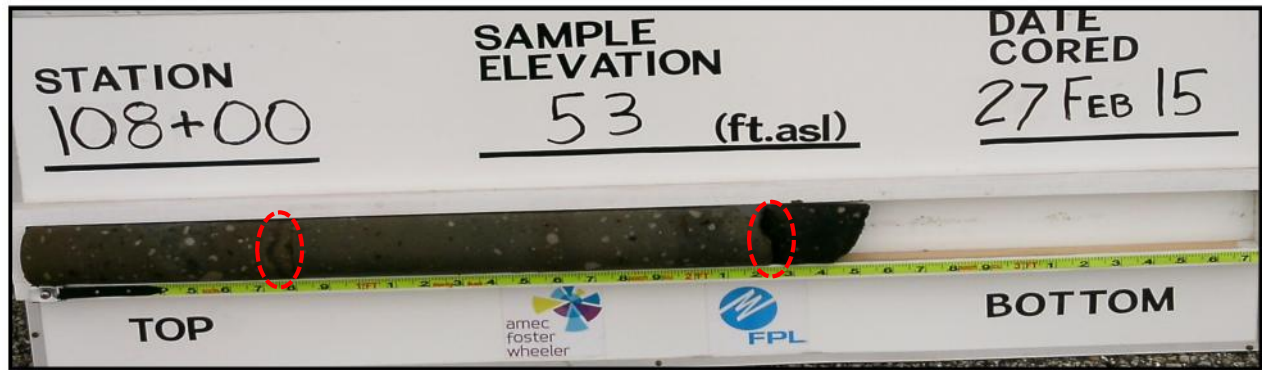
Location: STA 108+00

Core ID:	108+00 (bottom)	Date Cored:	2/27/15
Core Elevation:	53' ASL	Date Photographed:	2/27/15
Recovered Length (ft):	2.51	SC Thickness (ft):	2.51
RQD (%):	90	Void Depth (ft):	N/A
Notes:

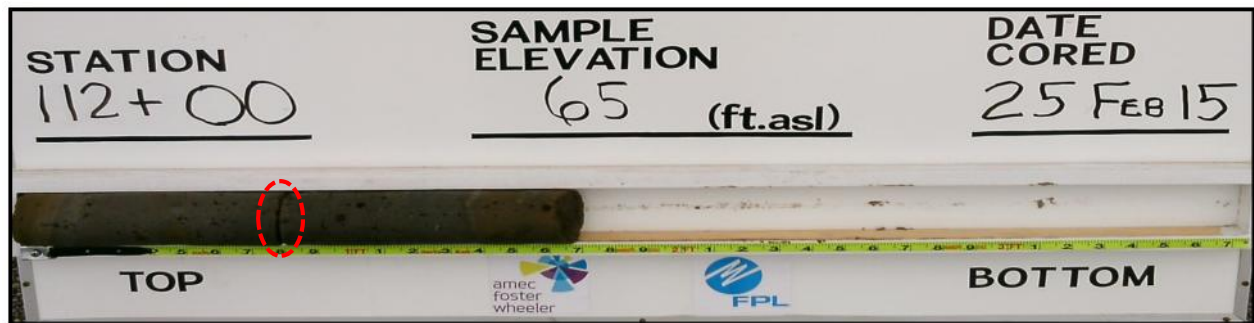
Location: STA 112+00

Core ID:	112+00 (top)	Date Cored:	2/25/15
Core Elevation:	65' ASL	Date Photographed:	2/25/15
Recovered Length (ft):	1.7	SC Thickness (ft):	1.7
RQD (%):	100	Void Depth (ft):	N/A
Notes:

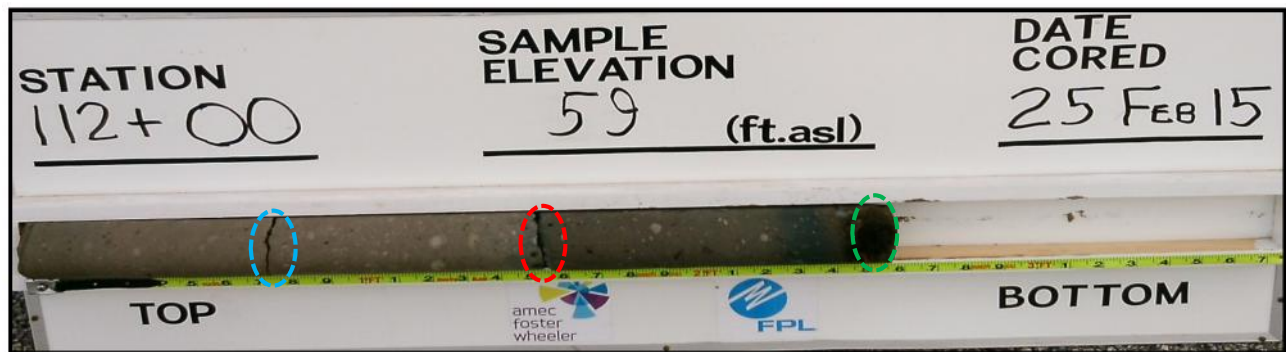
Location: STA 112+00

Core ID:	112+00 (middle)	Date Cored:	2/25/15
Core Elevation:	59' ASL	Date Photographed:	2/25/15
Recovered Length (ft):	2.55	SC Thickness (ft):	3.16
RQD (%):	100	Void Depth (ft):	N/A
Notes:	Plant material 2.52 feet

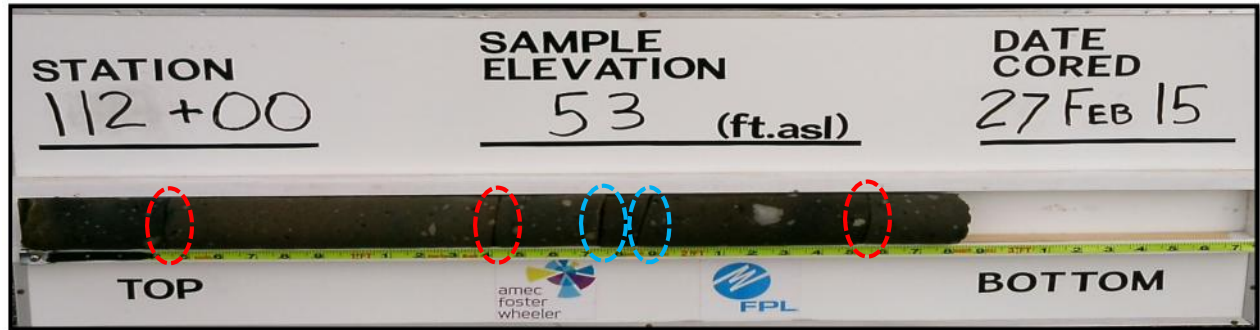
Location: STA 112+00

Core ID:	112+00 (bottom)	Date Cored:	2/27/15
Core Elevation:	53' ASL	Date Photographed:	2/27/15
Recovered Length (ft):	2.8	SC Thickness (ft):	3.25
RQD (%):	74	Void Depth (ft):	N/A
Notes:

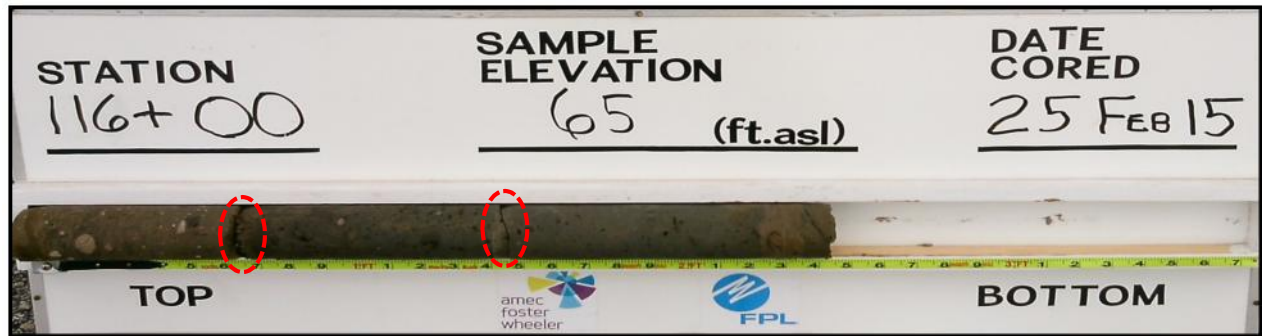
Location: STA 116+00

Core ID:	116+00 (top)	Date Cored:	2/25/15
Core Elevation:	65' ASL	Date Photographed:	2/25/15
Recovered Length (ft):	2.43	SC Thickness (ft):	2.43
RQD (%):	100	Void Depth (ft):	N/A
Notes:

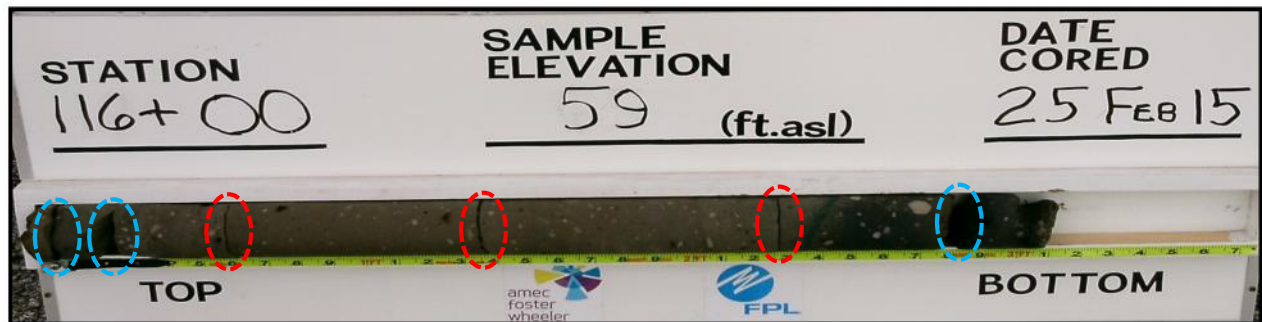
Location: STA 116+00

Core ID:	116+00 (middle)	Date Cored:	2/25/15
Core Elevation:	59' ASL	Date Photographed:	2/25/15
Recovered Length (ft):	3.1	SC Thickness (ft):	3.1
RQD (%):	82	Void Depth (ft):	N/A
Notes:

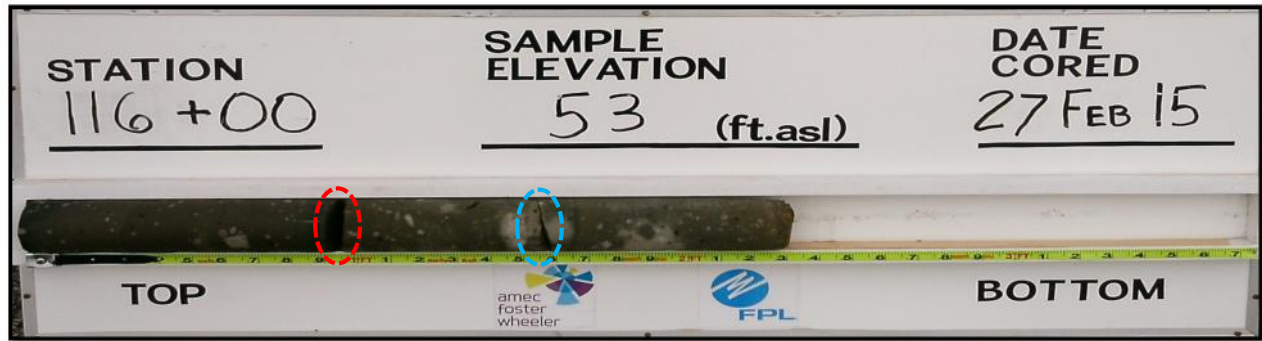
Location: STA 116+00

Core ID:	116+00 (bottom)	Date Cored:	2/27/15
Core Elevation:	53' ASL	Date Photographed:	2/27/15
Recovered Length (ft):	2.3	SC Thickness (ft):	2.3
RQD (%):	100	Void Depth (ft):	N/A
Notes:

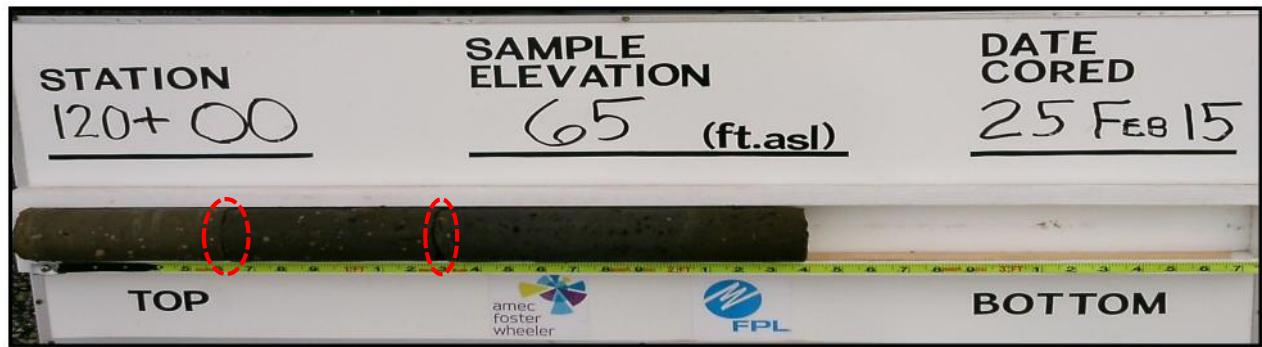
Location: STA 120+00

Core ID:	120+00 (top)	Date Cored:	2/25/15
Core Elevation:	65' ASL	Date Photographed:	2/25/15
Recovered Length (ft):	2.4	SC Thickness (ft):	2.4
RQD (%):	100	Void Depth (ft):	N/A
Notes:

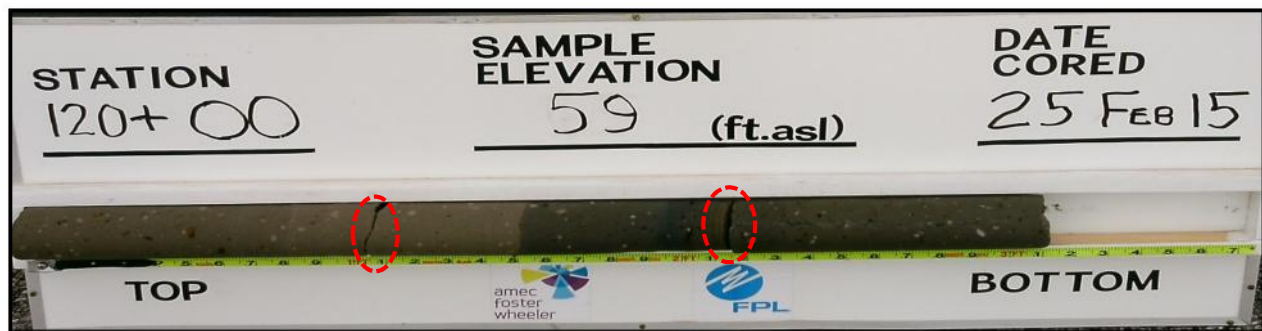
Location: STA 120+00

Core ID:	120+00 (middle)	Date Cored:	2/25/15
Core Elevation:	59' ASL	Date Photographed:	2/25/15
Recovered Length (ft):	4.0	SC Thickness (ft):	4.0
RQD (%):	100	Void Depth (ft):	N/A
Notes:

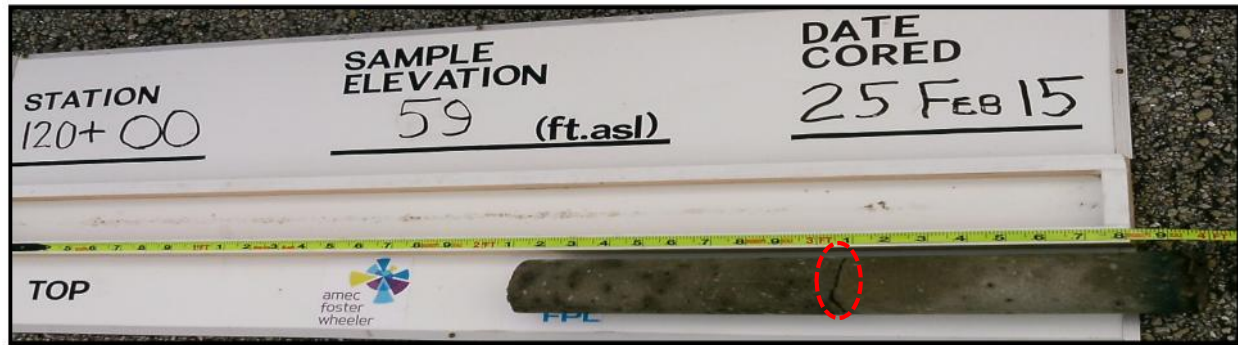
Location: STA 120+00

Core ID:	120+00 (mid)	Date Cored:	2/25/15
Core Elevation:	59' ASL	Date Photographed:	2/25/15
Recovered Length (ft):	4.0	SC Thickness (ft):	4.0
RQD (%):	100	Void Depth (ft):	N/A
Notes:

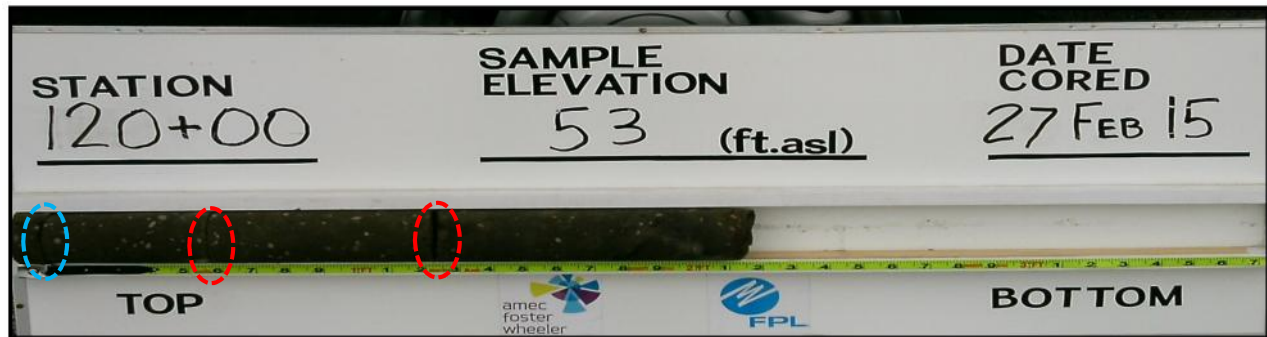
Location: STA 120+00

Core ID:	120+00 (bot)	Date Cored:	2/27/15
Core Elevation:	53' ASL	Date Photographed:	2/27/15
Recovered Length (ft):	2.15	SC Thickness (ft):	3.0
RQD (%):	99	Void Depth (ft):	N/A
Notes:

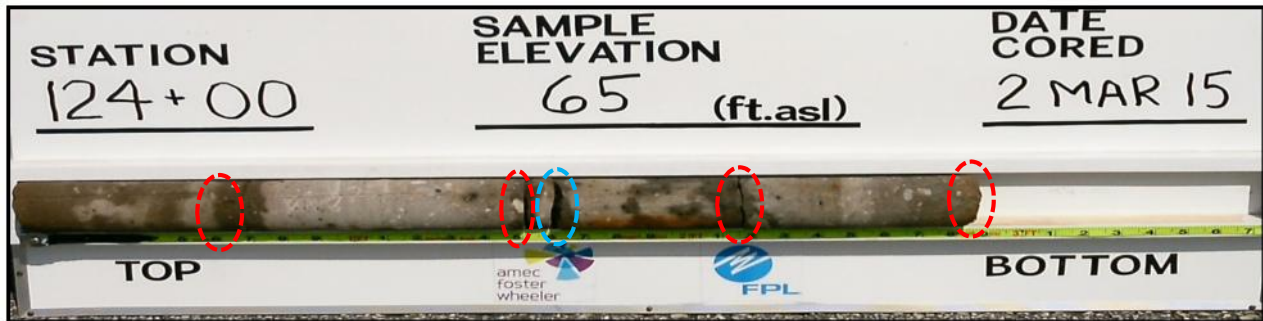
Location: STA 124+00

Core ID:	124+00 (top)	Date Cored:	3/2/15
Core Elevation:	65' ASL	Date Photographed:	3/2/15
Recovered Length (ft):	2.82	SC Thickness (ft):	2.82
RQD (%):	99	Void Depth (ft):	N/A
Notes:

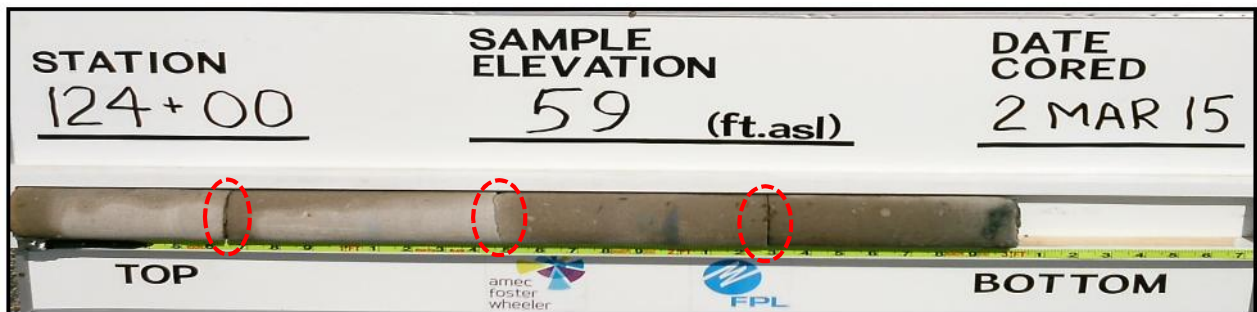
Location: STA 124+00

Core ID:	124+00 (middle)	Date Cored:	3/2/15
Core Elevation:	59' ASL	Date Photographed:	3/2/15
Recovered Length (ft):	3.0	SC Thickness (ft):	3.0
RQD (%):	100	Void Depth (ft):	N/A
Notes:

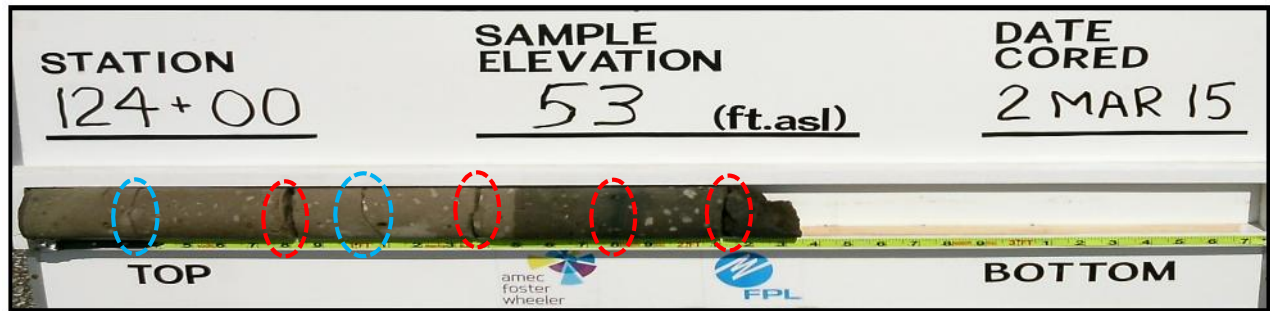
Location: STA 124+00

Core ID:	124+00 (bottom)	Date Cored:	3/2/15
Core Elevation:	53' ASL	Date Photographed:	3/2/15
Recovered Length (ft):	2.3	SC Thickness (ft):	2.3
RQD (%):	70	Void Depth (ft):	N/A
Notes:

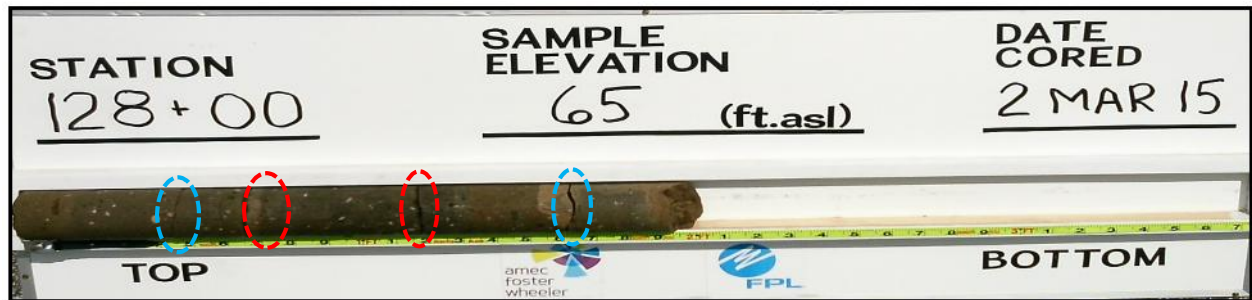
Location: STA 128+00

Core ID:	128+00 (top)	Date Cored:	3/2/15
Core Elevation:	65' ASL	Date Photographed:	3/2/15
Recovered Length (ft):	2.0	SC Thickness (ft):	2.0
RQD (%):	90	Void Depth (ft):	N/A
Notes:
