**Assessment and Design Report
Soil-Cement Condition Assessment and Design Project
Manatee Plant Cooling Pond Dam
Parrish, Florida
Project Number 300906**

To: Mr. Lewis Rounds, P.E.
FPL Manatee Plant

Date: June 2015

From: Jeff Beriswill
Amec Foster Wheeler Environment & Infrastructure, Inc.

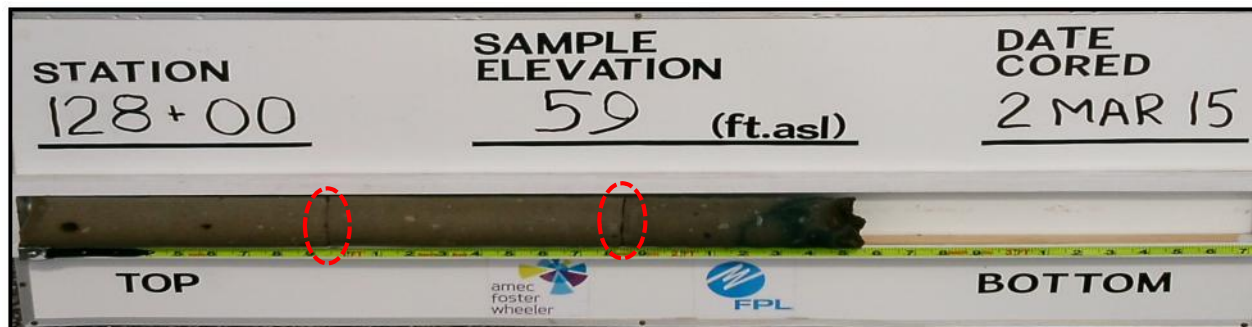
Location: STA 128+00

Core ID:	128+00 (middle)	Date Cored:	3/2/15
Core Elevation:	59' ASL	Date Photographed:	3/2/15
Recovered Length (ft):	2.55	SC Thickness (ft):	2.97
RQD (%):	100	Void Depth (ft):	N/A
Notes:

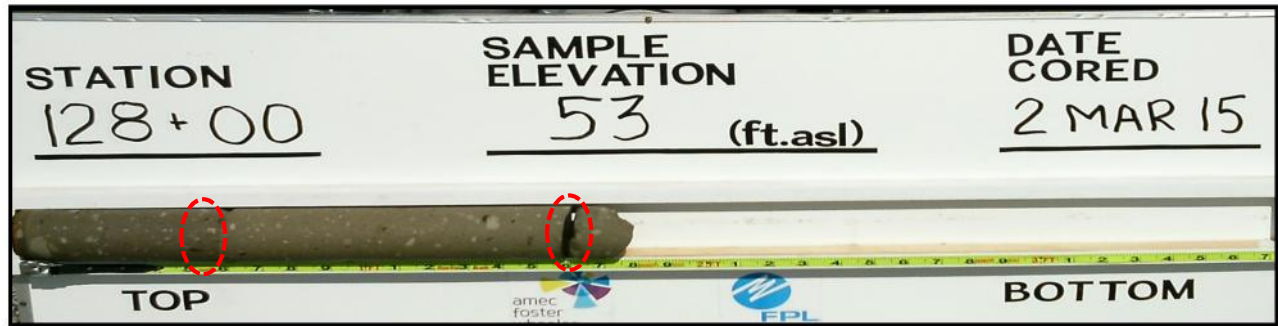
Location: STA 128+00

Core ID:	128+00 (bottom)	Date Cored:	3/2/15
Core Elevation:	53' ASL	Date Photographed:	3/2/15
Recovered Length (ft):	1.75	SC Thickness (ft):	2.0
RQD (%):	91	Void Depth (ft):	N/A
Notes:

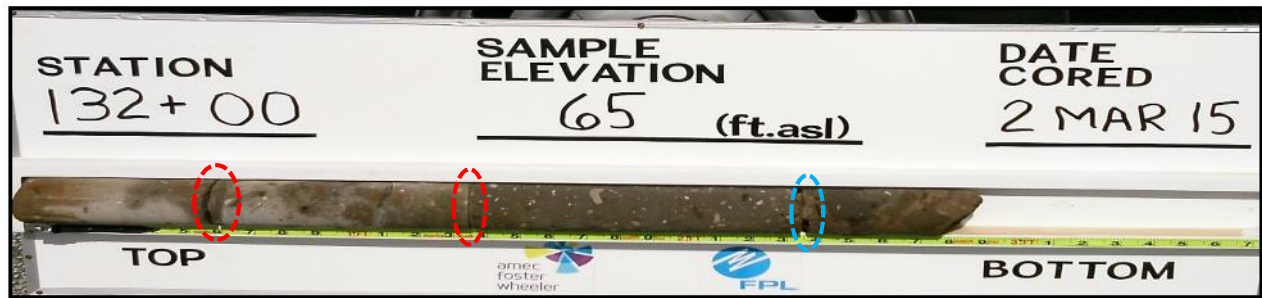
Location: STA 132+00

Core ID:	132+00 (top)	Date Cored:	3/2/15
Core Elevation:	65' ASL	Date Photographed:	3/2/15
Recovered Length (ft):	2.8	SC Thickness (ft):	2.8
RQD (%):	84	Void Depth (ft):	N/A
Notes:

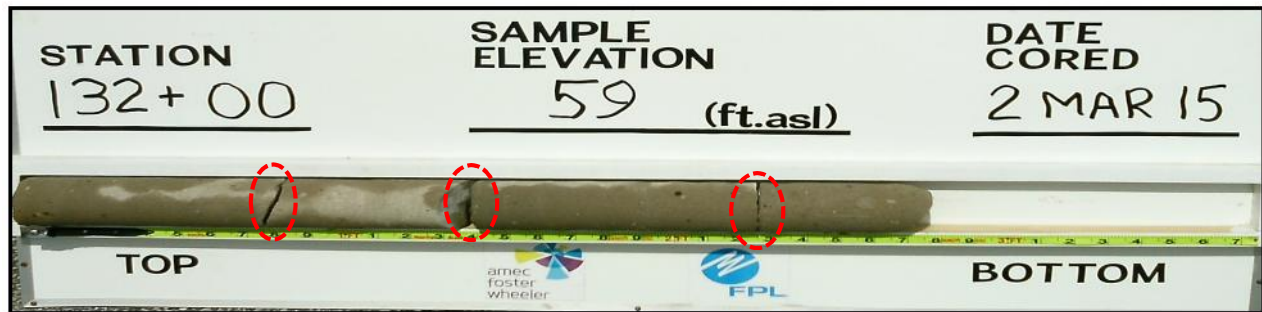
Location: STA 132+00

Core ID:	128+00 (middle)	Date Cored:	3/2/15
Core Elevation:	59' ASL	Date Photographed:	3/2/15
Recovered Length (ft):	2.7	SC Thickness (ft):	3.0
RQD (%):	100	Void Depth (ft):	N/A
Notes:

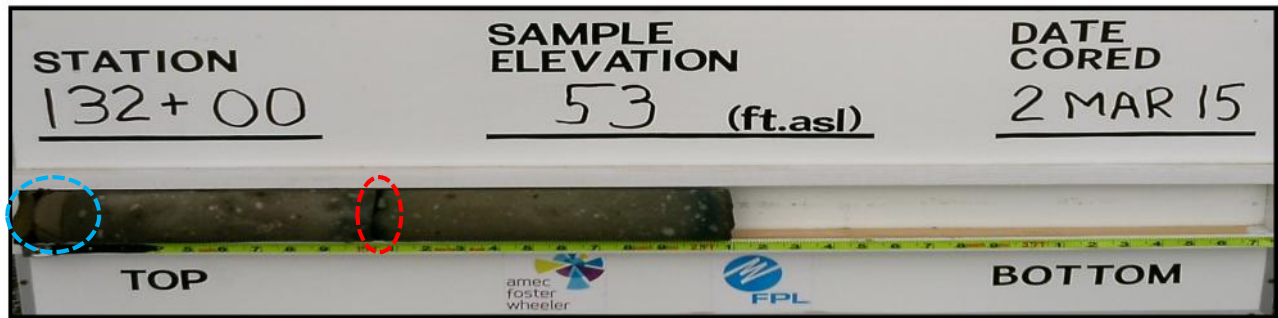
Location: STA 132+00

Core ID:	132+00 (bottom)	Date Cored:	3/2/15
Core Elevation:	53' ASL	Date Photographed:	3/2/15
Recovered Length (ft):	2.1	SC Thickness (ft):	2.5
RQD (%):	99	Void Depth (ft):	N/A
Notes:

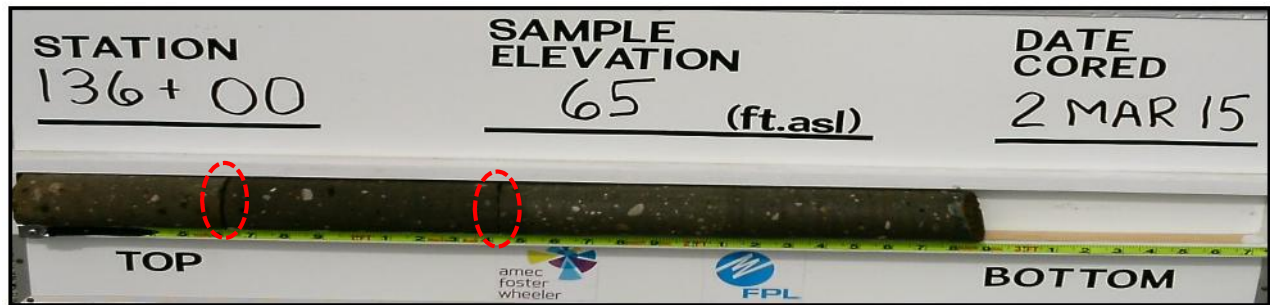
Location: STA 136+00

Core ID:	136+00 (top)	Date Cored:	3/2/15
Core Elevation:	65' ASL	Date Photographed:	3/2/15
Recovered Length (ft):	2.85	SC Thickness (ft):	2.85
RQD (%):	100	Void Depth (ft):	N/A
Notes:

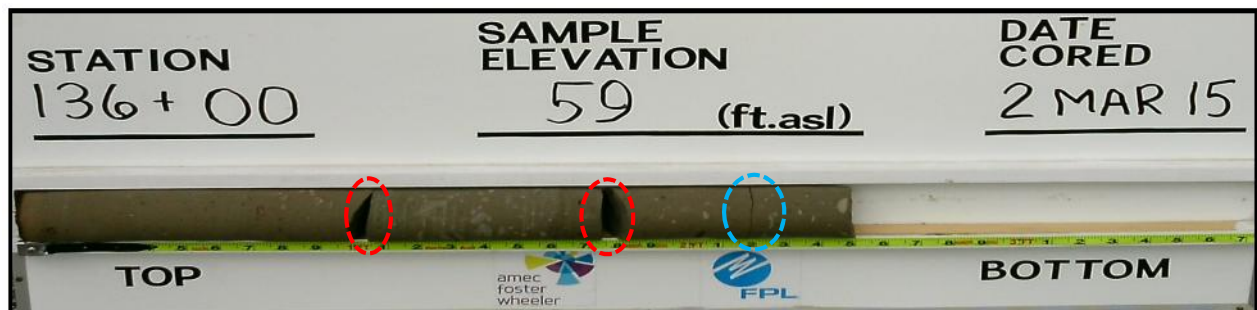
Location: STA 136+00

Core ID:	136+00 (middle)	Date Cored:	3/2/15
Core Elevation:	59' ASL	Date Photographed:	3/2/15
Recovered Length (ft):	2.5	SC Thickness (ft):	2.5
RQD (%):	100	Void Depth (ft):	N/A
Notes:

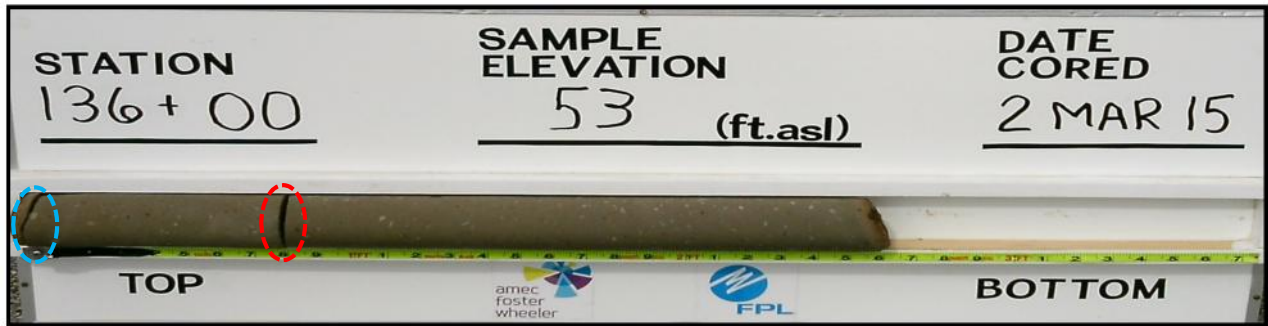
Location: STA 136+00

Core ID:	136+00 (bottom)	Date Cored:	3/2/15
Core Elevation:	53' ASL	Date Photographed:	3/2/15
Recovered Length (ft):	2.6	SC Thickness (ft):	2.6
RQD (%):	99	Void Depth (ft):	N/A
Notes:

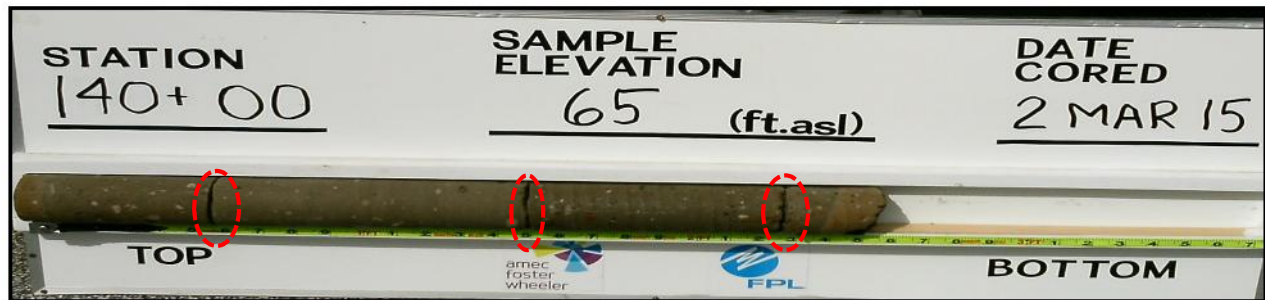
Location: STA 140+00

Core ID:	140+00 (top)	Date Cored:	3/2/15
Core Elevation:	65' ASL	Date Photographed:	3/2/15
Recovered Length (ft):	2.55	SC Thickness (ft):	2.55
RQD (%):	100	Void Depth (ft):	N/A
Notes:

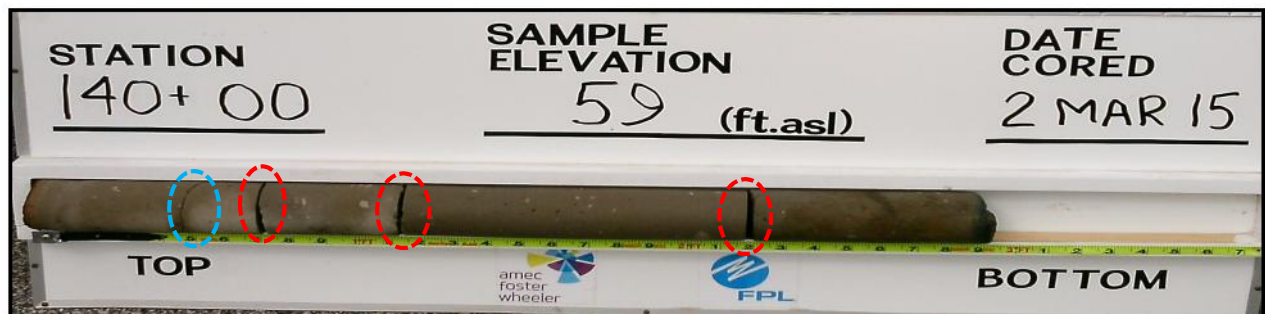
Location: STA 140+00

Core ID:	140+00 (middle)	Date Cored:	3/2/15
Core Elevation:	59' ASL	Date Photographed:	3/2/15
Recovered Length (ft):	2.9	SC Thickness (ft):	2.9
RQD (%):	93	Void Depth (ft):	N/A
Notes:

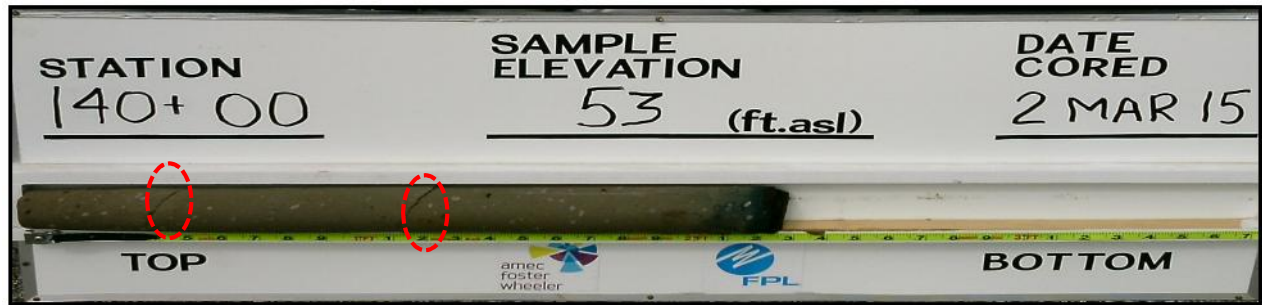
Location: STA 140+00

Core ID:	140+00 (bottom)	Date Cored:	3/2/15
Core Elevation:	53' ASL	Date Photographed:	3/2/15
Recovered Length (ft):	2.25	SC Thickness (ft):	2.67
RQD (%):	100	Void Depth (ft):	N/A
Notes:

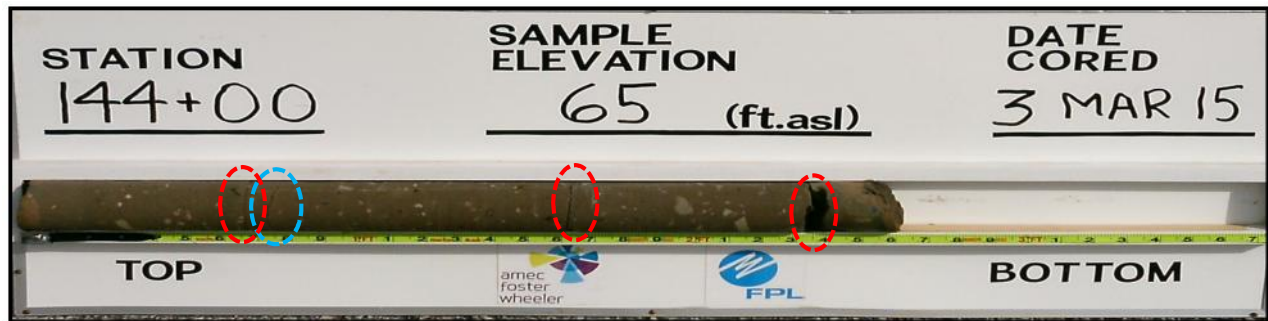
Location: STA 144+00

Core ID:	144+00 (top)	Date Cored:	3/3/15
Core Elevation:	65' ASL	Date Photographed:	3/3/15
Recovered Length (ft):	2.6	SC Thickness (ft):	2.75
RQD (%):	86	Void Depth (ft):	N/A
Notes:

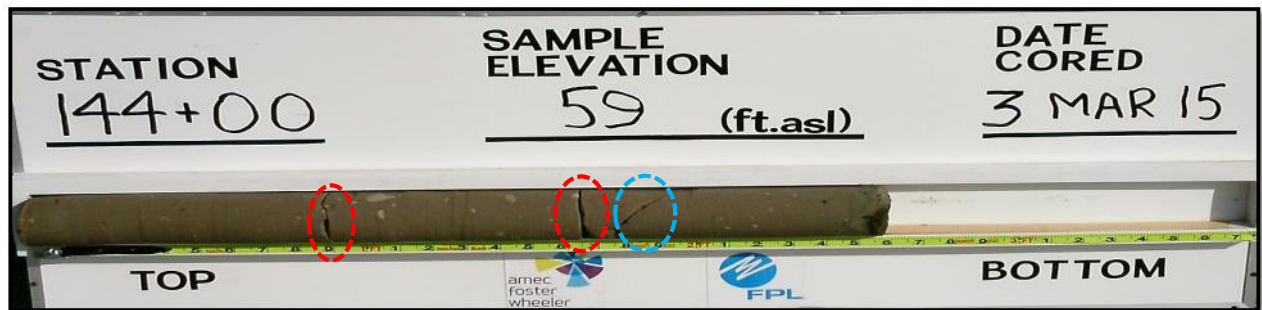
Location: STA 144+00

Core ID:	144+00 (middle)	Date Cored:	3/3/15
Core Elevation:	59' ASL	Date Photographed:	3/3/15
Recovered Length (ft):	2.6	SC Thickness (ft):	2.75
RQD (%):	92	Void Depth (ft):	N/A
Notes:

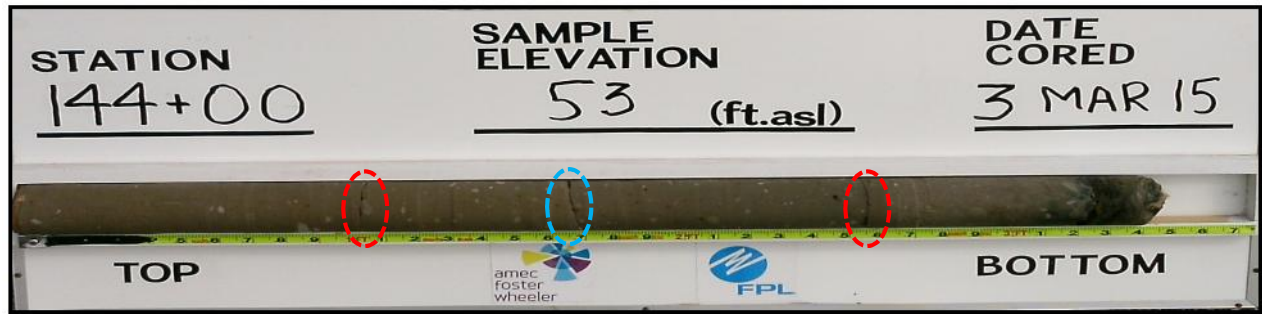
Location: STA 144+00

Core ID:	144+00 (bottom)	Date Cored:	3/3/15
Core Elevation:	53' ASL	Date Photographed:	3/3/15
Recovered Length (ft):	3.4	SC Thickness (ft):	3.67
RQD (%):	100	Void Depth (ft):	N/A
Notes:

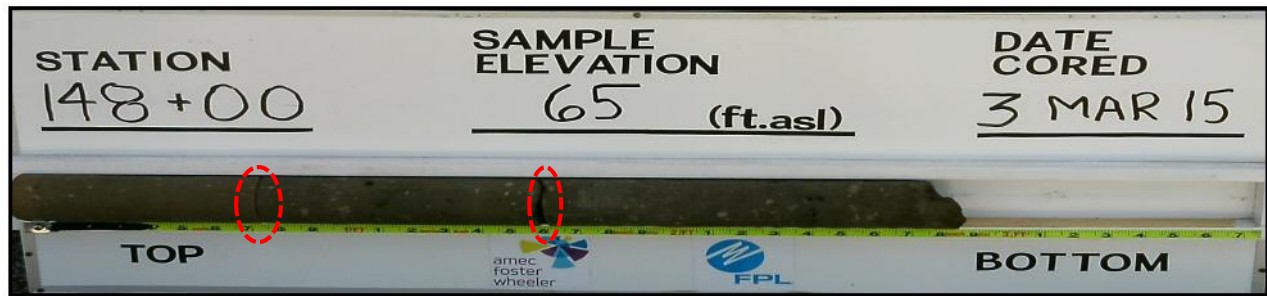
Location: STA 148+00

Core ID:	148+00 (top)	Date Cored:	3/3/15
Core Elevation:	65' ASL	Date Photographed:	3/3/15
Recovered Length (ft):	2.75	SC Thickness (ft):	2.75
RQD (%):	100	Void Depth (ft):	N/A
Notes:

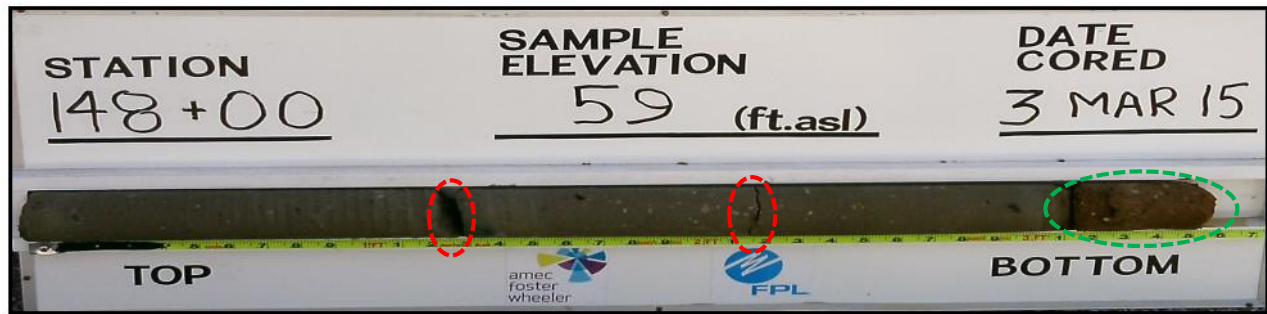
Location: STA 148+00

Core ID:	148+00 (middle)	Date Cored:	3/3/15
Core Elevation:	59' ASL	Date Photographed:	3/3/15
Recovered Length (ft):	3.1	SC Thickness (ft):	3.1
RQD (%):	100	Void Depth (ft):	N/A
Notes:	Native soil from 3.1 to 3.5 feet

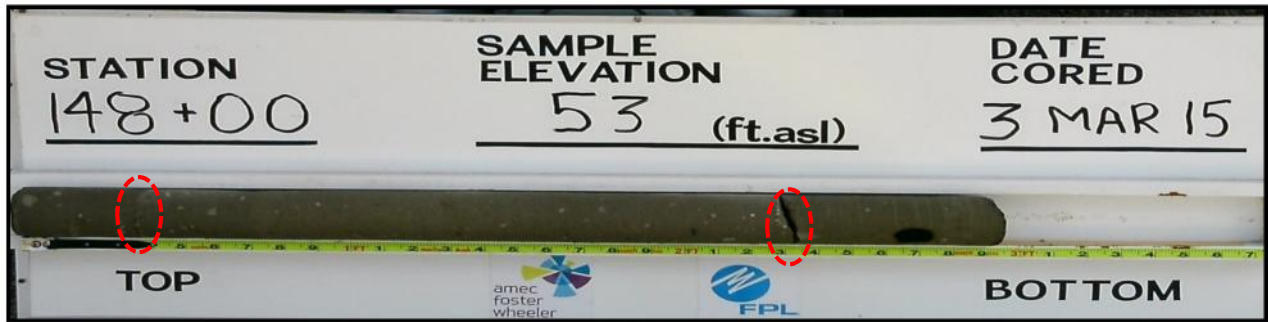
Location: STA 148+00

Core ID:	148+00 (bottom)	Date Cored:	3/3/15
Core Elevation:	53' ASL	Date Photographed:	3/3/15
Recovered Length (ft):	2.95	SC Thickness (ft):	3.83
RQD (%):	100	Void Depth (ft):	N/A
Notes:

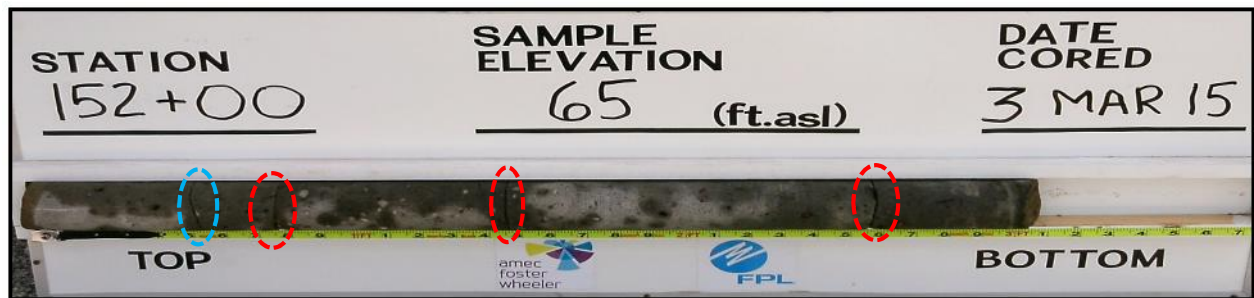
Location: STA 152+00

Core ID:	152+00 (top)	Date Cored:	3/3/15
Core Elevation:	65' ASL	Date Photographed:	3/3/15
Recovered Length (ft):	3.05	SC Thickness (ft):	3.05
RQD (%):	93	Void Depth (ft):	N/A
Notes:

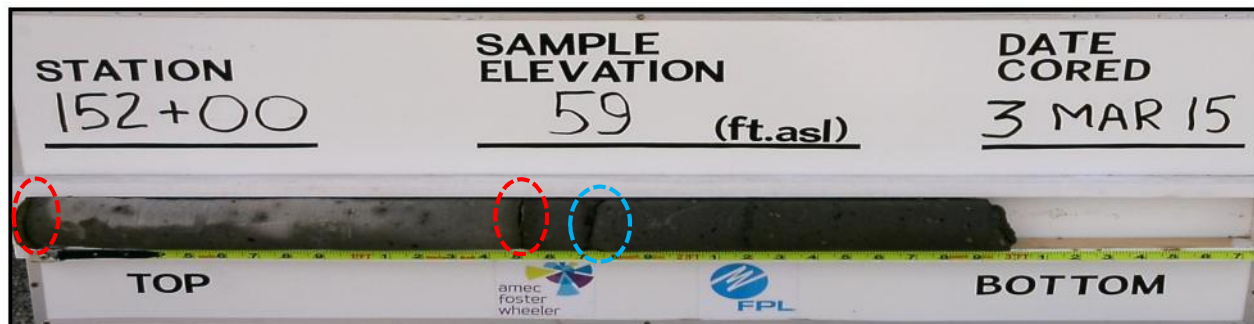
Location: STA 152+00

Core ID:	152+00 (middle)	Date Cored:	3/3/15
Core Elevation:	59' ASL	Date Photographed:	3/3/15
Recovered Length (ft):	2.96	SC Thickness (ft):	3.25
RQD (%):	91	Void Depth (ft):	N/A
Notes:

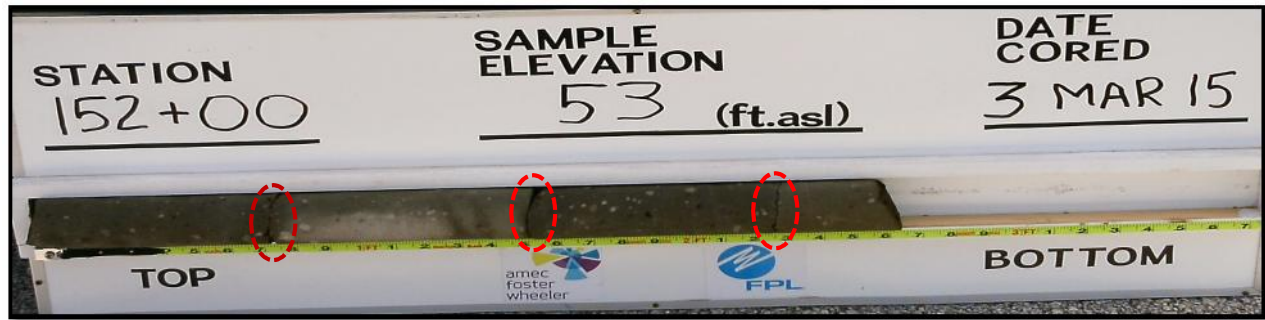
Location: STA 152+00

Core ID:	152+00 (bottom)	Date Cored:	3/3/15
Core Elevation:	53' ASL	Date Photographed:	3/3/15
Recovered Length (ft):	2.62	SC Thickness (ft):	3.75
RQD (%):	100	Void Depth (ft):	N/A
Notes:

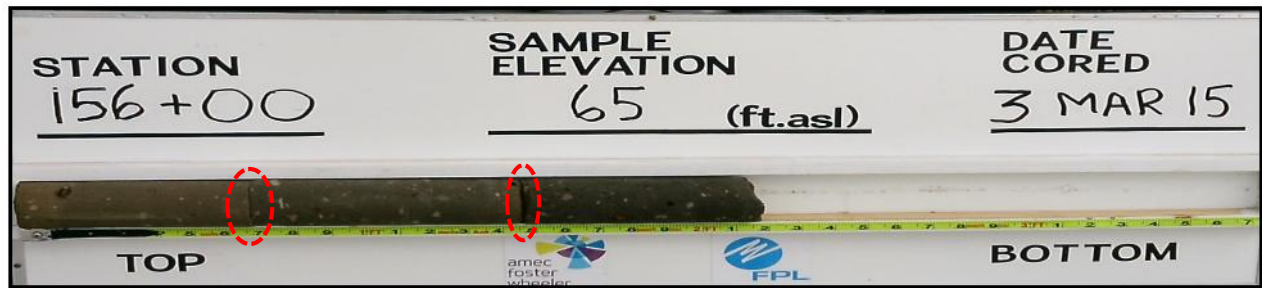
Location: STA 156+00

Core ID:	156+00 (top)	Date Cored:	3/3/15
Core Elevation:	65' ASL	Date Photographed:	3/3/15
Recovered Length (ft):	2.15	SC Thickness (ft):	2.5
RQD (%):	100	Void Depth (ft):	N/A
Notes:

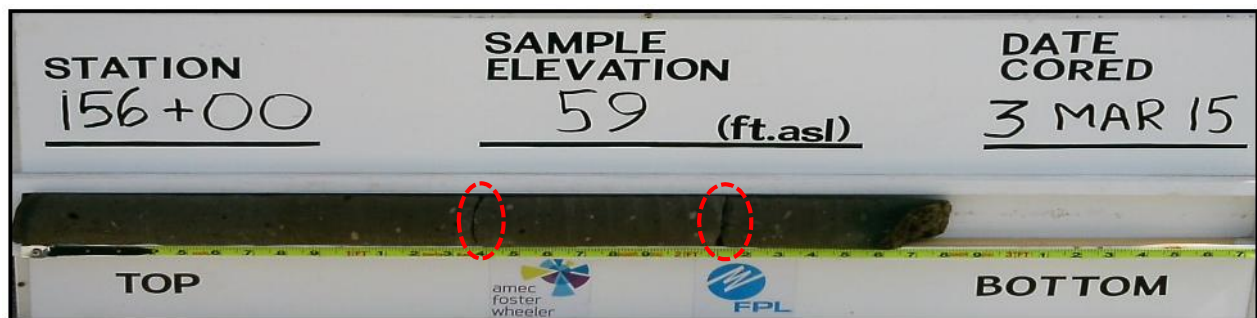
Location: STA 156+00

Core ID:	156+00 (middle)	Date Cored:	3/3/15
Core Elevation:	59' ASL	Date Photographed:	3/3/15
Recovered Length (ft):	2.7	SC Thickness (ft):	2.7
RQD (%):	100	Void Depth (ft):	N/A
Notes:

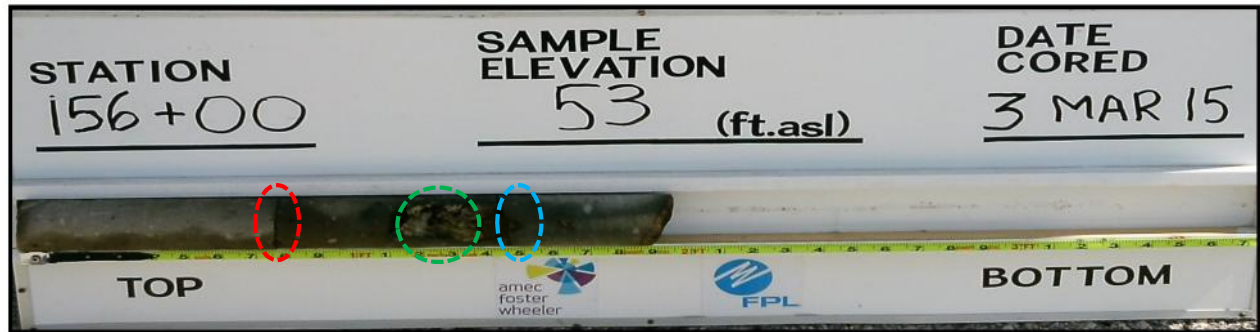
Location: STA 156+00

Core ID:	156+00 (bottom)	Date Cored:	3/3/15
Core Elevation:	53' ASL	Date Photographed:	3/3/15
Recovered Length (ft):	1.9	SC Thickness (ft):	3.0
RQD (%):	100	Void Depth (ft):	N/A
Notes:	Section broke off exposing plant matter

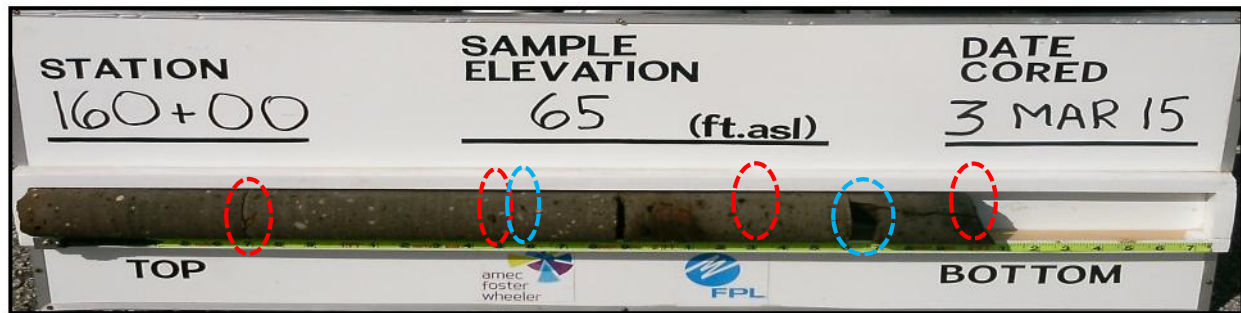
Location: STA 160+00

Core ID:	160+00 (top)	Date Cored:	3/3/15
Core Elevation:	65' ASL	Date Photographed:	3/3/15
Recovered Length (ft):	3	SC Thickness (ft):	3
RQD (%):	86	Void Depth (ft):	N/A
Notes:	Piece of core missing following last mechanical break

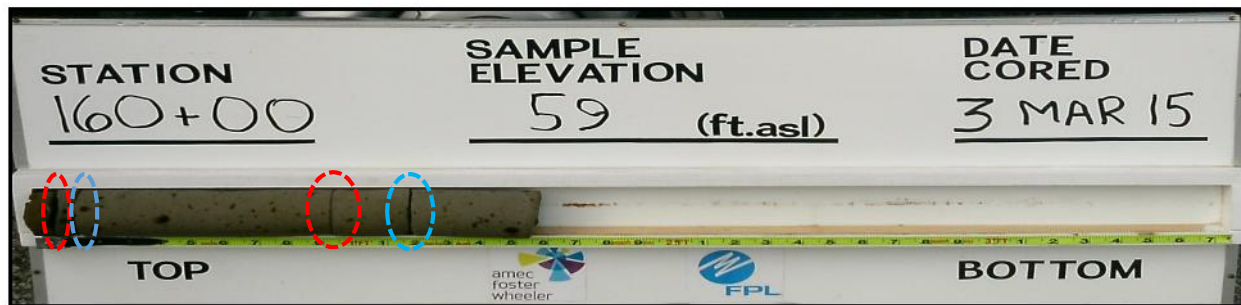
Location: STA 160+00

Core ID:	160+00 (middle)	Date Cored:	3/3/15
Core Elevation:	59' ASL	Date Photographed:	3/3/15
Recovered Length (ft):	1.55	SC Thickness (ft):	1.55
RQD (%):	95	Void Depth (ft):	N/A
Notes:

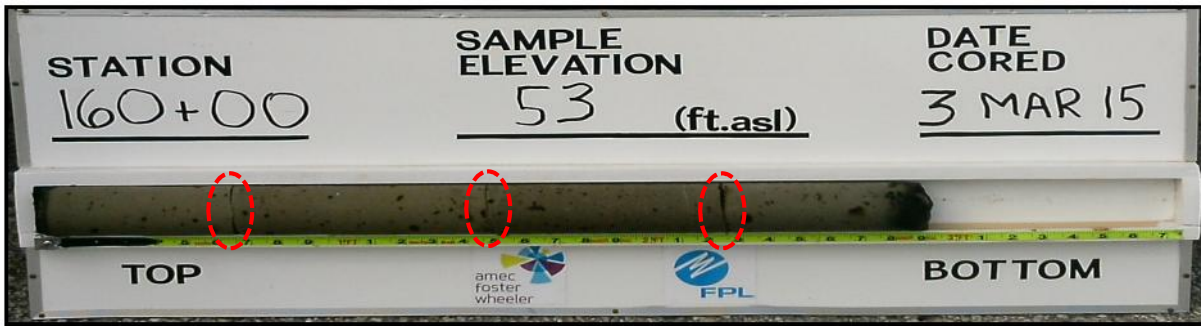
Location: STA 160+00

Core ID:	160+00 (bottom)	Date Cored:	3/3/15
Core Elevation:	53' ASL	Date Photographed:	3/3/15
Recovered Length (ft):	2.9	SC Thickness (ft):	2.9
RQD (%):	100	Void Depth (ft):	N/A
Notes:

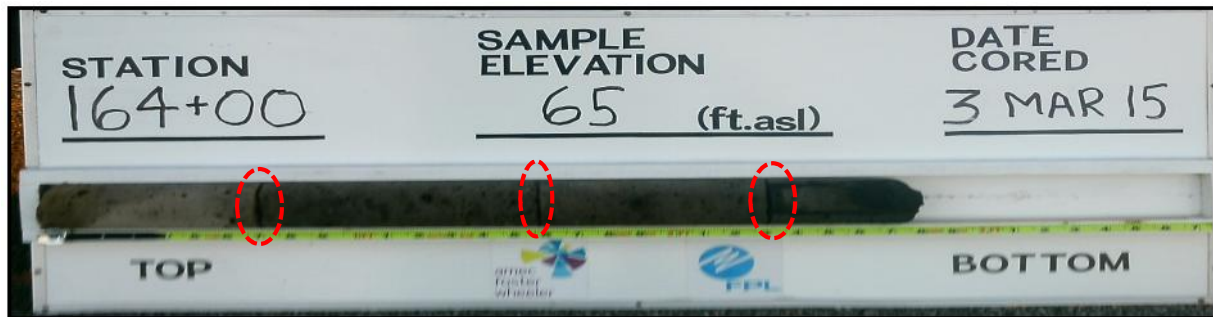
Location: STA 164+00

Core ID:	164+00 (top)	Date Cored:	3/3/15
Core Elevation:	65' ASL	Date Photographed:	3/4/15
Recovered Length (ft):	2.7	SC Thickness (ft):	2.75
RQD (%):	100	Void Depth (ft):	N/A
Notes:

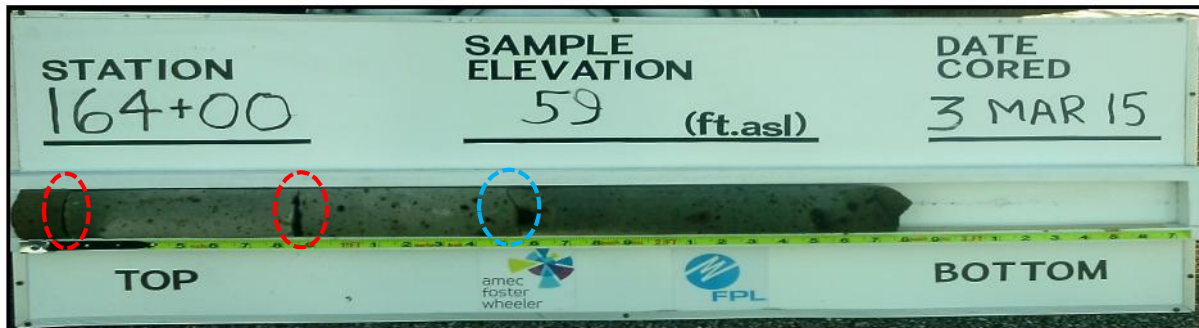
Location: STA 164+00

Core ID:	164+00 (middle)	Date Cored:	3/3/15
Core Elevation:	59' ASL	Date Photographed:	3/4/15
Recovered Length (ft):	2.15	SC Thickness (ft):	3.5
RQD (%):	99	Void Depth (ft):	N/A
Notes:

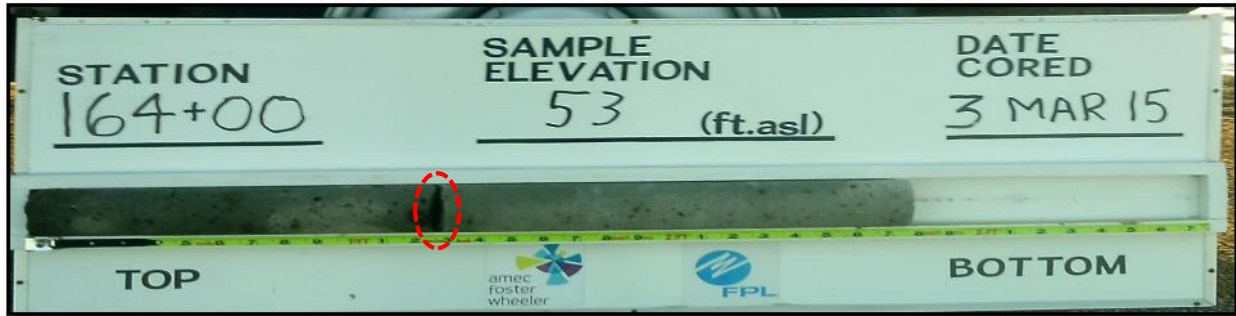
Location: STA 164+00

Core ID:	164+00 (bottom)	Date Cored:	3/3/15
Core Elevation:	53' ASL	Date Photographed:	3/4/15
Recovered Length (ft):	2.75	SC Thickness (ft):	2.75
RQD (%):	100	Void Depth (ft):	N/A
Notes:

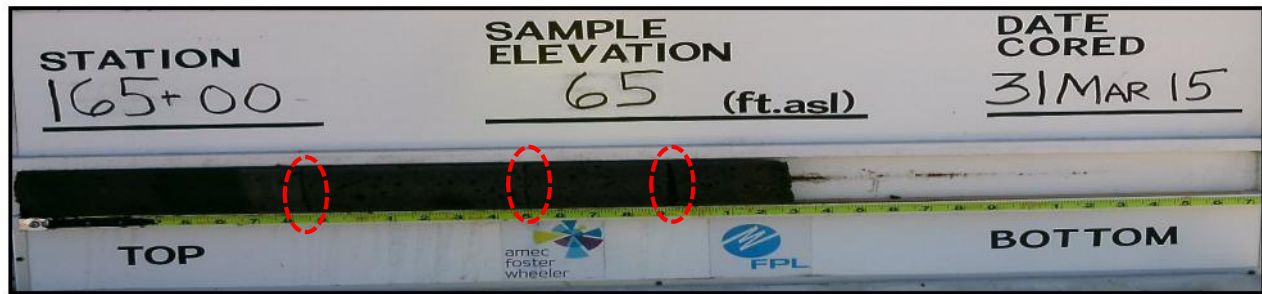
Location: STA 165+00

Core ID:	165+00 (top)	Date Cored:	3/31/15
Core Elevation:	65' ASL	Date Photographed:	3/31/15
Recovered Length (ft):	2.25	SC Thickness (ft):	2.5
RQD (%):	100	Void Depth (ft):	N/A
Notes:

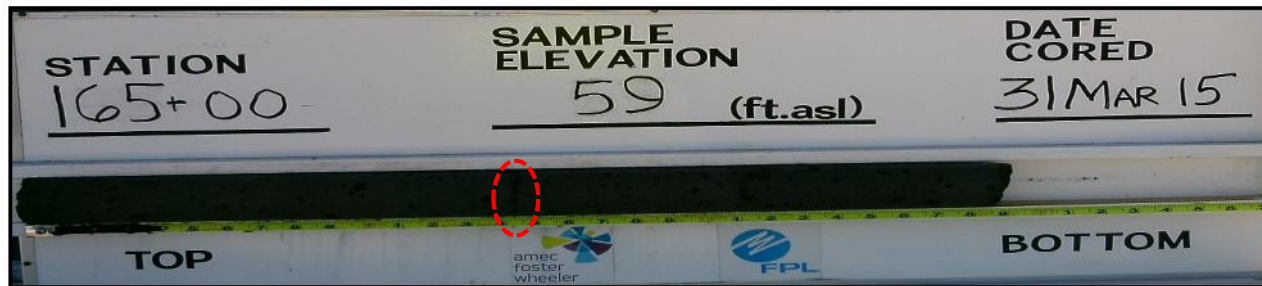
Location: STA 165+00

Core ID:	165+00 (middle)	Date Cored:	3/31/15
Core Elevation:	59' ASL	Date Photographed:	3/31/15
Recovered Length (ft):	2.85	SC Thickness (ft):	2.85
RQD (%):	100	Void Depth (ft):	N/A
Notes:

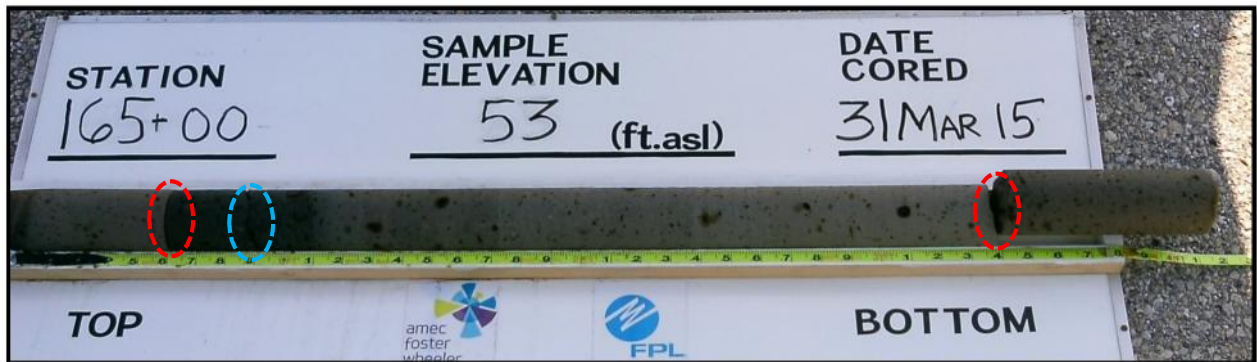
Location: STA 165+00

Core ID:	165+00 (bottom)	Date Cored:	3/31/15
Core Elevation:	53' ASL	Date Photographed:	3/31/15
Recovered Length (ft):	4.0	SC Thickness (ft):	4.0
RQD (%):	100	Void Depth (ft):	N/A
Notes:

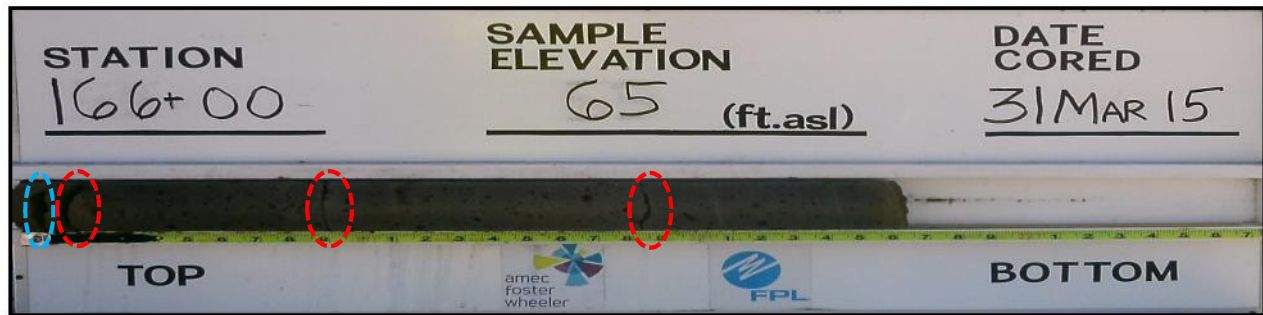
Location: STA 166+00

Core ID:	166+00 (top)	Date Cored:	3/31/15
Core Elevation:	65' ASL	Date Photographed:	3/31/15
Recovered Length (ft):	2.6	SC Thickness (ft):	2.67
RQD (%):	92	Void Depth (ft):	N/A
Notes:	Soft material from 0.1 to 0.2 feet.

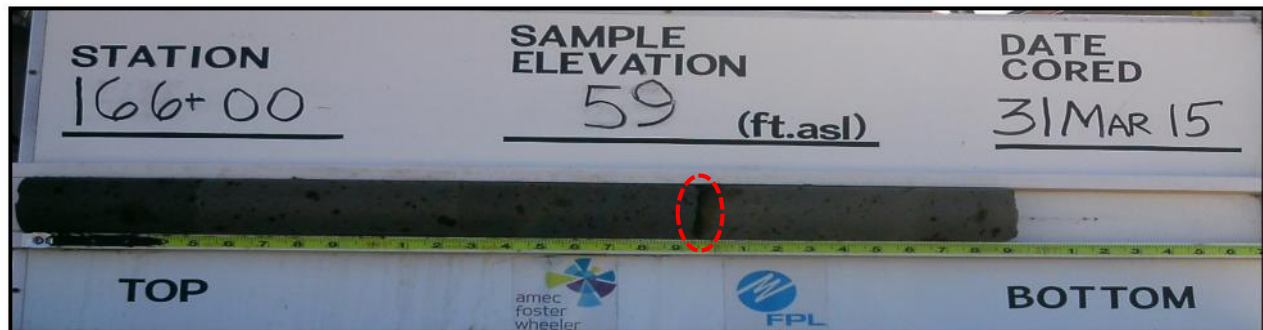
Location: STA 166+00

Core ID:	166+00 (middle)	Date Cored:	3/31/15
Core Elevation:	59' ASL	Date Photographed:	3/31/15
Recovered Length (ft):	2.9	SC Thickness (ft):	3.33
RQD (%):	100	Void Depth (ft):	N/A
Notes:

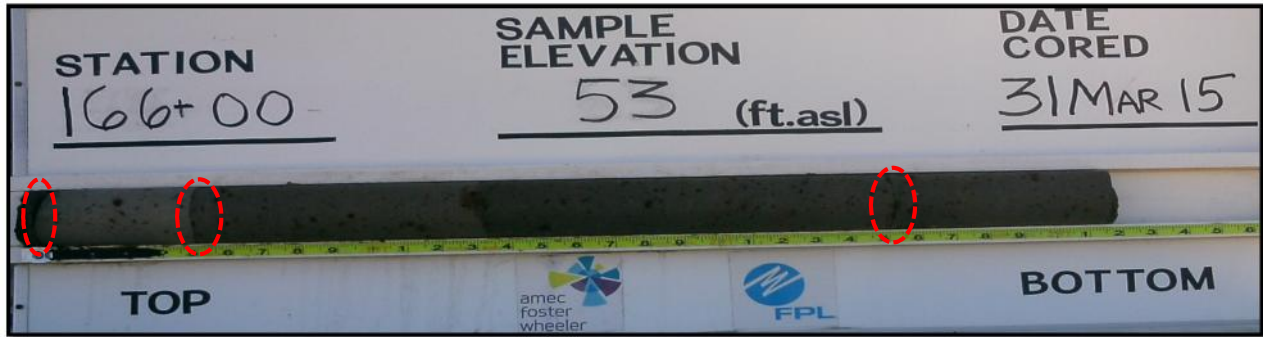
Location: STA 166+00

Core ID:	166+00 (bottom)	Date Cored:	3/31/15
Core Elevation:	53' ASL	Date Photographed:	3/31/15
Recovered Length (ft):	3.15	SC Thickness (ft):	2.5
RQD (%):	99	Void Depth (ft):	N/A
Notes:

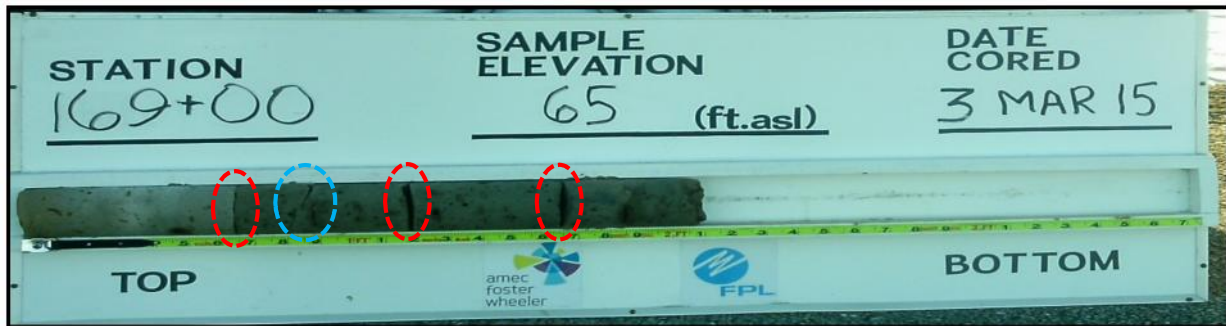
Location: STA 169+00

Core ID:	169+00 (top)	Date Cored:	3/3/15
Core Elevation:	65' ASL	Date Photographed:	3/4/15
Recovered Length (ft):	2.1	SC Thickness (ft):	2.1
RQD (%):	76	Void Depth (ft):	N/A
Notes:

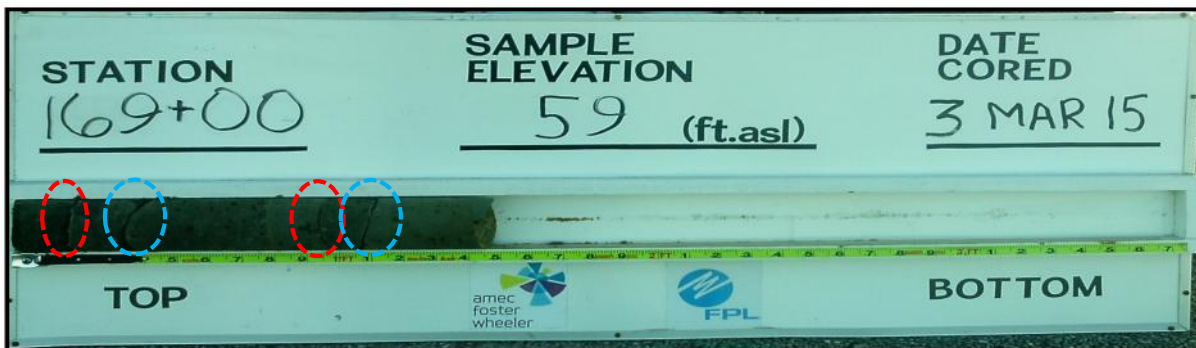
Location: STA 169+00

Core ID:	169+00 (middle)	Date Cored:	3/3/15
Core Elevation:	59' ASL	Date Photographed:	3/4/15
Recovered Length (ft):	1.45	SC Thickness (ft):	2.83
RQD (%):	69	Void Depth (ft):	N/A
Notes:

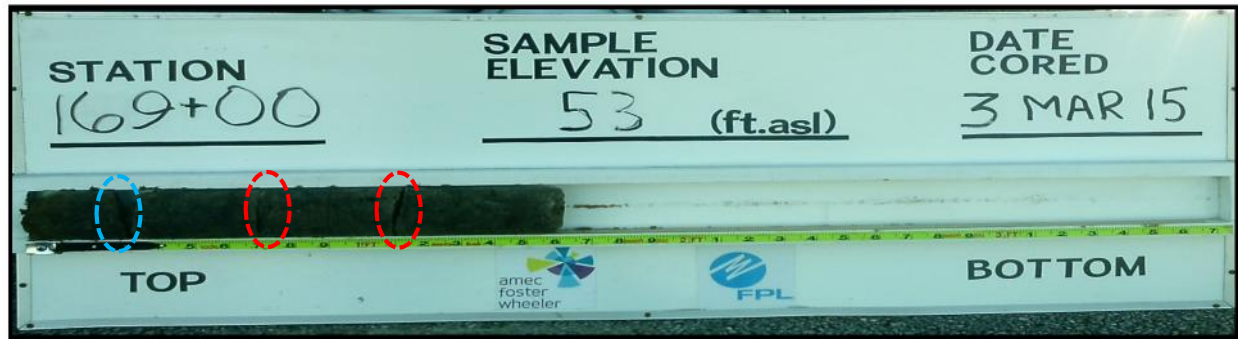
Location: STA 169+00

Core ID:	169+00 (bottom)	Date Cored:	3/3/15
Core Elevation:	53' ASL	Date Photographed:	3/4/15
Recovered Length (ft):	1.6	SC Thickness (ft):	2.5
RQD (%):	100	Void Depth (ft):	N/A
Notes:

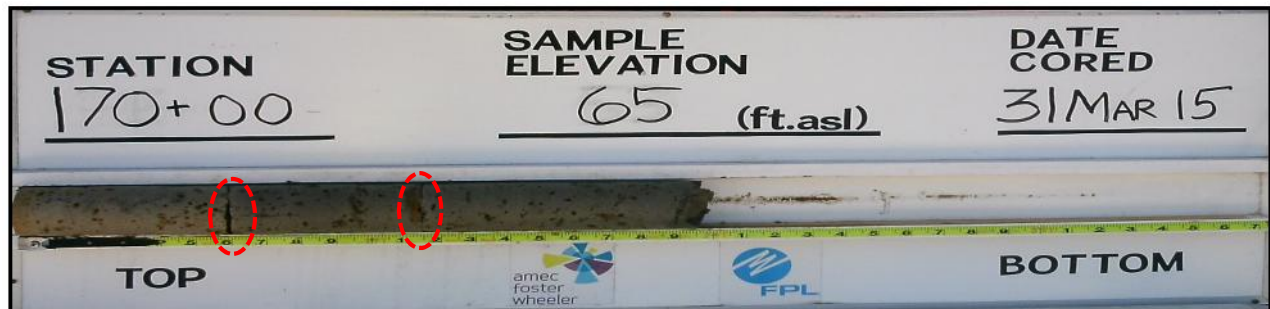
Location: STA 170+00

Core ID:	170+00 (top)	Date Cored:	3/31/15
Core Elevation:	65' ASL	Date Photographed:	3/31/15
Recovered Length (ft):	1.95	SC Thickness (ft):	2.165
RQD (%):	100	Void Depth (ft):	N/A
Notes:

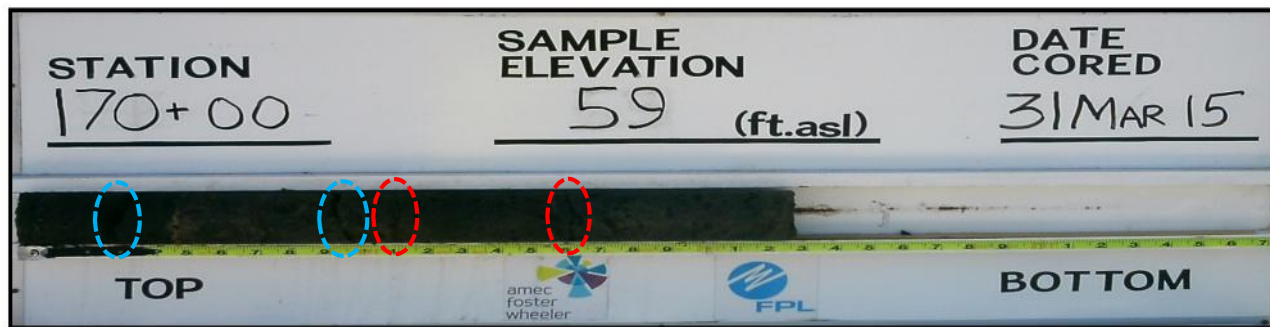
Location: STA 170+00

Core ID:	170+00 (middle)	Date Cored:	3/31/15
Core Elevation:	59' ASL	Date Photographed:	3/31/15
Recovered Length (ft):	2.25	SC Thickness (ft):	2.5
RQD (%):	79	Void Depth (ft):	N/A
Notes:	Entire recovered core comprised of soft material.

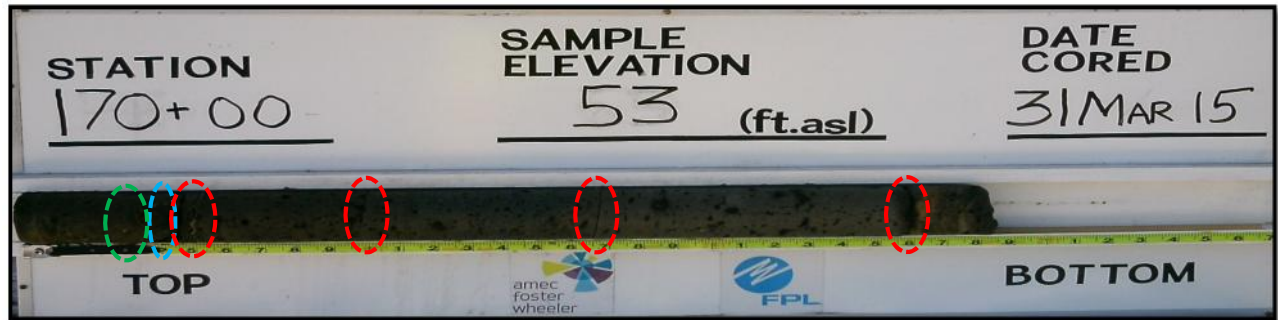
Location: STA 170+00

Core ID:	170+00 (bottom)	Date Cored:	3/31/15
Core Elevation:	53' ASL	Date Photographed:	3/31/15
Recovered Length (ft):	2.55	SC Thickness (ft):	3.0
RQD (%):	98	Void Depth (ft):	N/A
Notes:	Decay vegetation at 0.35 feet. Insitu soil from 2.55 to 2.8 feet.

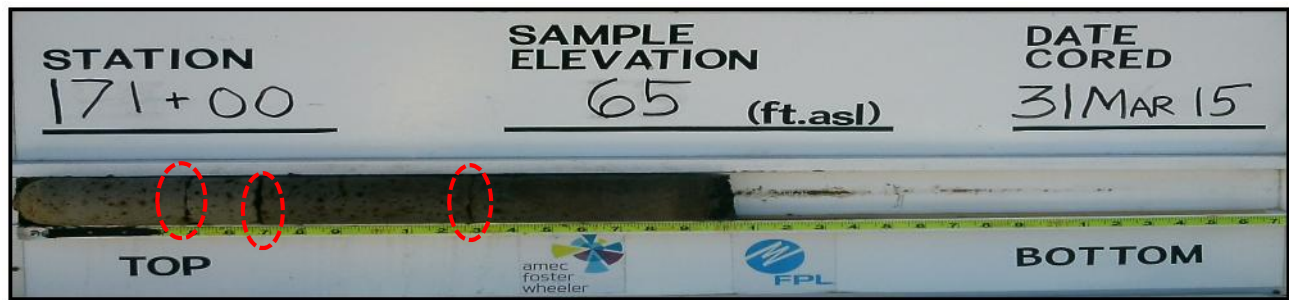
Location: STA 171+00

Core ID:	171+00 (top)	Date Cored:	3/31/15
Core Elevation:	65' ASL	Date Photographed:	3/31/15
Recovered Length (ft):	1.95	SC Thickness (ft):	2.83
RQD (%):	90	Void Depth (ft):	N/A
Notes:

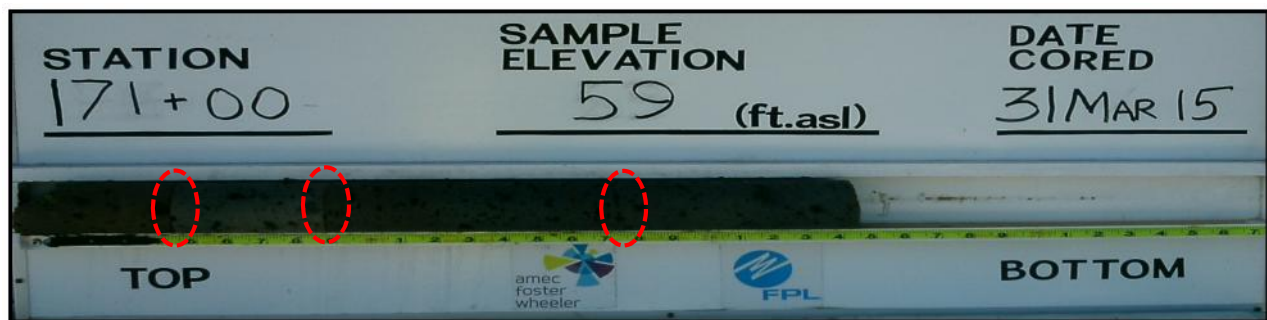
Location: STA 171+00

Core ID:	171+00 (middle)	Date Cored:	3/31/15
Core Elevation:	59' ASL	Date Photographed:	3/31/15
Recovered Length (ft):	2.41	SC Thickness (ft):	2.75
RQD (%):	100	Void Depth (ft):	N/A
Notes:

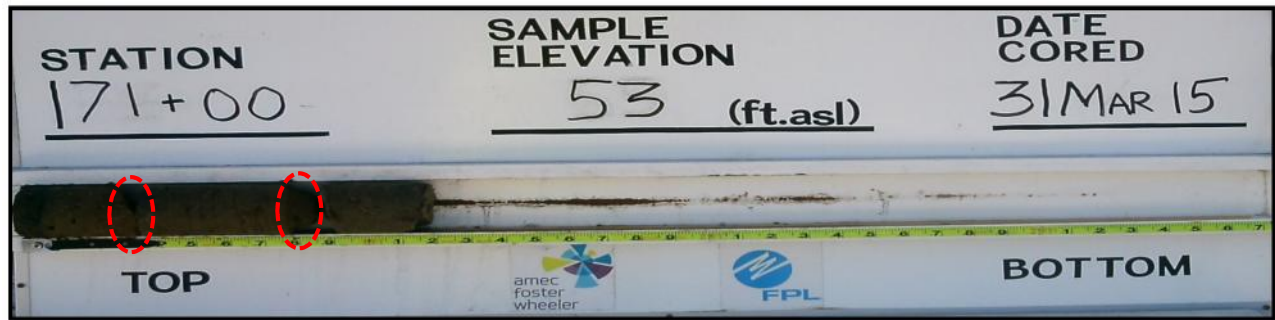
Location: STA 171+00

Core ID:	171+00 (bottom)	Date Cored:	3/31/15
Core Elevation:	53' ASL	Date Photographed:	3/31/15
Recovered Length (ft):	1.15	SC Thickness (ft):	1.5
RQD (%):	74	Void Depth (ft):	N/A
Notes:	Entire recovered core comprised of soft material.

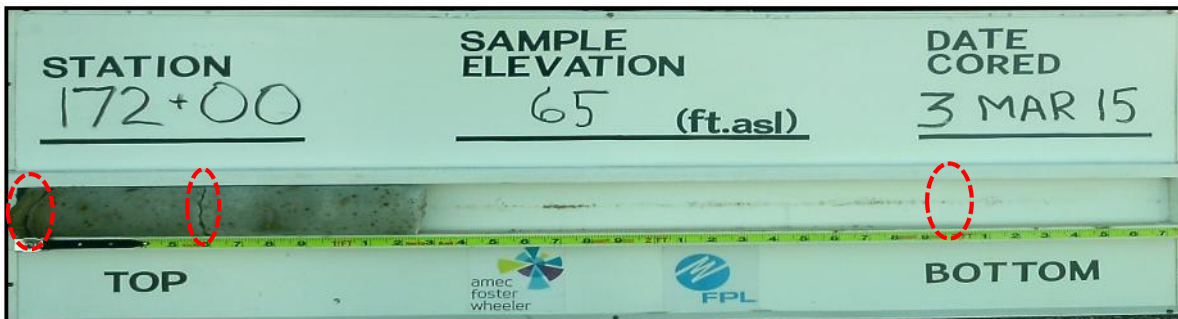
Location: STA 172+00

Core ID:	172+00 (top)	Date Cored:	3/3/15
Core Elevation:	65' ASL	Date Photographed:	3/4/15
Recovered Length (ft):	1.25	SC Thickness (ft):	1.5
RQD (%):	99	Void Depth (ft):	N/A
Notes:

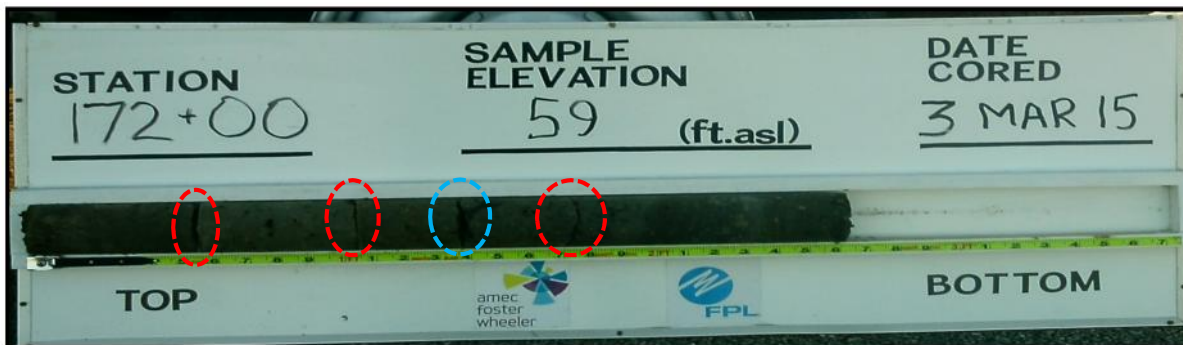
Location: STA 172+00

Core ID:	172+00 (middle)	Date Cored:	3/3/15
Core Elevation:	59' ASL	Date Photographed:	3/4/15
Recovered Length (ft):	2.6	SC Thickness (ft):	2.83
RQD (%):	88	Void Depth (ft):	N/A
Notes:

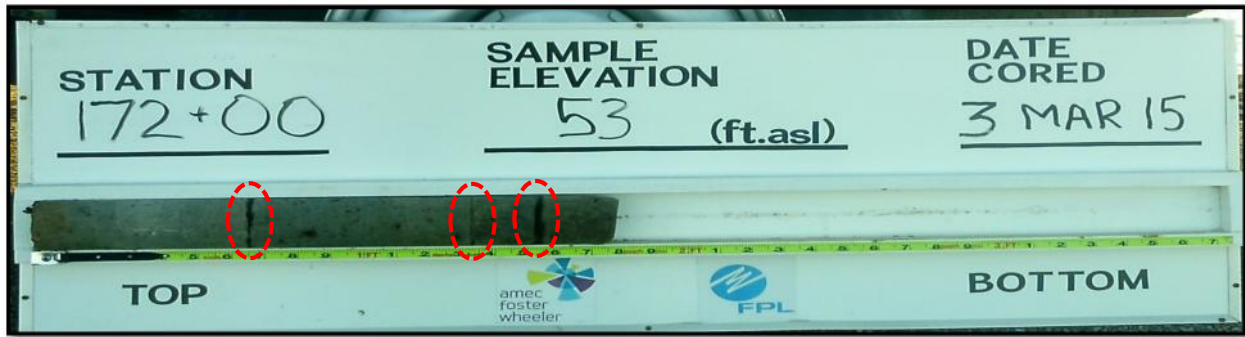
Location: STA 172+00

Core ID:	172+00 (bottom)	Date Cored:	3/3/15
Core Elevation:	53' ASL	Date Photographed:	3/4/15
Recovered Length (ft):	1.75	SC Thickness (ft):	2.5
RQD (%):	75	Void Depth (ft):	N/A
Notes:

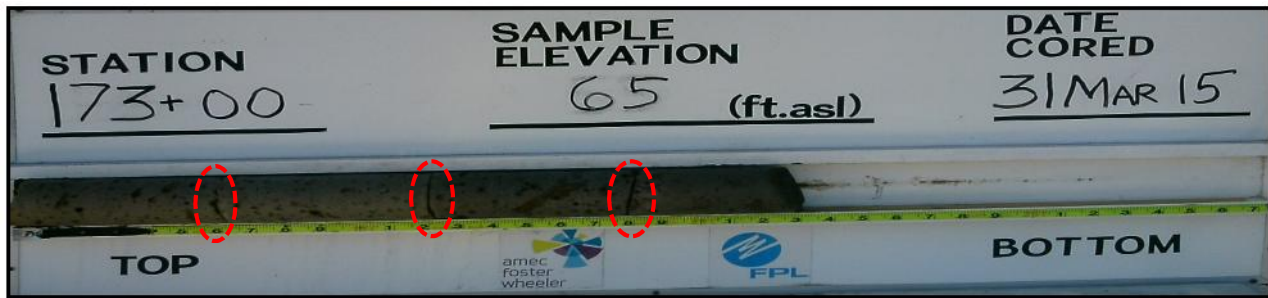
Location: STA 173+00

Core ID:	173+00 (top)	Date Cored:	3/31/15
Core Elevation:	65' ASL	Date Photographed:	3/31/15
Recovered Length (ft):	2.25	SC Thickness (ft):	2.58
RQD (%):	89	Void Depth (ft):	N/A
Notes:

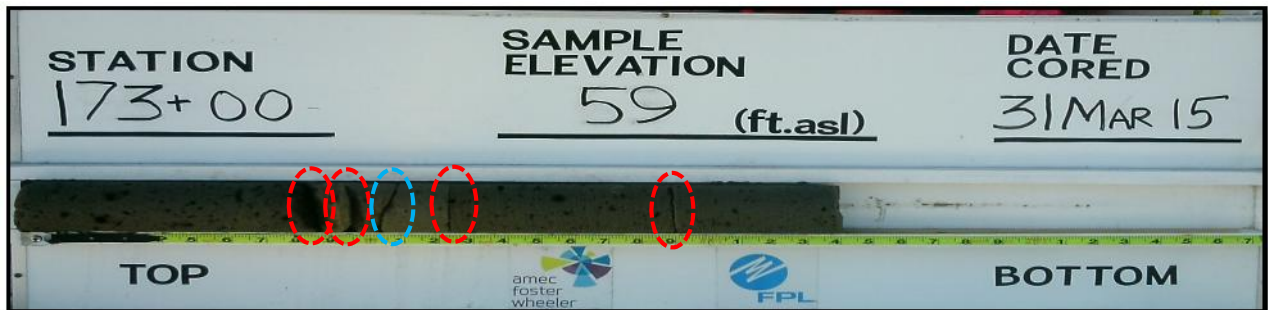
Location: STA 173+00

Core ID:	173+00 (middle)	Date Cored:	3/31/15
Core Elevation:	59' ASL	Date Photographed:	3/31/15
Recovered Length (ft):	2.4	SC Thickness (ft):	2.42
RQD (%):	88	Void Depth (ft):	N/A
Notes:

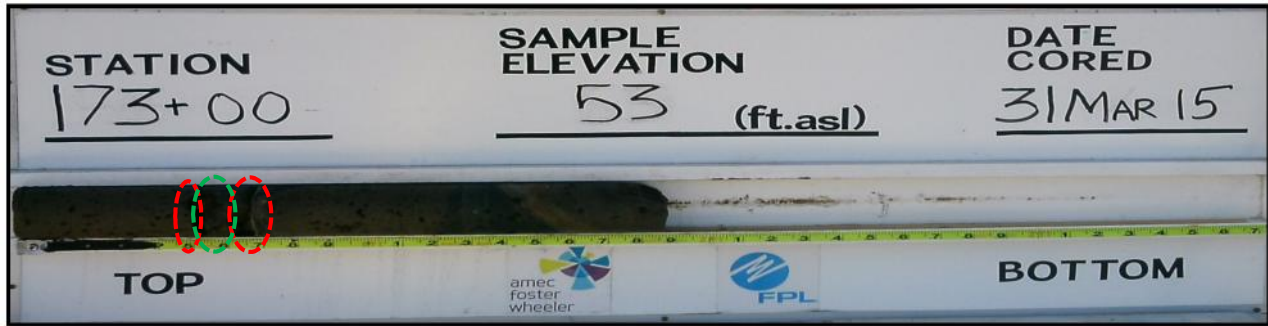
Location: STA 173+00

Core ID:	173+00 (bottom)	Date Cored:	3/31/15
Core Elevation:	53' ASL	Date Photographed:	3/31/15
Recovered Length (ft):	1.85	SC Thickness (ft):	2.165
RQD (%):	91	Void Depth (ft):	N/A
Notes:	Wood piece at 0.52 feet.
