**Assessment and Design Report
Soil-Cement Condition Assessment and Design Project
Manatee Plant Cooling Pond Dam
Parrish, Florida
Project Number 300906**

To: Mr. Lewis Rounds, P.E.
FPL Manatee Plant

Date: June 2015

From: Jeff Beriswill
Amec Foster Wheeler Environment & Infrastructure, Inc.

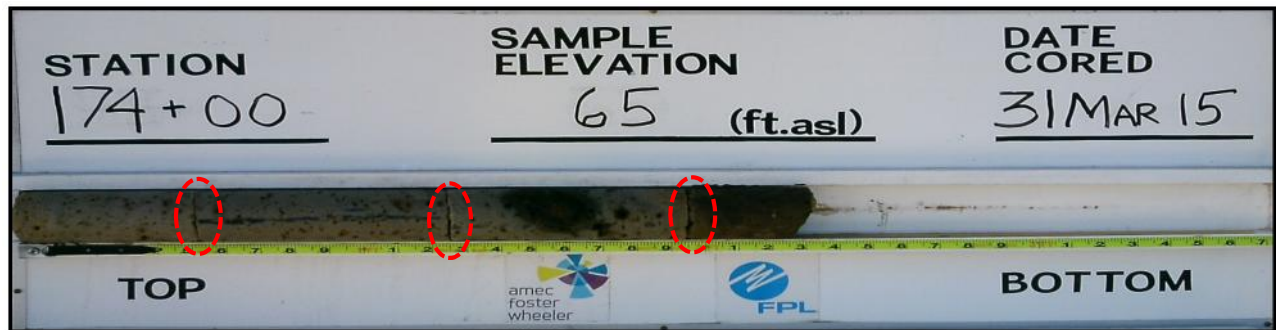
Location: STA 174+00

Core ID:	174+00 (top)	Date Cored:	3/31/15
Core Elevation:	65' ASL	Date Photographed:	3/31/15
Recovered Length (ft):	2.25	SC Thickness (ft):	2.5
RQD (%):	100	Void Depth (ft):	N/A
Notes:

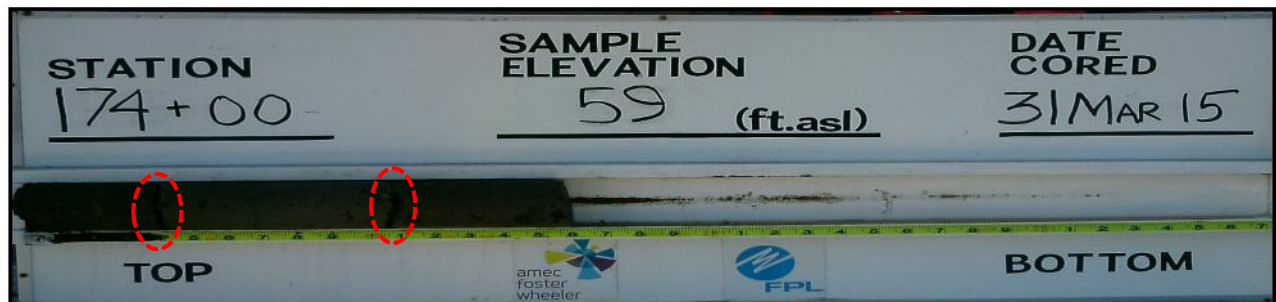
Location: STA 174+00

Core ID:	174+00 (middle)	Date Cored:	3/31/15
Core Elevation:	59' ASL	Date Photographed:	3/31/15
Recovered Length (ft):	1.57	SC Thickness (ft):	2.0
RQD (%):	100	Void Depth (ft):	N/A
Notes:	Soft material from 0 to 0.4 feet.

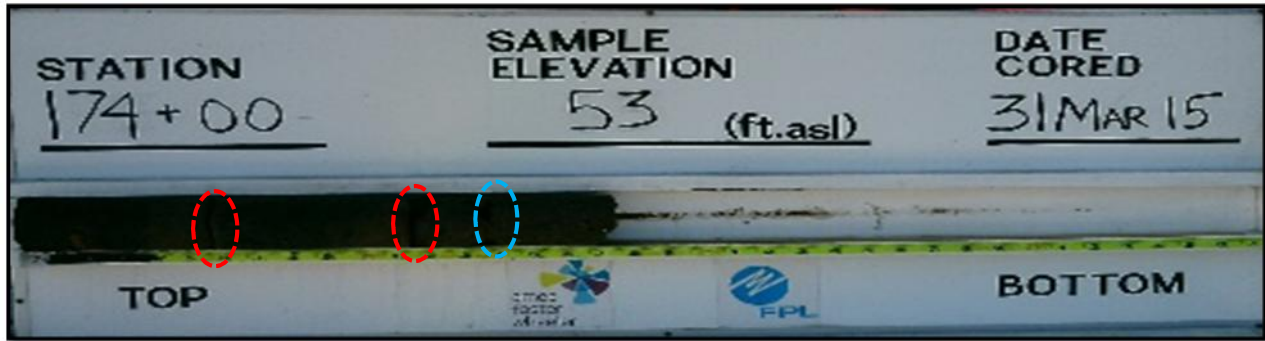
Location: STA 174+00

Core ID:	174+00 (bottom)	Date Cored:	3/31/15
Core Elevation:	53' ASL	Date Photographed:	3/31/15
Recovered Length (ft):	1.7	SC Thickness (ft):	2.0
RQD (%):	86	Void Depth (ft):	N/A
Notes:	Entire recovered core comprised of soft material. Wood piece at 0.2 feet.

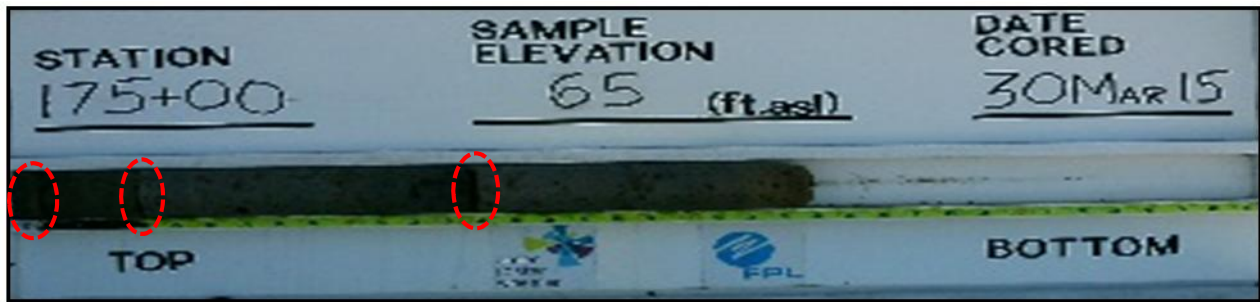
Location: STA 175+00

Core ID:	175+00 (top)	Date Cored:	3/30/15
Core Elevation:	65' ASL	Date Photographed:	3/30/15
Recovered Length (ft):	2.35	SC Thickness (ft):	2.5
RQD (%):	98	Void Depth (ft):	N/A
Notes:

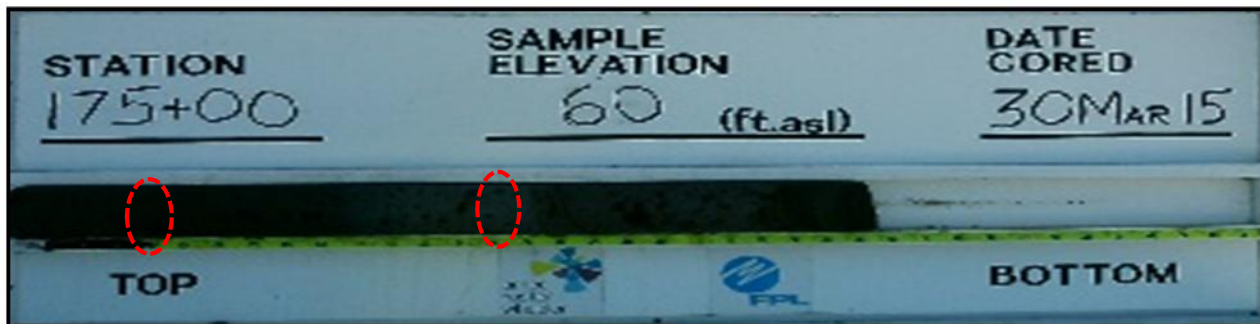
Location: STA 175+00

Core ID:	175+00 (middle)	Date Cored:	3/30/15
Core Elevation:	60' ASL	Date Photographed:	3/30/15
Recovered Length (ft):	2.25	SC Thickness (ft):	2.67
RQD (%):	100	Void Depth (ft):	N/A
Notes:	Insitu soil from 2.25 to 2.5 feet.

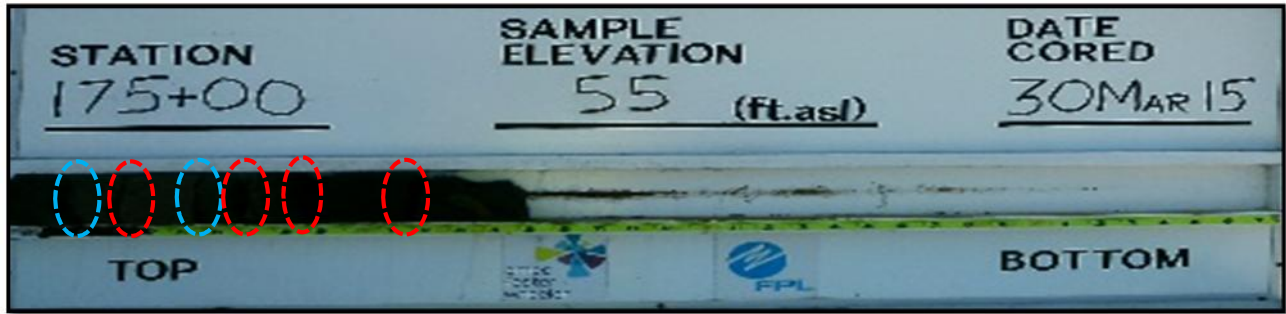
Location: STA 175+00

Core ID:	175+00 (bottom)	Date Cored:	3/30/15
Core Elevation:	55' ASL	Date Photographed:	3/30/15
Recovered Length (ft):	1.45	SC Thickness (ft):	1.67
RQD (%):	0	Void Depth (ft):	N/A
Notes:	Entire recovered core variably soft to very soft. Partial recovered of core from 1.15 to 1.45 feet.

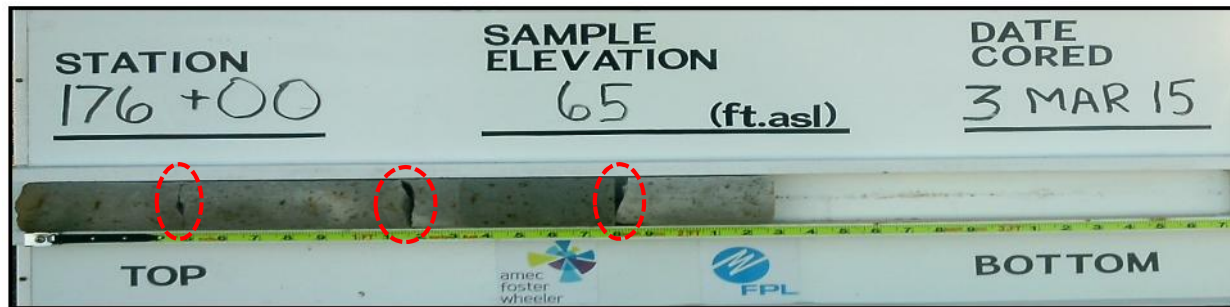
Location: STA 176+00

Core ID:	176+00 (top)	Date Cored:	3/3/15
Core Elevation:	65' ASL	Date Photographed:	3/4/15
Recovered Length (ft):	2.25	SC Thickness (ft):	2.25
RQD (%):	100	Void Depth (ft):	N/A
Notes:

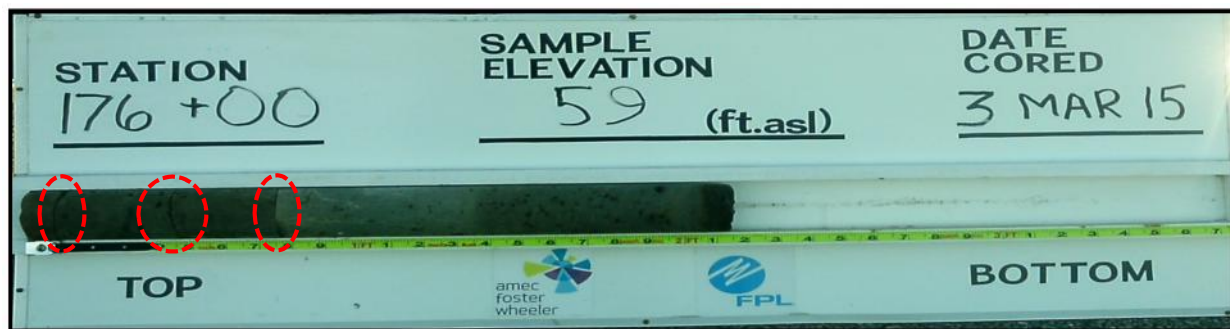
Location: STA 176+00

Core ID:	176+00 (middle)	Date Cored:	3/3/15
Core Elevation:	59' ASL	Date Photographed:	3/4/15
Recovered Length (ft):	2.15	SC Thickness (ft):	2.15
RQD (%):	65	Void Depth (ft):	N/A
Notes:

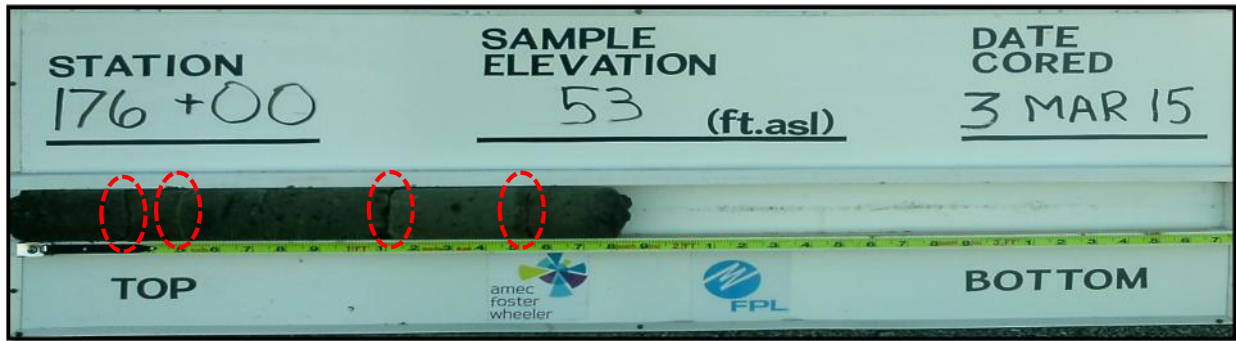
Location: STA 176+00

Core ID:	176+00 (bottom)	Date Cored:	3/3/15
Core Elevation:	53' ASL	Date Photographed:	3/4/15
Recovered Length (ft):	1.8	SC Thickness (ft):	2.0
RQD (%):	66	Void Depth (ft):	N/A
Notes:

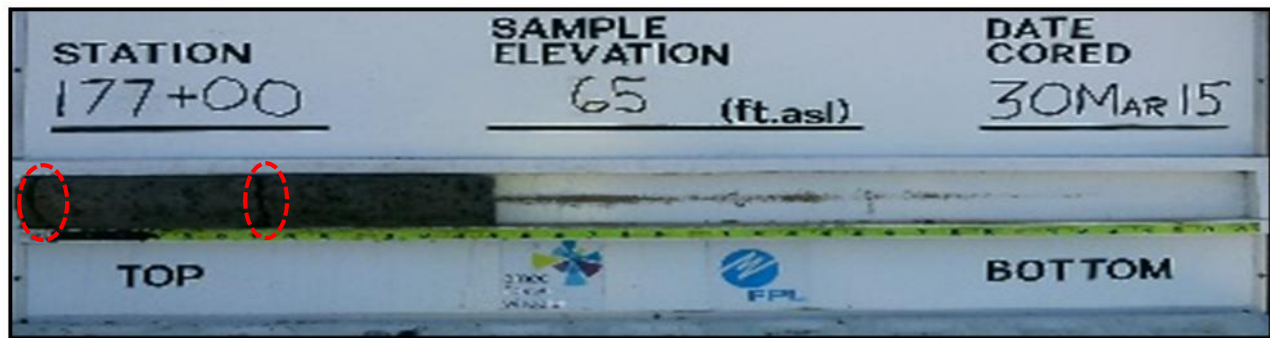
Location: STA 177+00

Core ID:	177+00 (top)	Date Cored:	3/30/15
Core Elevation:	65' ASL	Date Photographed:	3/30/15
Recovered Length (ft):	21.4	SC Thickness (ft):	1.83
RQD (%):	99	Void Depth (ft):	N/A
Notes:

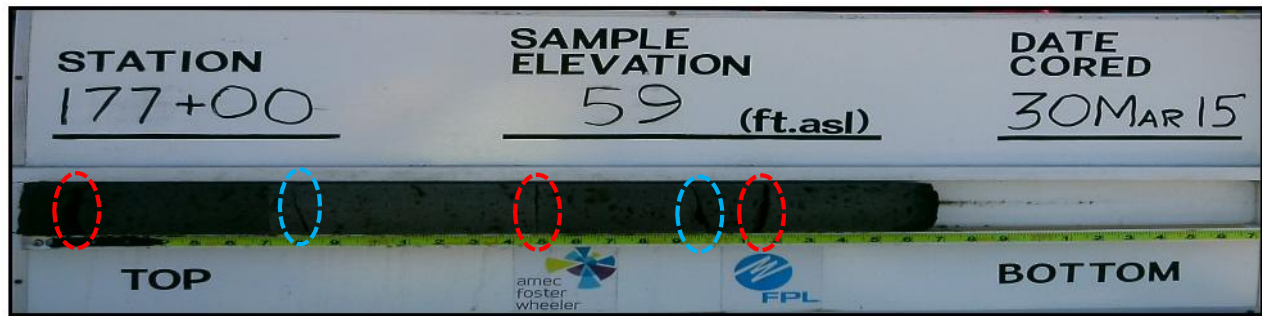
Location: STA 177+00

Core ID:	177+00 (middle)	Date Cored:	3/30/15
Core Elevation:	59' ASL	Date Photographed:	3/30/15
Recovered Length (ft):	2.62	SC Thickness (ft):	3.0
RQD (%):	85	Void Depth (ft):	N/A
Notes:

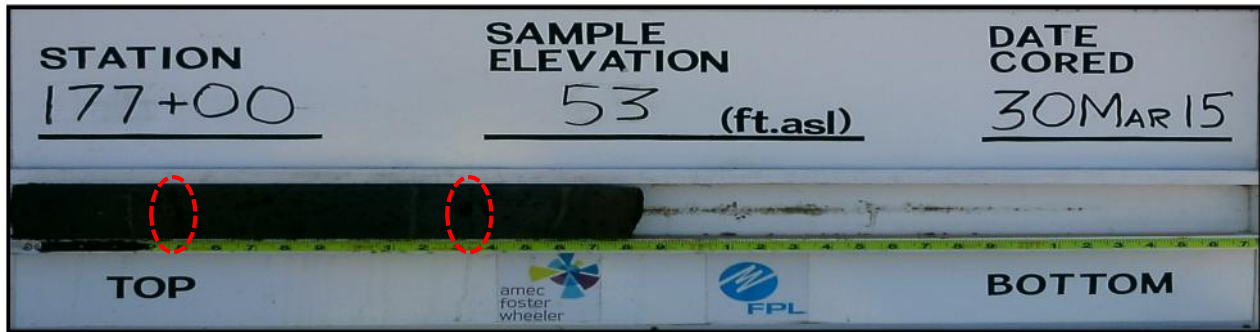
Location: STA 177+00

Core ID:	177+00 (bottom)	Date Cored:	3/30/15
Core Elevation:	53' ASL	Date Photographed:	3/30/15
Recovered Length (ft):	1.78	SC Thickness (ft):	2.0
RQD (%):	100	Void Depth (ft):	N/A
Notes:	Soft material from 0 to 0.47 feet.

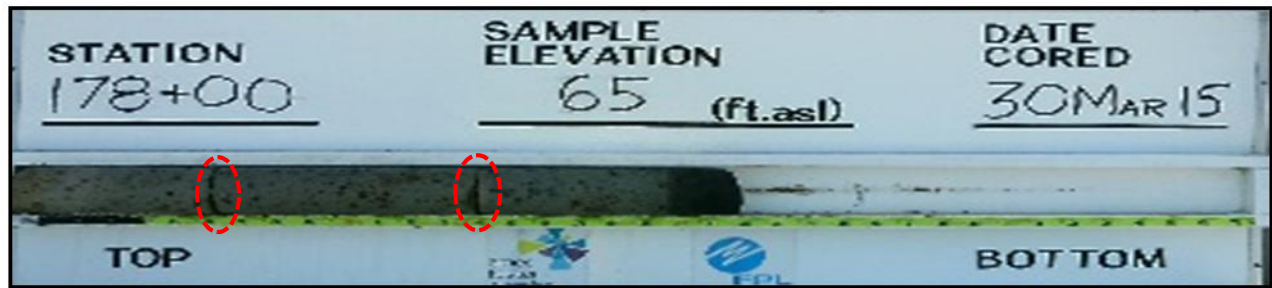
Location: STA 178+00

Core ID:	178+00 (top)	Date Cored:	3/30/15
Core Elevation:	65' ASL	Date Photographed:	3/30/15
Recovered Length (ft):	2.15	SC Thickness (ft):	2.42
RQD (%):	100	Void Depth (ft):	N/A
Notes:

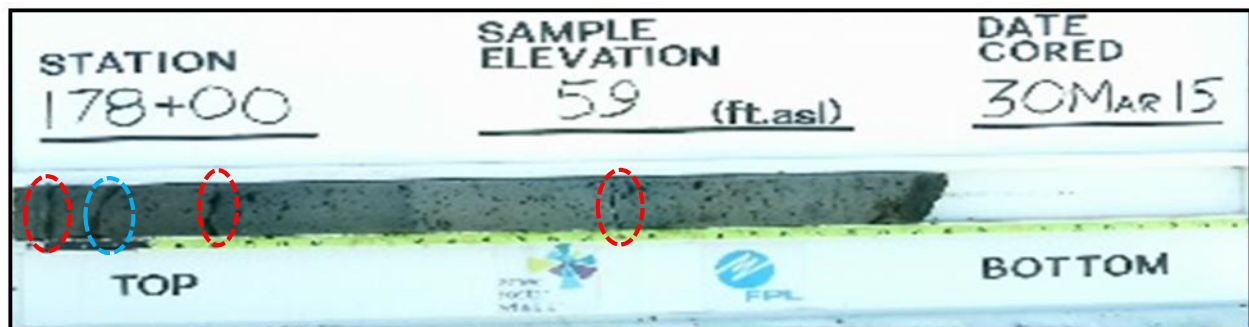
Location: STA 178+00

Core ID:	178+00 (middle)	Date Cored:	3/30/15
Core Elevation:	59' ASL	Date Photographed:	3/30/15
Recovered Length (ft):	2.7	SC Thickness (ft):	3.0
RQD (%):	78	Void Depth (ft):	N/A
Notes:

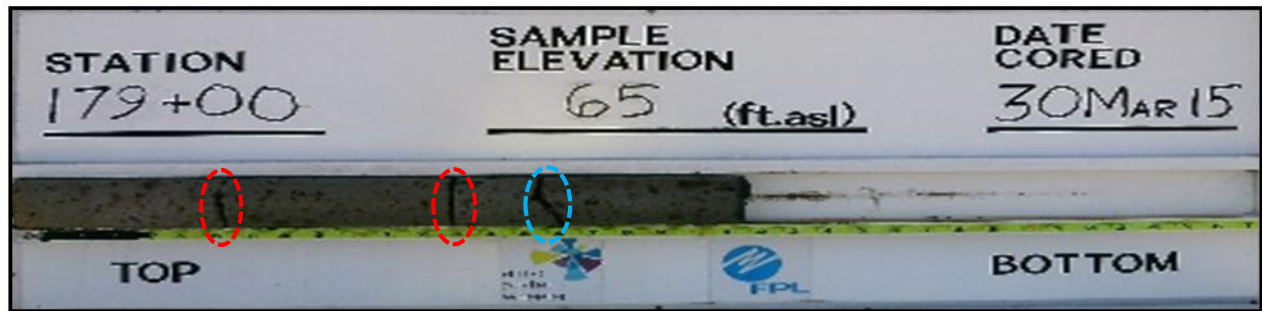
Location: STA 179+00

Core ID:	179+00 (top)	Date Cored:	3/30/15
Core Elevation:	65' ASL	Date Photographed:	3/30/15
Recovered Length (ft):	2.12	SC Thickness (ft):	2.5
RQD (%):	88	Void Depth (ft):	N/A
Notes:

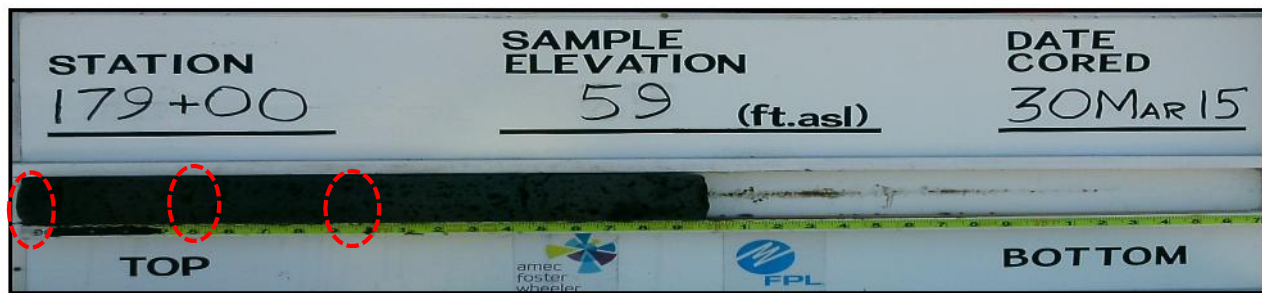
Location: STA 179+00

Core ID:	179+00 (middle)	Date Cored:	3/30/15
Core Elevation:	59' ASL	Date Photographed:	3/30/15
Recovered Length (ft):	1.95	SC Thickness (ft):	2.33
RQD (%):	92	Void Depth (ft):	N/A
Notes:	Recovered core moderately pitted.

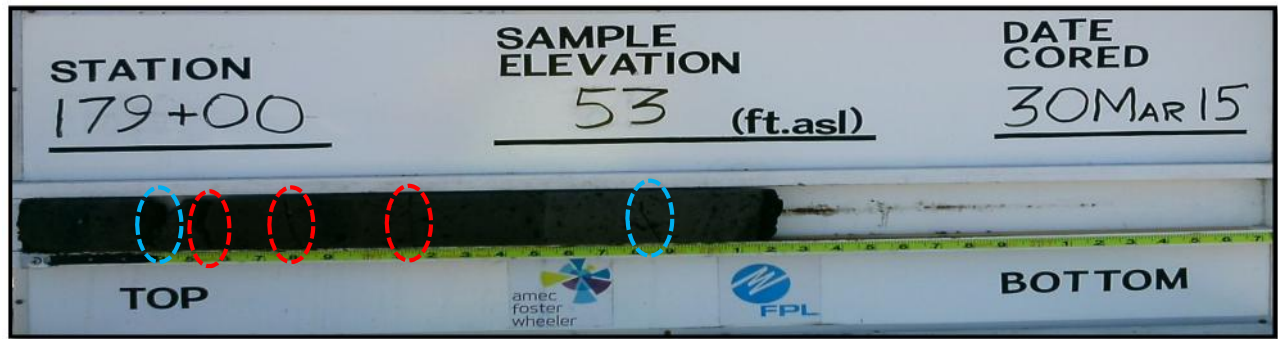
Location: STA 179+00

Core ID:	179+00 (bottom)	Date Cored:	3/30/15
Core Elevation:	53' ASL	Date Photographed:	3/30/15
Recovered Length (ft):	2.15	SC Thickness (ft):	2.67
RQD (%):	81	Void Depth (ft):	N/A
Notes:	Very soft material from 0 to 0.55 feet. Soft material from 0.55 to 1.13 feet. Insitu soil from 2.15 to 2.2 feet.

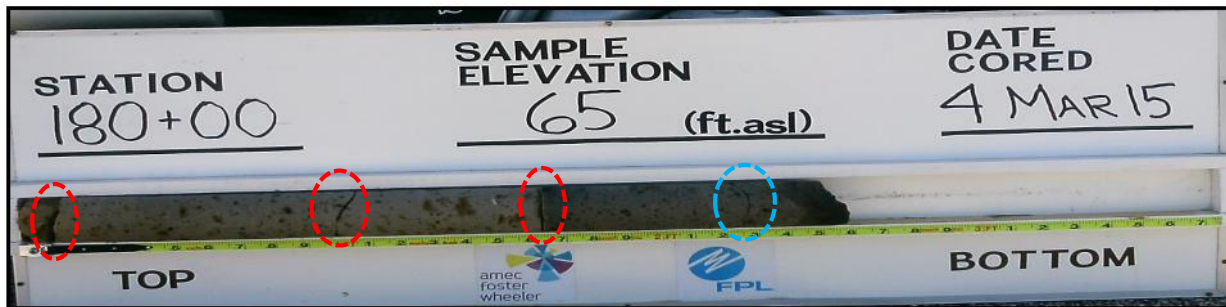
Location: STA 180+00

Core ID:	180+00 (top)	Date Cored:	3/4/15
Core Elevation:	65' ASL	Date Photographed:	3/4/15
Recovered Length (ft):	2.5	SC Thickness (ft):	2.92
RQD (%):	94	Void Depth (ft):	N/A
Notes:

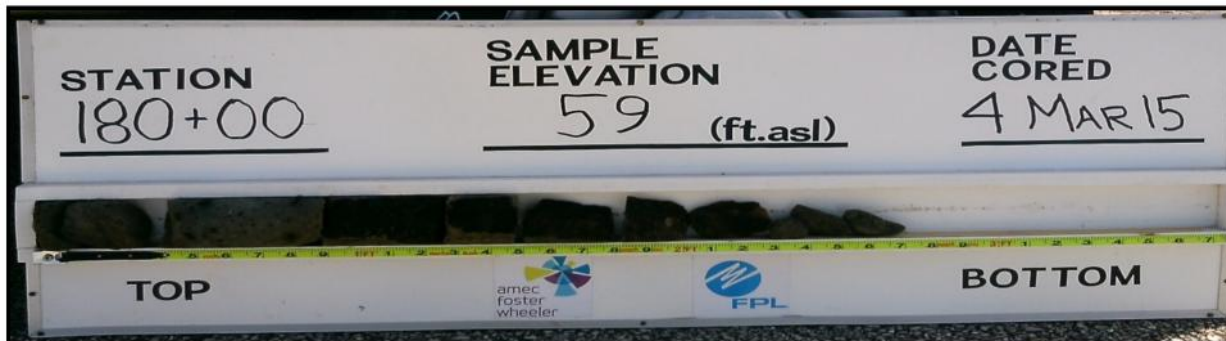
Location: STA 180+00

Core ID:	180+00 (middle)	Date Cored:	3/4/15
Core Elevation:	59' ASL	Date Photographed:	3/4/15
Recovered Length (ft):		SC Thickness (ft):	2.16
RQD (%):	0	Void Depth (ft):	N/A
Notes:	Core was un-recoverable, pieces were unable to be re-configured

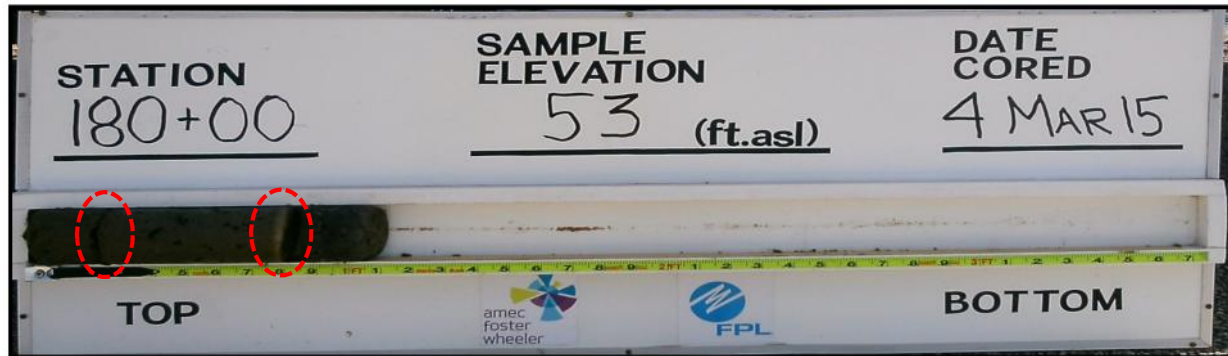
Location: STA 180+00

Core ID:	180+00 (bottom)	Date Cored:	3/4/15
Core Elevation:	53' ASL	Date Photographed:	3/4/15
Recovered Length (ft):	1.1	SC Thickness (ft):	1.3
RQD (%):	77	Void Depth (ft):	N/A
Notes:

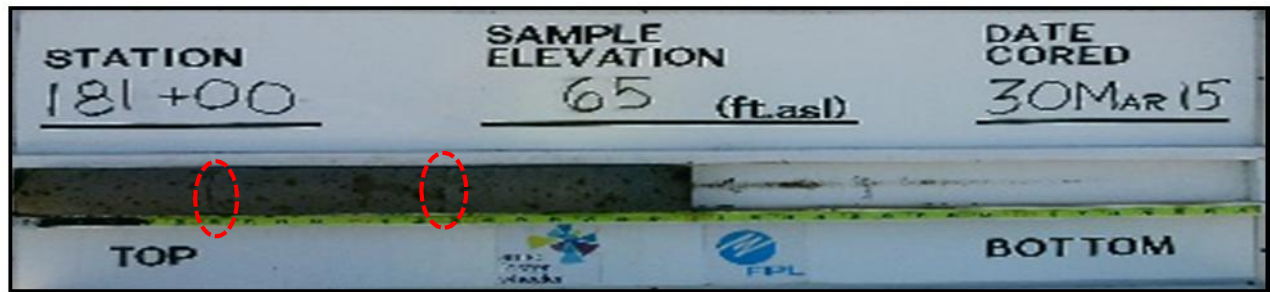
Location: STA 181+00

Core ID:	181+00 (top)	Date Cored:	3/30/15
Core Elevation:	65' ASL	Date Photographed:	3/30/15
Recovered Length (ft):	1.99	SC Thickness (ft):	2.08
RQD (%):	100	Void Depth (ft):	N/A
Notes:

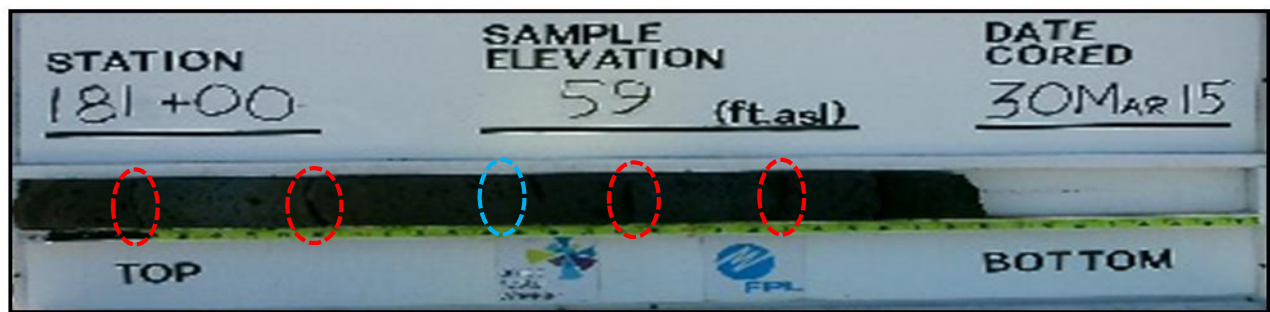
Location: STA 181+00

Core ID:	181+00 (middle)	Date Cored:	3/30/15
Core Elevation:	59' ASL	Date Photographed:	3/30/15
Recovered Length (ft):	2.55	SC Thickness (ft):	3.0
RQD (%):	77	Void Depth (ft):	N/A
Notes:	Insitu soil from 2.55 to 2.85 feet.

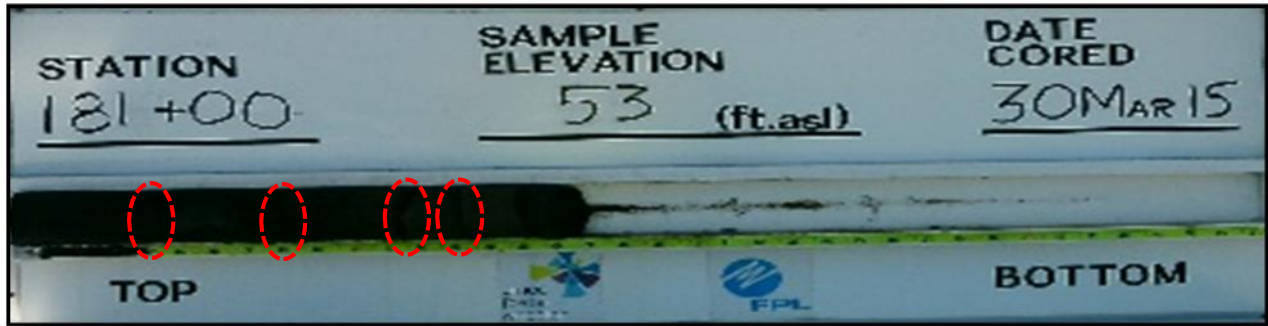
Location: STA 181+00

Core ID:	181+00 (bottom)	Date Cored:	3/30/15
Core Elevation:	53' ASL	Date Photographed:	3/30/15
Recovered Length (ft):	1.5	SC Thickness (ft):	3.0
RQD (%):	76	Void Depth (ft):	N/A
Notes:	Insitu soil from 1.5 to 1.6 feet.

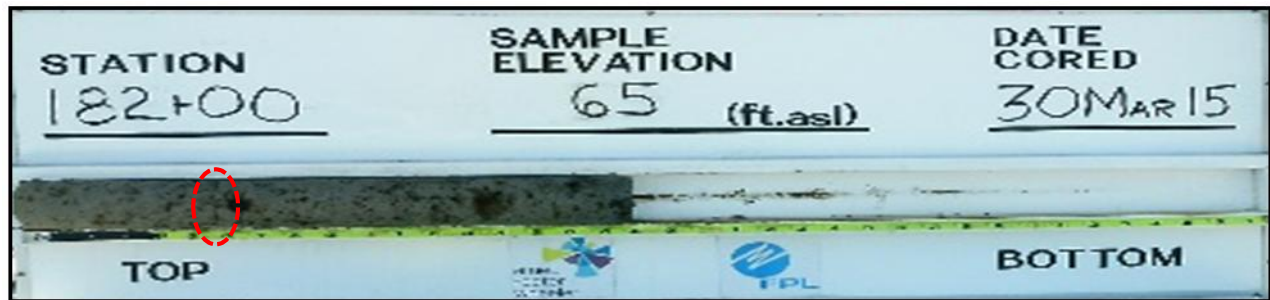
Location: STA 182+00

Core ID:	182+00 (top)	Date Cored:	3/30/15
Core Elevation:	65' ASL	Date Photographed:	3/30/15
Recovered Length (ft):	1.75	SC Thickness (ft):	1.67
RQD (%):	100	Void Depth (ft):	N/A
Notes:

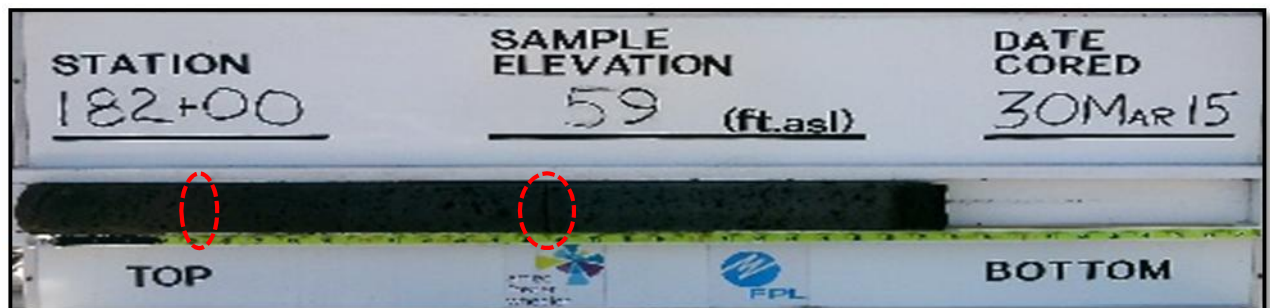
Location: STA 182+00

Core ID:	182+00 (middle)	Date Cored:	3/30/15
Core Elevation:	59' ASL	Date Photographed:	3/30/15
Recovered Length (ft):	2.6	SC Thickness (ft):	3.0
RQD (%):	100	Void Depth (ft):	N/A
Notes:	Insitu soil from 2.6 to 2.75 feet.

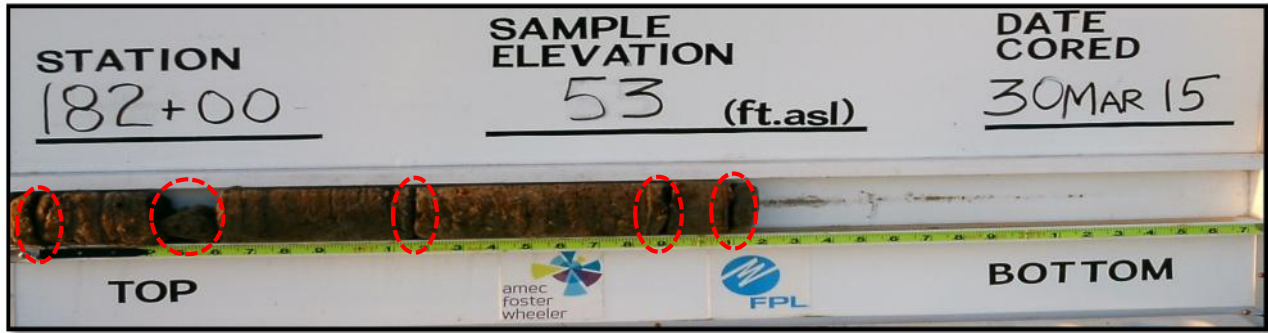
Location: STA 182+00

Core ID:	182+00 (bottom)	Date Cored:	3/30/15
Core Elevation:	53' ASL	Date Photographed:	3/30/15
Recovered Length (ft):	2.0	SC Thickness (ft):	2.5
RQD (%):	87	Void Depth (ft):	N/A
Notes:

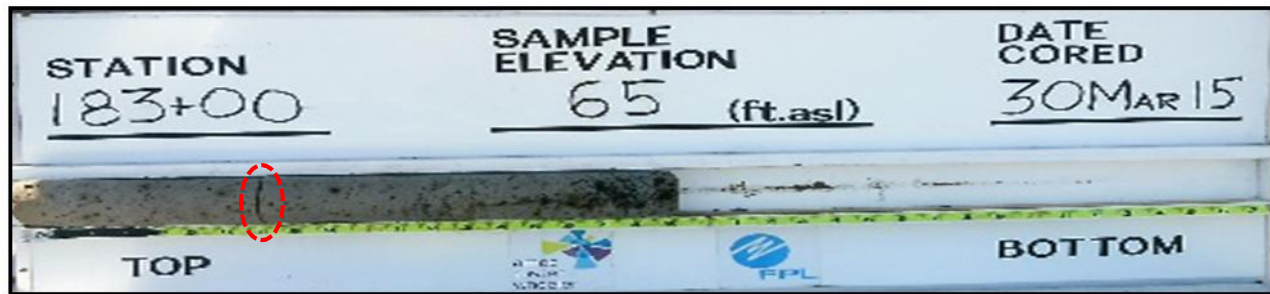
Location: STA 183+00

Core ID:	183+00 (top)	Date Cored:	3/30/15
Core Elevation:	65' ASL	Date Photographed:	3/30/15
Recovered Length (ft):	1.9	SC Thickness (ft):	2.0
RQD (%):	100	Void Depth (ft):	N/A
Notes:

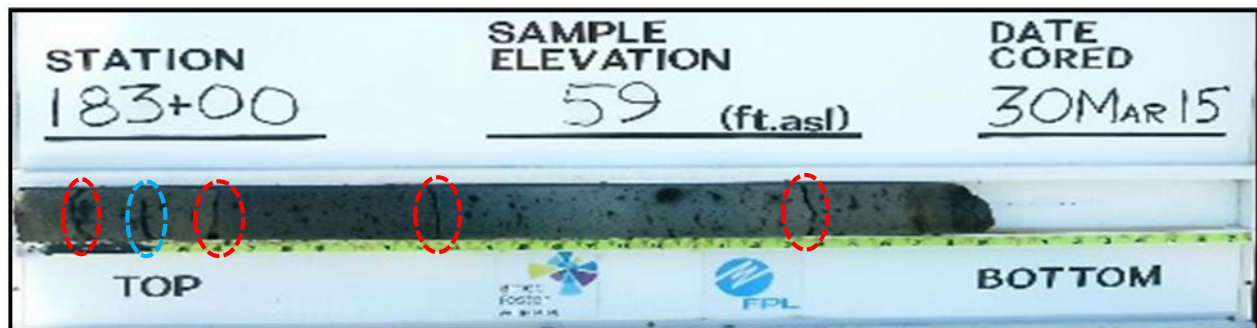
Location: STA 183+00

Core ID:	183+00 (middle)	Date Cored:	3/30/15
Core Elevation:	59' ASL	Date Photographed:	3/30/15
Recovered Length (ft):	2.75	SC Thickness (ft):	3.0
RQD (%):	78	Void Depth (ft):	N/A
Notes:	Soft material from 0 to 0.2 feet. Insitu soil from 2.75 to 2.8 feet.

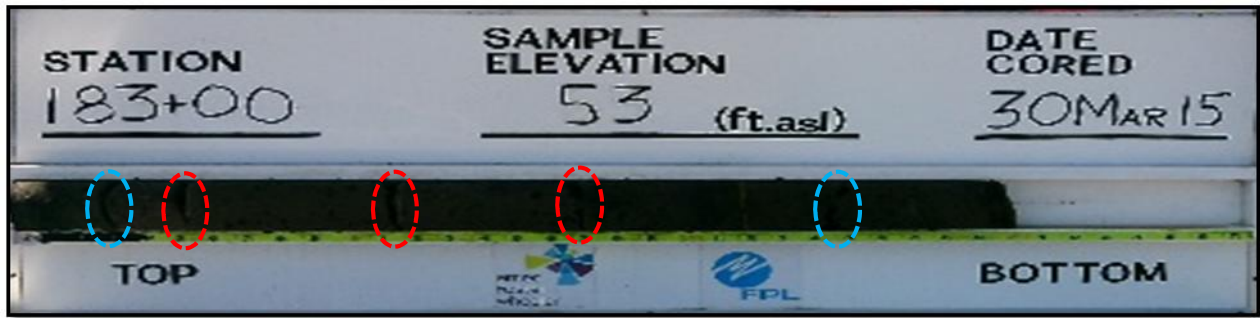
Location: STA 183+00

Core ID:	183+00 (bottom)	Date Cored:	3/30/15
Core Elevation:	53' ASL	Date Photographed:	3/30/15
Recovered Length (ft):	2.9	SC Thickness (ft):	3.33
RQD (%):	81	Void Depth (ft):	N/A
Notes:	Insitu soil from to 2.9 to 2.95 feet.

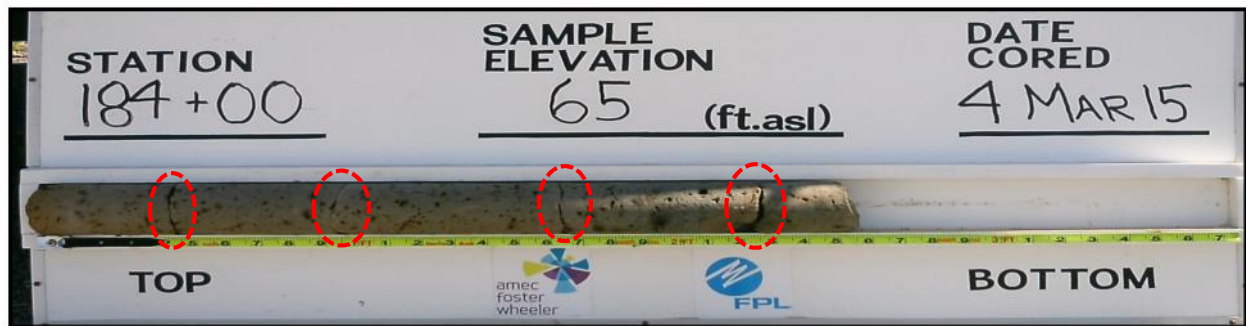
Location: STA 184+00

Core ID:	184+00 (top)	Date Cored:	3/4/15
Core Elevation:	65' ASL	Date Photographed:	3/4/15
Recovered Length (ft):	2.5	SC Thickness (ft):	2.5
RQD (%):	89	Void Depth (ft):	N/A
Notes:

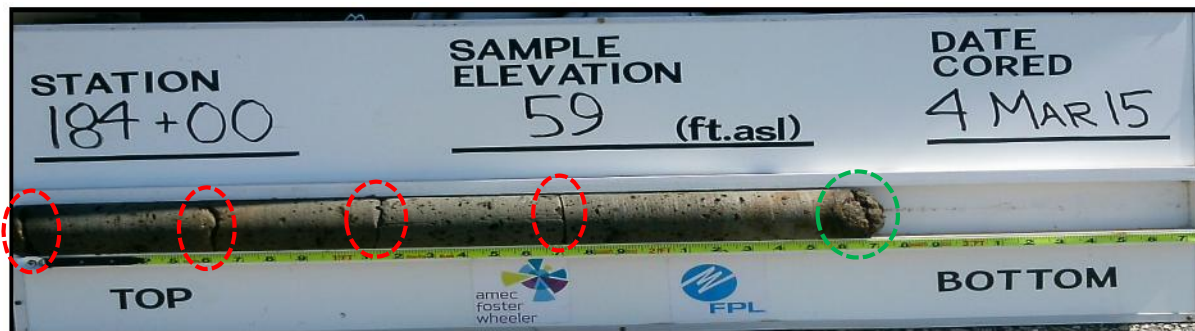
Location: STA 184+00

Core ID:	184+00 (middle)	Date Cored:	3/4/15
Core Elevation:	59' ASL	Date Photographed:	3/4/15
Recovered Length (ft):	2.65	SC Thickness (ft):	2.65
RQD (%):	99	Void Depth (ft):	N/A
Notes:	Last 0.05 feet of sample was soil

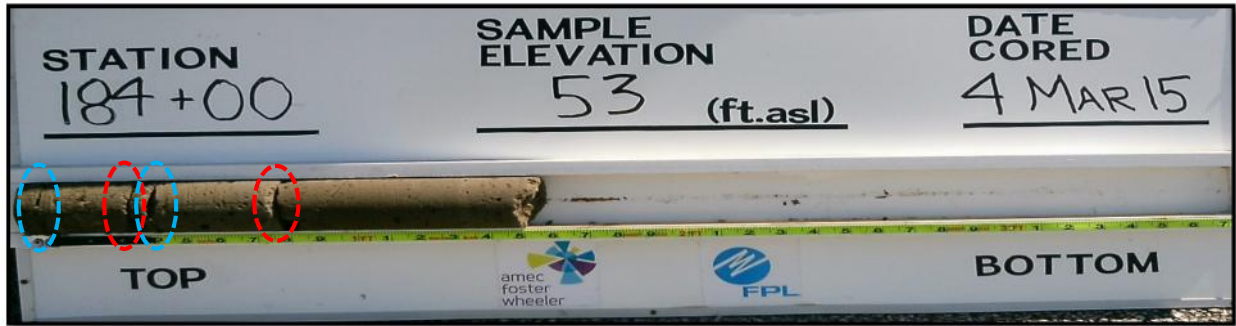
Location: STA 184+00

Core ID:	184+00 (bottom)	Date Cored:	3/4/15
Core Elevation:	53' ASL	Date Photographed:	3/4/15
Recovered Length (ft):	1.5	SC Thickness (ft):	2.33
RQD (%):	51	Void Depth (ft):	N/A
Notes:

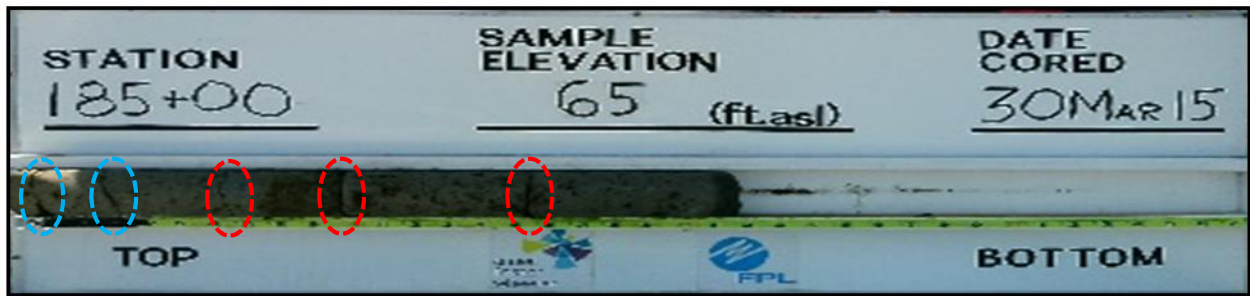
Location: STA 185+00

Core ID:	185+00 (top)	Date Cored:	3/30/15
Core Elevation:	65' ASL	Date Photographed:	3/30/15
Recovered Length (ft):	2.13	SC Thickness (ft):	2.33
RQD (%):	85	Void Depth (ft):	N/A
Notes:

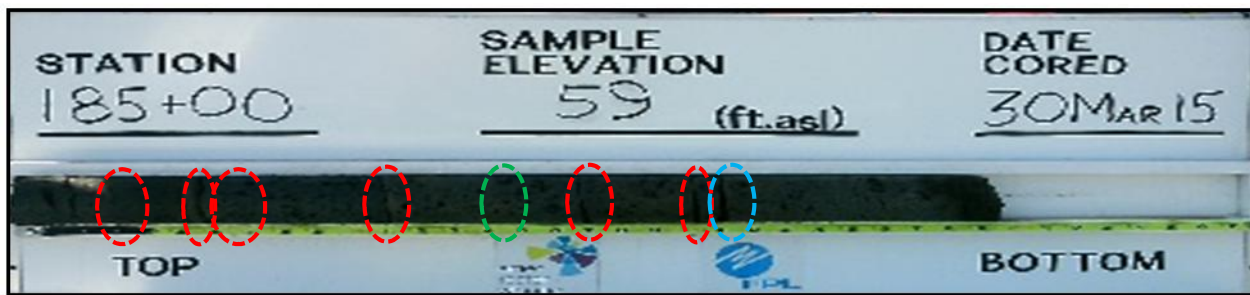
Location: STA 185+00

Core ID:	185+00 (middle)	Date Cored:	3/30/15
Core Elevation:	59' ASL	Date Photographed:	3/30/15
Recovered Length (ft):	1.92	SC Thickness (ft):	2.08
RQD (%):	49	Void Depth (ft):	N/A
Notes:	Wood piece at 1.45 feet. Insitu soil from 2.8 to 2.9 feet.

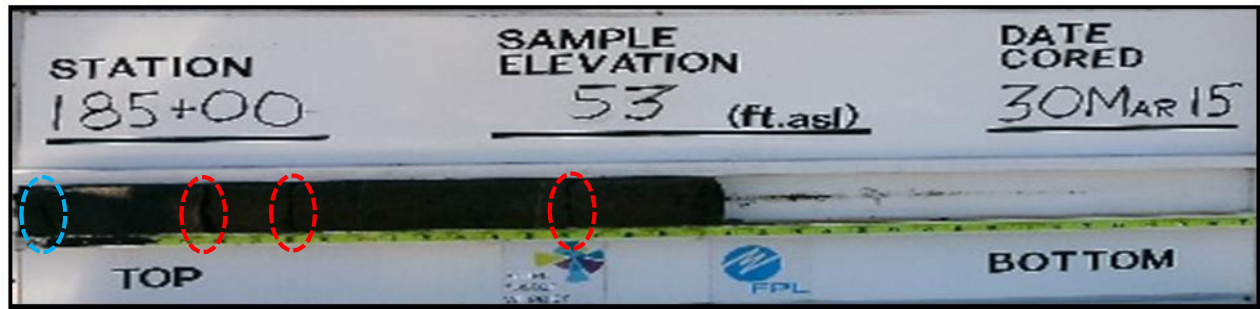
Location: STA 185+00

Core ID:	185+00 (bottom)	Date Cored:	3/30/15
Core Elevation:	53' ASL	Date Photographed:	3/30/15
Recovered Length (ft):	2.05	SC Thickness (ft):	2.67
RQD (%):	82	Void Depth (ft):	N/A
Notes:	Entire recovered core is of soft material.

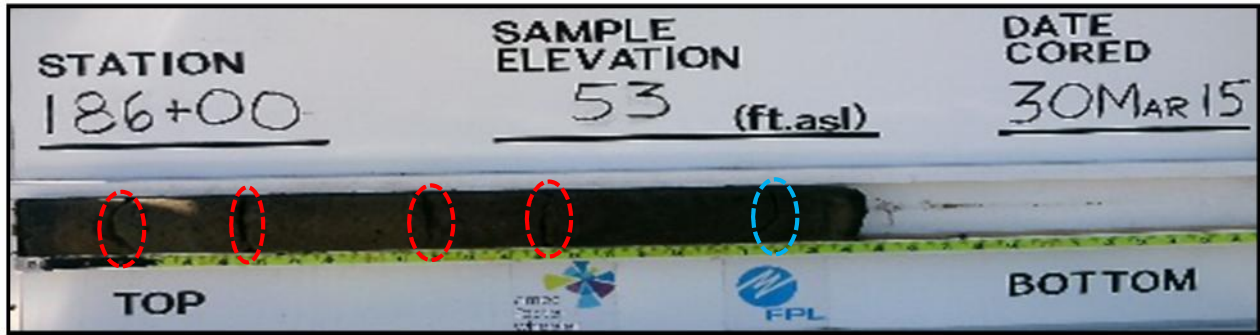
Location: STA 186+00

Core ID:	186+00 (bottom)	Date Cored:	3/30/15
Core Elevation:	53' ASL	Date Photographed:	3/30/15
Recovered Length (ft):	2.4	SC Thickness (ft):	2.67
RQD (%):	79	Void Depth (ft):	N/A
Notes:	Soft material from 0 to 1.5 feet.

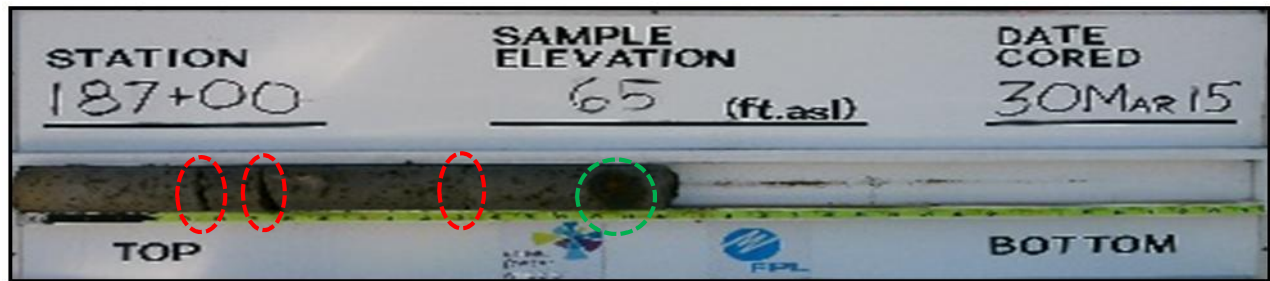
Location: STA 187+00

Core ID:	187+00 (top)	Date Cored:	3/30/15
Core Elevation:	65' ASL	Date Photographed:	3/30/15
Recovered Length (ft):	1.88	SC Thickness (ft):	2.0
RQD (%):	88	Void Depth (ft):	N/A
Notes:	Wood piece at 1.75 feet. Soft material from 0 to 0.2 feet.

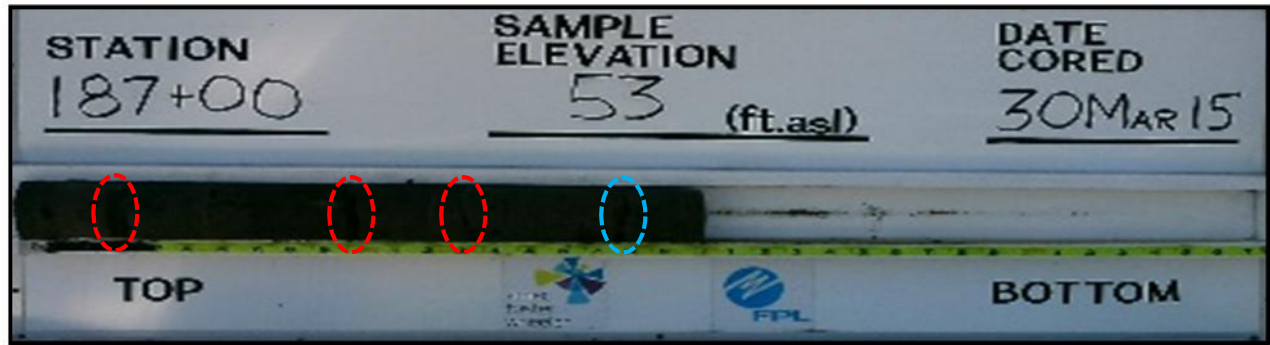
Location: STA 187+00

Core ID:	187+00 (bottom)	Date Cored:	3/30/15
Core Elevation:	53' ASL	Date Photographed:	3/30/15
Recovered Length (ft):	2.0	SC Thickness (ft):	2.33
RQD (%):	88	Void Depth (ft):	N/A
Notes:	Entire recovered core is soft material.

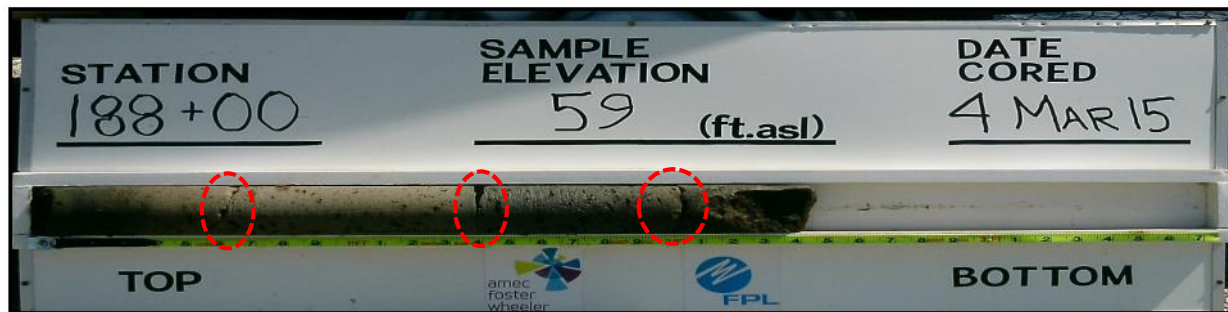
Location: STA 188+00

Core ID:	188+00 (middle)	Date Cored:	3/4/15
Core Elevation:	59' ASL	Date Photographed:	3/4/15
Recovered Length (ft):	2.4	SC Thickness (ft):	3.0
RQD (%):	83	Void Depth (ft):	N/A
Notes:	50% missing from bottom portion after last mechanical break

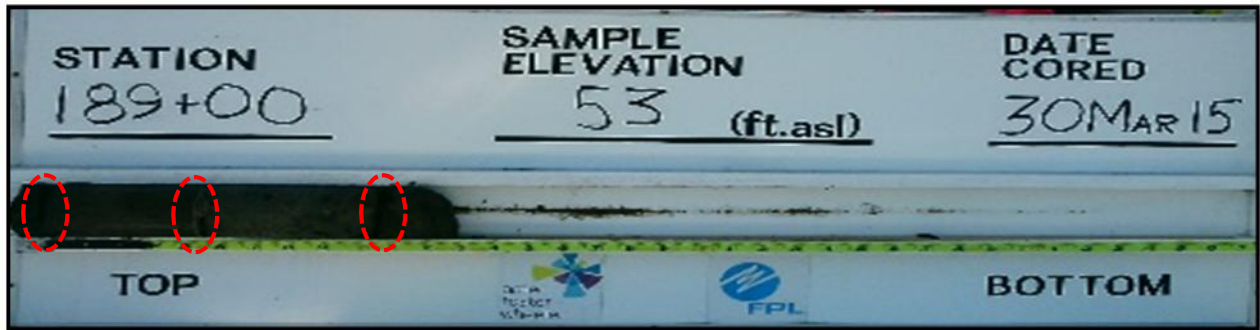
Location: STA 189+00

Core ID:	189+00 (bottom)	Date Cored:	3/30/15
Core Elevation:	53' ASL	Date Photographed:	3/30/15
Recovered Length (ft):	1.25	SC Thickness (ft):	1.58
RQD (%):	74	Void Depth (ft):	N/A
Notes:	Very soft material from 0 to 0.1 feet and from 1.03 to 1.25 feet. Soft material from 0.1 to 1.03 feet.

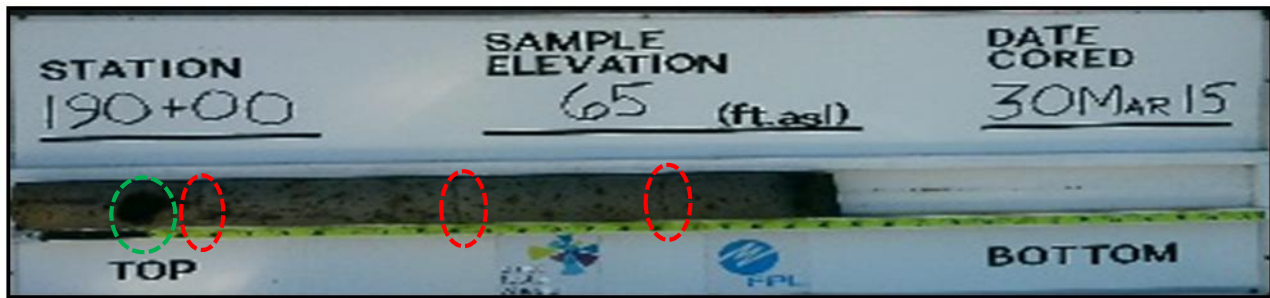
Location: STA 190+00

Core ID:	190+00 (top)	Date Cored:	3/30/15
Core Elevation:	65' ASL	Date Photographed:	3/30/15
Recovered Length (ft):	2.4	SC Thickness (ft):	2.42
RQD (%):	100	Void Depth (ft):	N/A
Notes:	Wood piece at 0.4 feet.

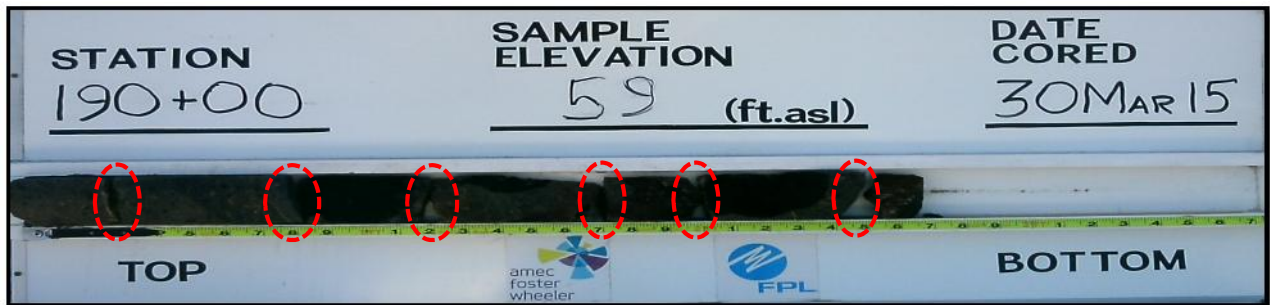
Location: STA 190+00

Core ID:	190+00 (middle)	Date Cored:	3/30/15
Core Elevation:	59' ASL	Date Photographed:	3/30/15
Recovered Length (ft):	2.6	SC Thickness (ft):	3.0
RQD (%):	19	Void Depth (ft):	N/A
Notes:	Soft material from 0 to 0.8 feet. From 0.8 to 2.6 feet, recovered core sections are laterally fractured in half.

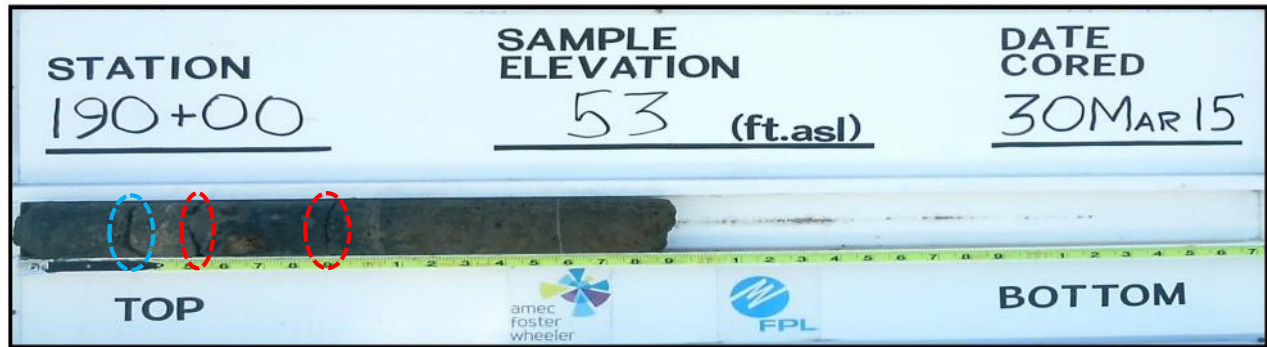
Location: STA 190+00

Core ID:	190+00 (bottom)	Date Cored:	3/30/15
Core Elevation:	53' ASL	Date Photographed:	3/30/15
Recovered Length (ft):	1.85	SC Thickness (ft):	2.0
RQD (%):	92	Void Depth (ft):	N/A
Notes:	Entire recovered core is soft.

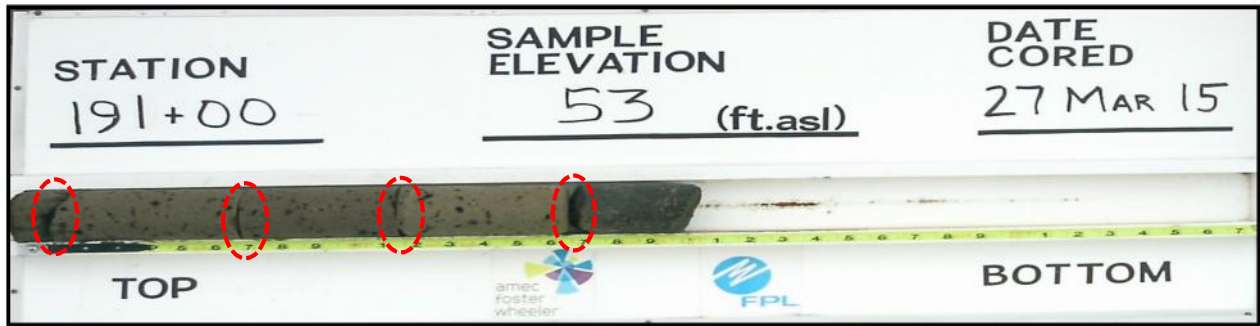
Location: STA 191+00

Core ID:	191+00 (bottom)	Date Cored:	3/27/15
Core Elevation:	53' ASL	Date Photographed:	3/27/15
Recovered Length (ft):	2.0	SC Thickness (ft):	2.5
RQD (%):	95	Void Depth (ft):	N/A
Notes:	Soft material from 0 to 0.15 feet and from 1.63 to 2.0 feet.

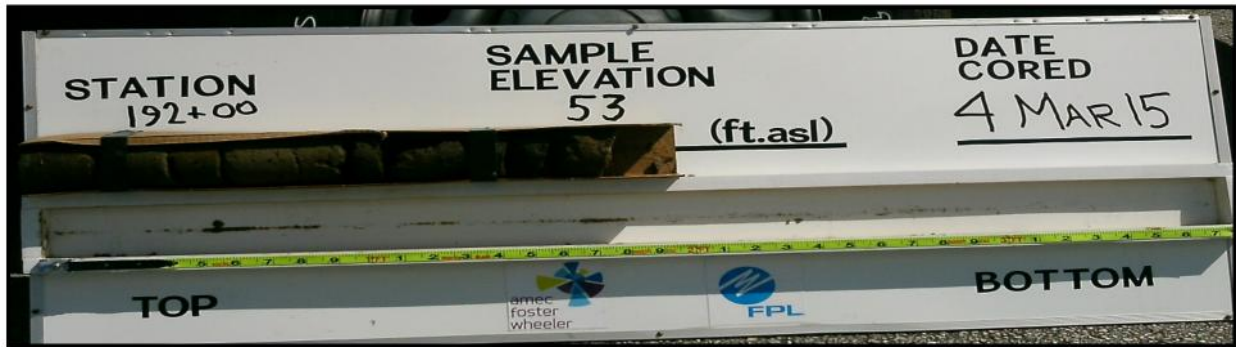
Location: STA 192+00

Core ID:	192+00 (bottom)	Date Cored:	3/4/15
Core Elevation:	53' ASL	Date Photographed:	3/4/15
Recovered Length (ft):		SC Thickness (ft):	2.33
RQD (%):	0	Void Depth (ft):	N/A
Notes:	Sample un-recoverable. Broke into pieces and could not be re-arranged.

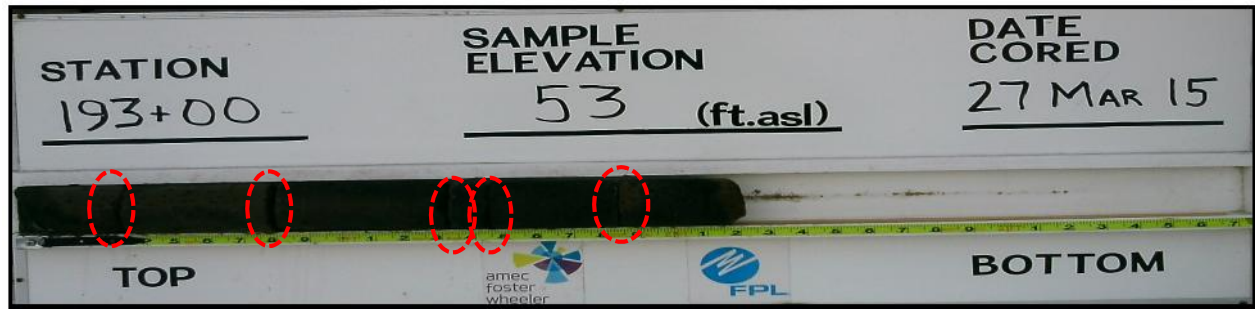
Location: STA 193+00

Core ID:	193+00 (bottom)	Date Cored:	3/27/15
Core Elevation:	53' ASL	Date Photographed:	3/27/15
Recovered Length (ft):	2.2	SC Thickness (ft):	3.0
RQD (%):	94	Void Depth (ft):	N/A
Notes:	Complete recovered core is soft.

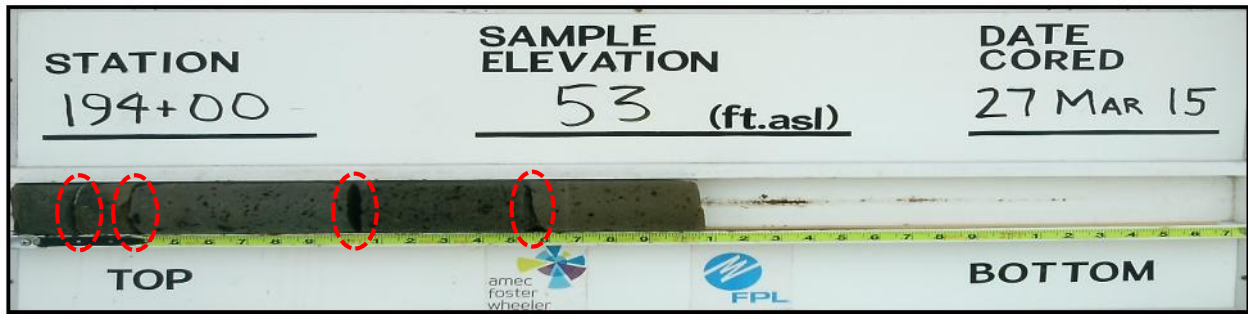
Location: STA 194+00

Core ID:	194+00 (bottom)	Date Cored:	3/27/15
Core Elevation:	53' ASL	Date Photographed:	3/27/15
Recovered Length (ft):	2.05	SC Thickness (ft):	2.165
RQD (%):	80	Void Depth (ft):	N/A
Notes:	Soft material from 0 to 0.4 feet.

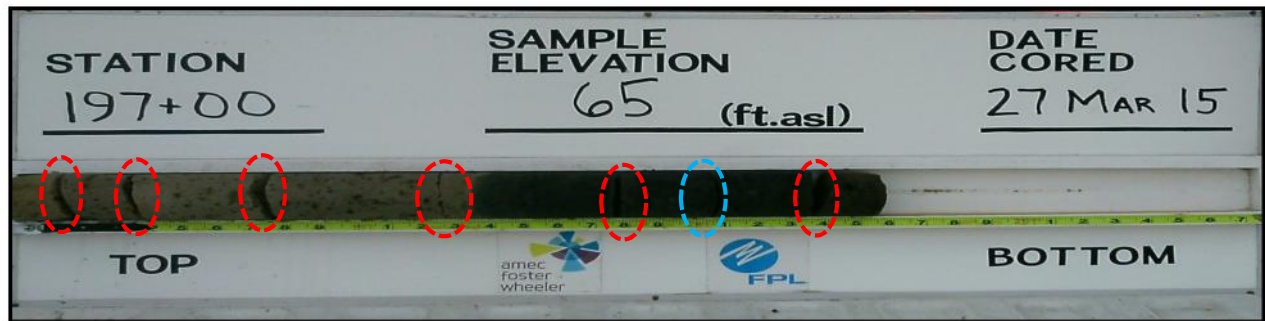
Location: STA 197+00

Core ID:	197+00 (top)	Date Cored:	3/27/15
Core Elevation:	65' ASL	Date Photographed:	3/27/15
Recovered Length (ft):	2.5	SC Thickness (ft):	2.83
RQD (%):	70	Void Depth (ft):	N/A
Notes:	Soft material from 0 to 0.2 feet.

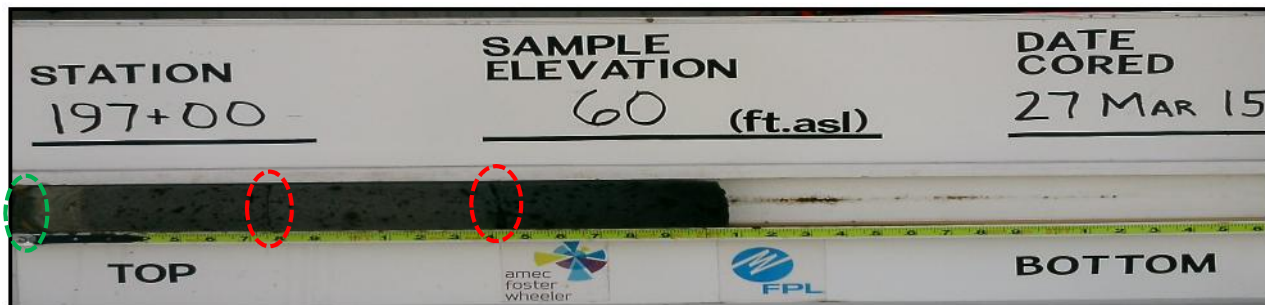
Location: STA 197+00

Core ID:	197+00 (middle)	Date Cored:	3/27/15
Core Elevation:	60' ASL	Date Photographed:	3/27/15
Recovered Length (ft):	2.05	SC Thickness (ft):	2.67
RQD (%):	100	Void Depth (ft):	N/A
Notes:	Wood piece at 0.1 feet.
