**Assessment and Design Report
Soil-Cement Condition Assessment and Design Project
Manatee Plant Cooling Pond Dam
Parrish, Florida
Project Number 300906**

To: Mr. Lewis Rounds, P.E.
FPL Manatee Plant

Date: June 2015

From: Jeff Beriswill
Amec Foster Wheeler Environment & Infrastructure, Inc.

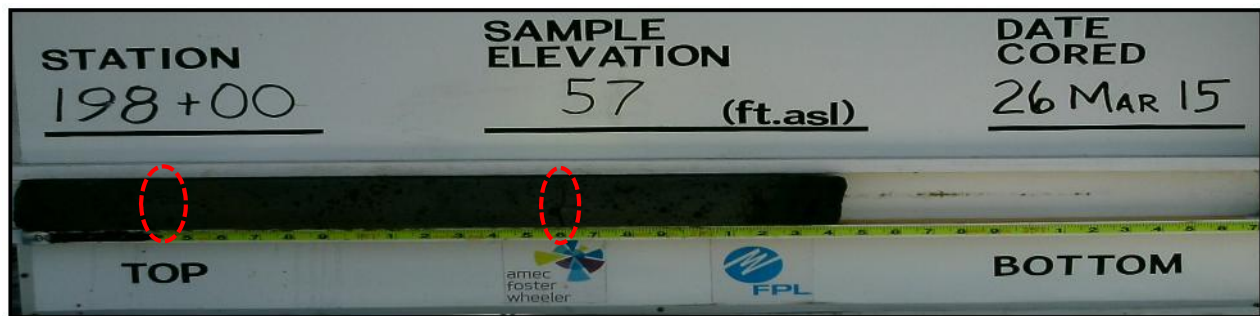
Location: STA 198+00

Core ID:	198+00 (middle)	Date Cored:	3/26/15
Core Elevation:	57' ASL	Date Photographed:	3/26/15
Recovered Length (ft):	12.2	SC Thickness (ft):	2.67
RQD (%):	100	Void Depth (ft):	N/A
Notes:	Insitu soil from 2.2 to 2.4 feet..

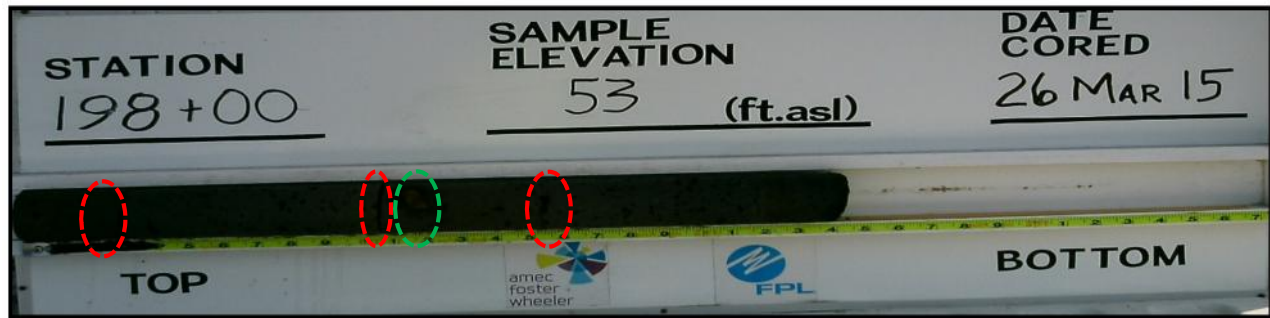
Location: STA 198+00

Core ID:	198+00 (bottom)	Date Cored:	3/26/15
Core Elevation:	53' ASL	Date Photographed:	3/26/15
Recovered Length (ft):	2.4	SC Thickness (ft):	3.0
RQD (%):	100	Void Depth (ft):	N/A
Notes:	Wood piece at 1.15 feet.

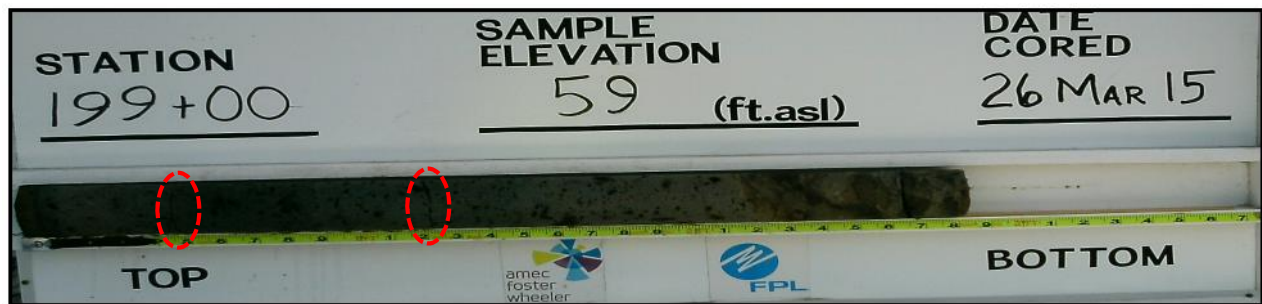
Location: STA 199+00

Core ID:	199+00 (middle)	Date Cored:	3/26/15
Core Elevation:	59' ASL	Date Photographed:	3/26/15
Recovered Length (ft):	2.15	SC Thickness (ft):	3.08
RQD (%):	100	Void Depth (ft):	N/A
Notes:	Insitu soil from 2.15 to 2.8 feet.

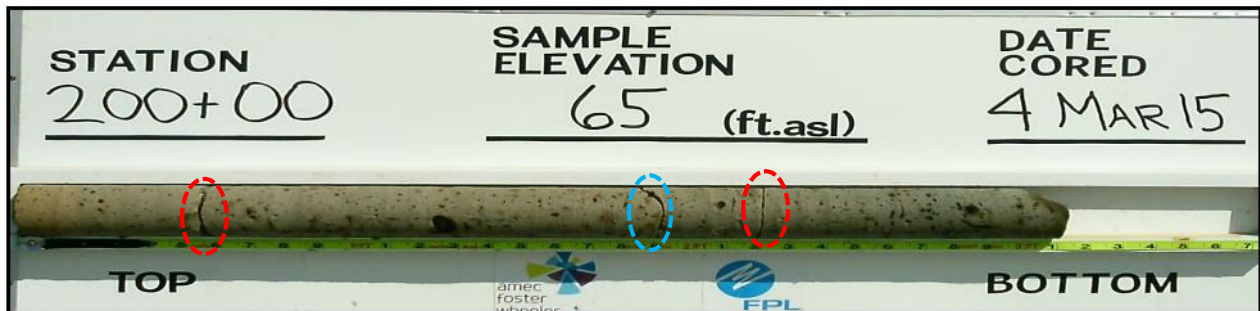
Location: STA 200+00

Core ID:	200+00 (top)	Date Cored:	3/4/15
Core Elevation:	65' ASL	Date Photographed:	3/4/15
Recovered Length (ft):	3.05	SC Thickness (ft):	3.05
RQD (%):	100	Void Depth (ft):	N/A
Notes:

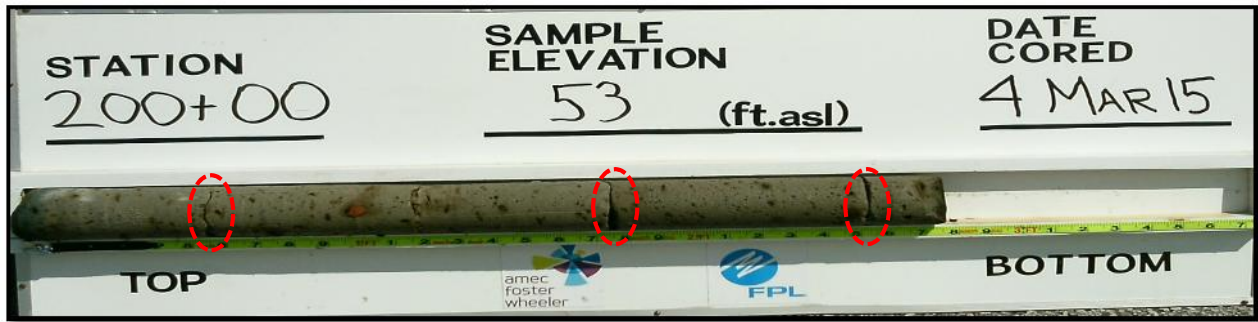
Location: STA 200+00

Core ID:	200+00 (bottom)	Date Cored:	3/4/15
Core Elevation:	53' ASL	Date Photographed:	3/4/15
Recovered Length (ft):	2.75	SC Thickness (ft):	2.92
RQD (%):	100	Void Depth (ft):	N/A
Notes:

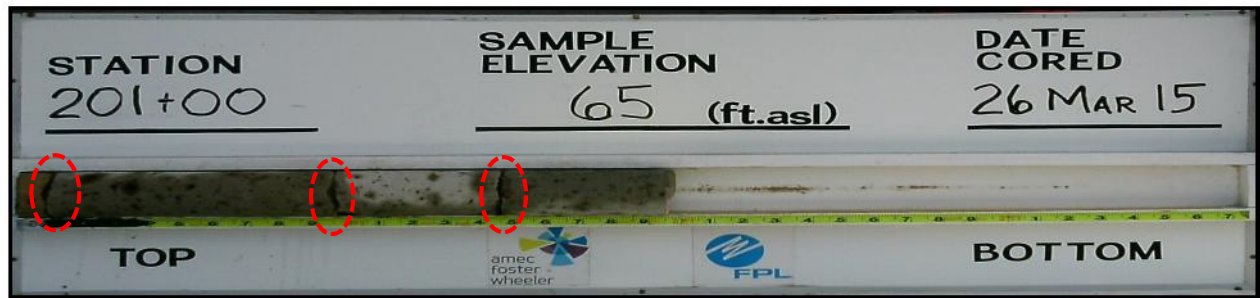
Location: STA 201+00

Core ID:	201+00 (top)	Date Cored:	3/26/15
Core Elevation:	65' ASL	Date Photographed:	3/26/15
Recovered Length (ft):	1.95	SC Thickness (ft):	3.0
RQD (%):	99	Void Depth (ft):	N/A
Notes:	Soft material from 0 to 0.1 feet.

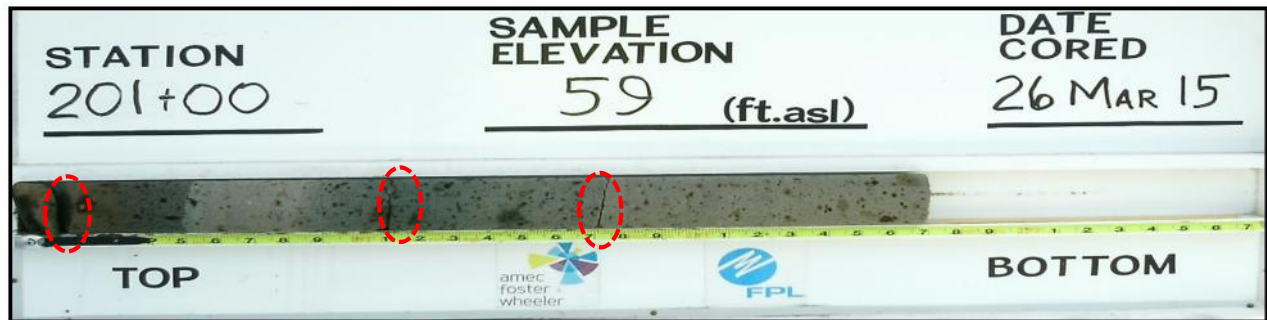
Location: STA 201+00

Core ID:	201+00 (middle)	Date Cored:	3/26/15
Core Elevation:	59' ASL	Date Photographed:	3/26/15
Recovered Length (ft):	2.67	SC Thickness (ft):	2.92
RQD (%):	99	Void Depth (ft):	N/A
Notes:	Soft material from 0 to 0.1 feet.

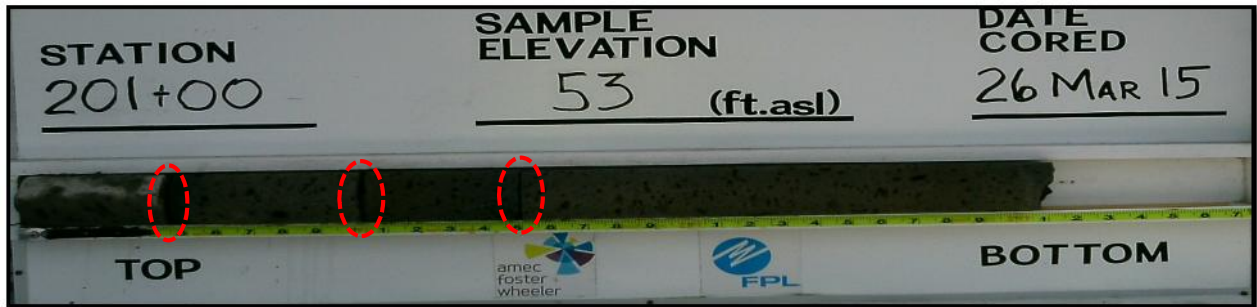
Location: STA 201+00

Core ID:	201+00 (bottom)	Date Cored:	3/26/15
Core Elevation:	53' ASL	Date Photographed:	3/26/15
Recovered Length (ft):	3.05	SC Thickness (ft):	3.33
RQD (%):	100	Void Depth (ft):	N/A
Notes:

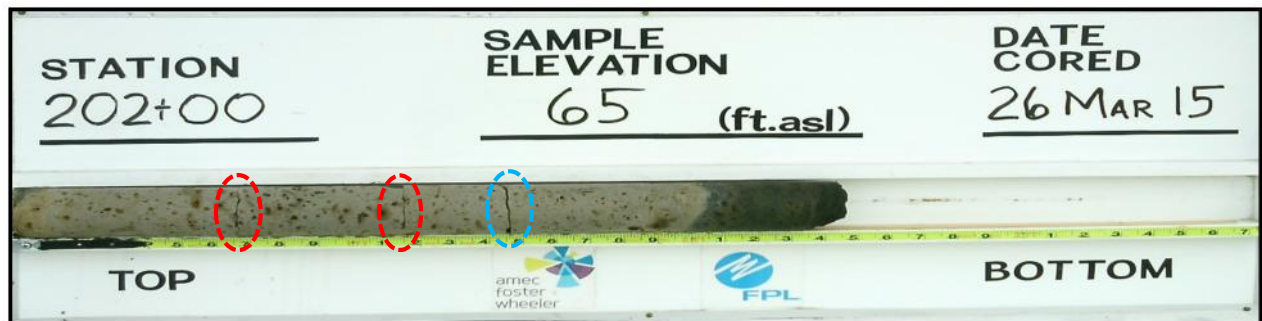
Location: STA 202+00

Core ID:	202+00 (top)	Date Cored:	3/26/15
Core Elevation:	65' ASL	Date Photographed:	3/26/15
Recovered Length (ft):	2.4	SC Thickness (ft):	2.75
RQD (%):	88	Void Depth (ft):	N/A
Notes:

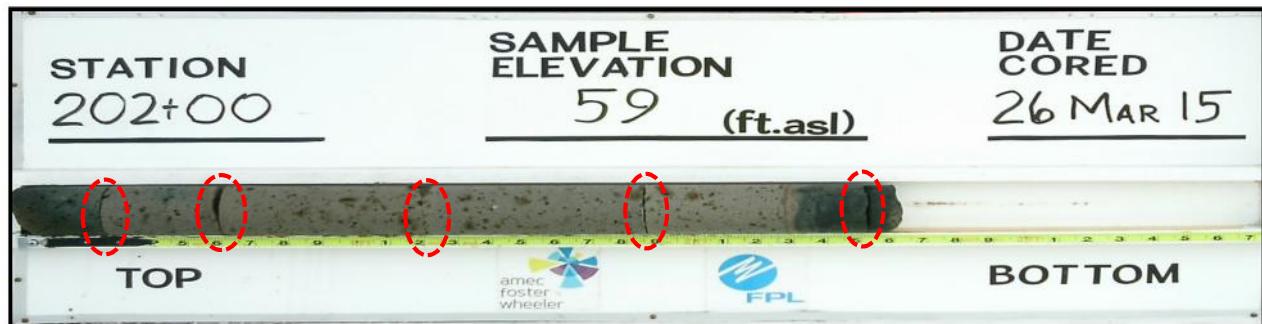
Location: STA 202+00

Core ID:	202+00 (middle)	Date Cored:	3/26/15
Core Elevation:	59' ASL	Date Photographed:	3/26/15
Recovered Length (ft):	2.6	SC Thickness (ft):	2.67
RQD (%):	73	Void Depth (ft):	N/A
Notes:

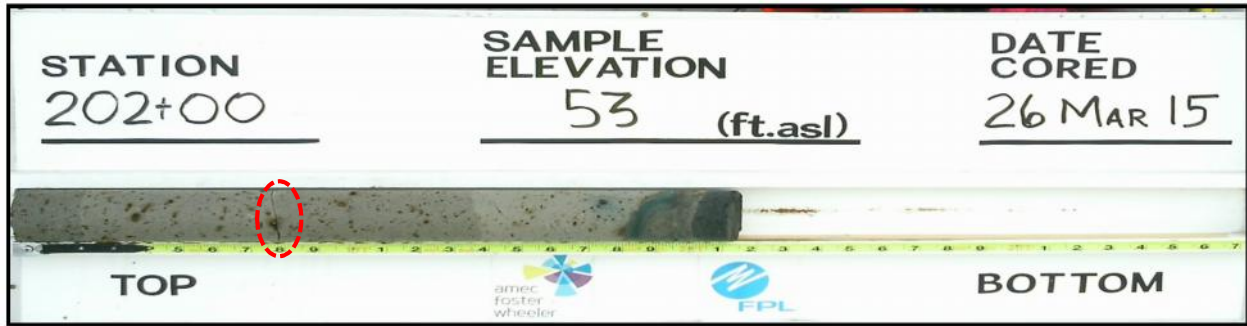
Location: STA 202+00

Core ID:	202+00 (bottom)	Date Cored:	3/26/15
Core Elevation:	53' ASL	Date Photographed:	3/26/15
Recovered Length (ft):	2.1	SC Thickness (ft):	2.58
RQD (%):	100	Void Depth (ft):	N/A
Notes:

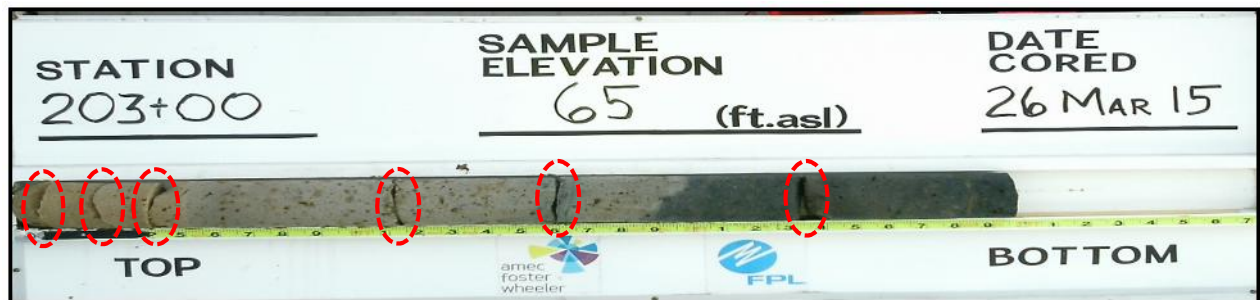
Location: STA 203+00

Core ID:	203+00 (top)	Date Cored:	3/26/15
Core Elevation:	65' ASL	Date Photographed:	3/26/15
Recovered Length (ft):	2.95	SC Thickness (ft):	3.0
RQD (%):	98	Void Depth (ft):	N/A
Notes:	Soft material from 0 to 0.52 feet.

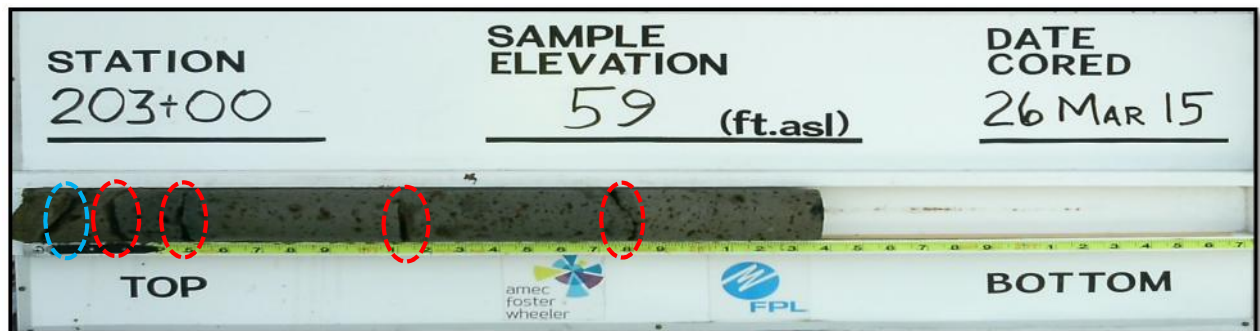
Location: STA 203+00

Core ID:	203+00 (middle)	Date Cored:	3/26/15
Core Elevation:	59' ASL	Date Photographed:	3/26/15
Recovered Length (ft):	2.35	SC Thickness (ft):	2.67
RQD (%):	98	Void Depth (ft):	N/A
Notes:	Very soft material from 0 to 0.3 feet.

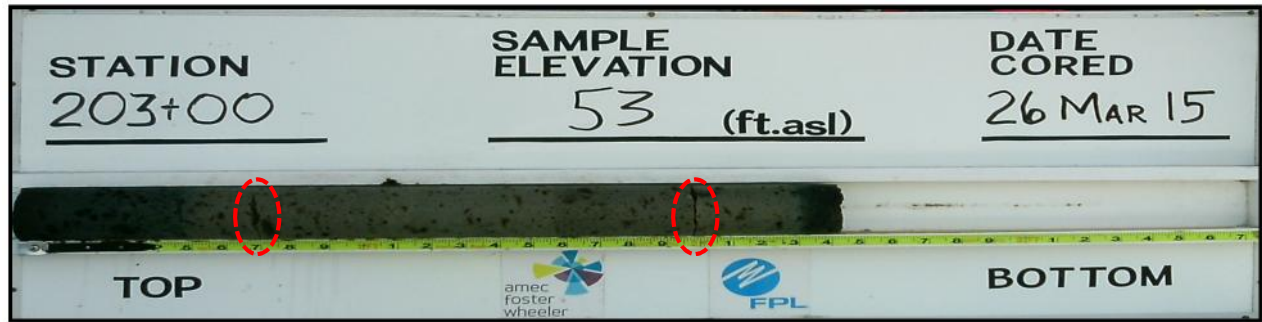
Location: STA 203+00

Core ID:	203+00 (bottom)	Date Cored:	3/26/15
Core Elevation:	53' ASL	Date Photographed:	3/26/15
Recovered Length (ft):	2.4	SC Thickness (ft):	2.83
RQD (%):	100	Void Depth (ft):	N/A
Notes:

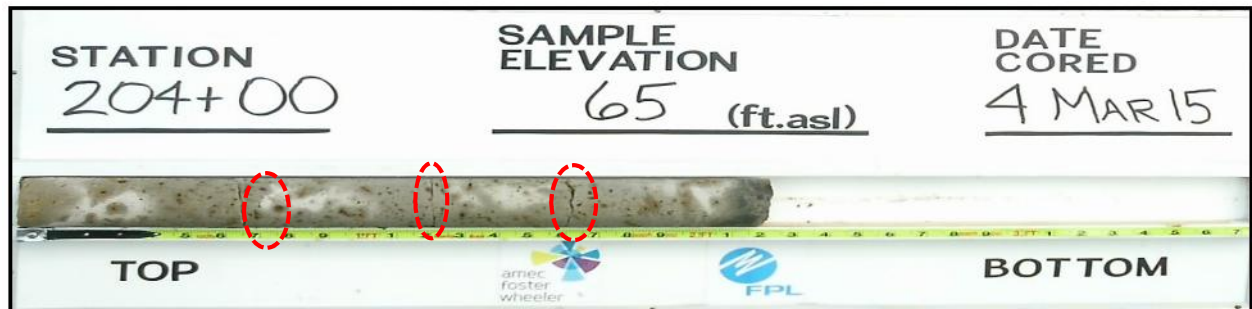
Location: STA 204+00

Core ID:	204+00 (top)	Date Cored:	3/4/15
Core Elevation:	65' ASL	Date Photographed:	3/4/15
Recovered Length (ft):	2.2	SC Thickness (ft):	2.75
RQD (%):	100	Void Depth (ft):	N/A
Notes:

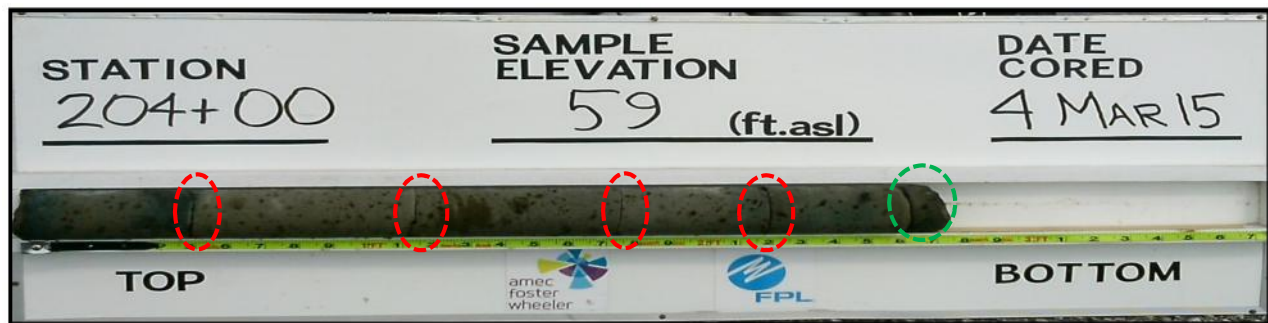
Location: STA 204+00

Core ID:	204+00 (middle)	Date Cored:	3/4/15
Core Elevation:	659' ASL	Date Photographed:	3/4/15
Recovered Length (ft):	2.6	SC Thickness (ft):	3.0
RQD (%):	100	Void Depth (ft):	N/A
Notes:	Soil at tip of core

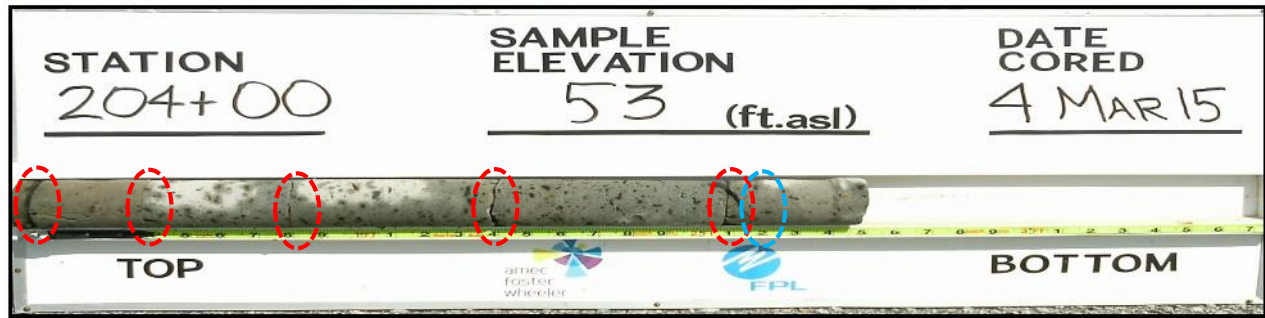
Location: STA 204+00

Core ID:	204+00 (bottom)	Date Cored:	3/4/15
Core Elevation:	53' ASL	Date Photographed:	3/4/15
Recovered Length (ft):	2.46	SC Thickness (ft):	3.0
RQD (%):	99	Void Depth (ft):	N/A
Notes:

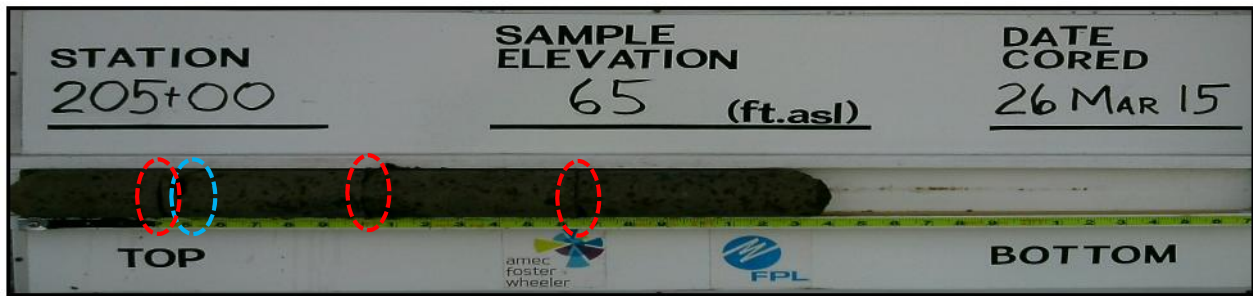
Location: STA 205+00

Core ID:	205+00 (top)	Date Cored:	3/26/15
Core Elevation:	65' ASL	Date Photographed:	3/26/15
Recovered Length (ft):	2.3	SC Thickness (ft):	3.0
RQD (%):	97	Void Depth (ft):	N/A
Notes:

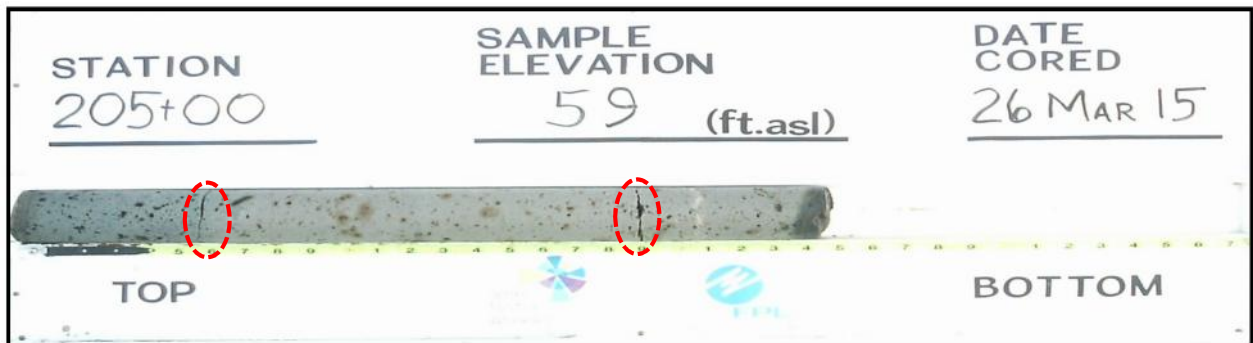
Location: STA 205+00

Core ID:	205+00 (middle)	Date Cored:	3/26/15
Core Elevation:	59' ASL	Date Photographed:	3/26/15
Recovered Length (ft):	2.4	SC Thickness (ft):	2.67
RQD (%):	100	Void Depth (ft):	N/A
Notes:

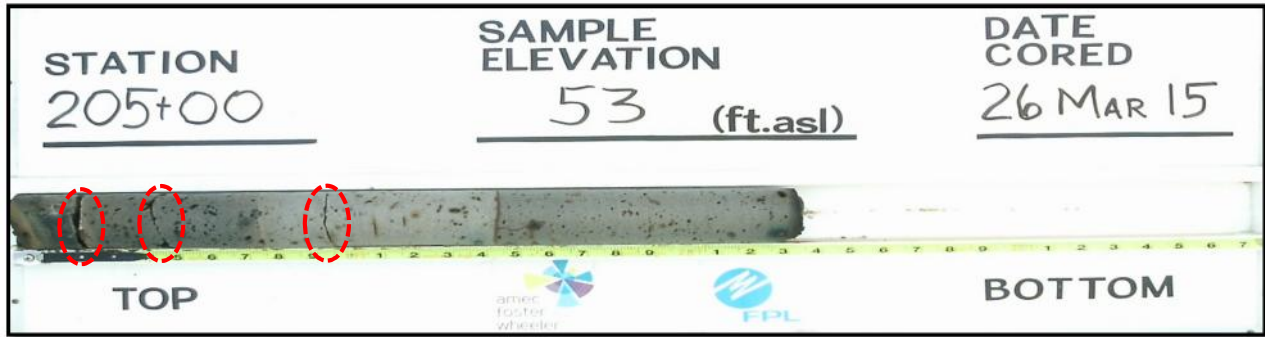
Location: STA 205+00

Core ID:	205+00 (bottom)	Date Cored:	3/26/15
Core Elevation:	53' ASL	Date Photographed:	3/26/15
Recovered Length (ft):	2.3	SC Thickness (ft):	2.58
RQD (%):	80	Void Depth (ft):	N/A
Notes:

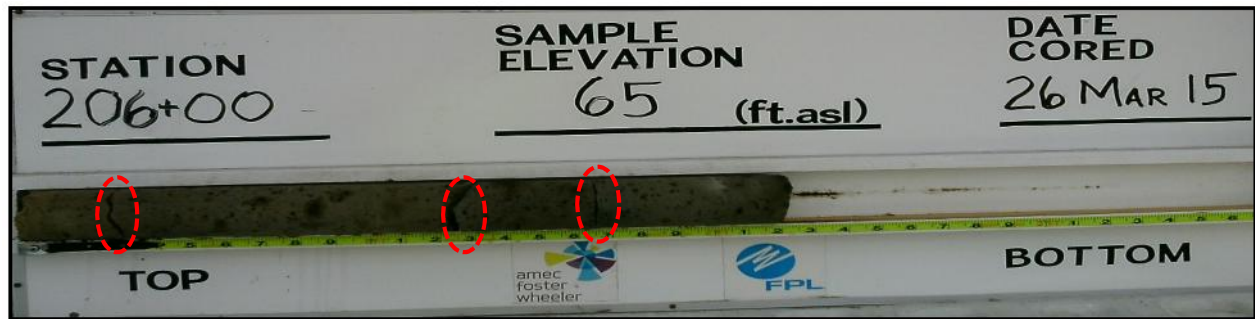
Location: STA 206+00

Core ID:	206+00 (top)	Date Cored:	3/26/15
Core Elevation:	65' ASL	Date Photographed:	3/26/15
Recovered Length (ft):	2.17	SC Thickness (ft):	2.83
RQD (%):	86	Void Depth (ft):	N/A
Notes:

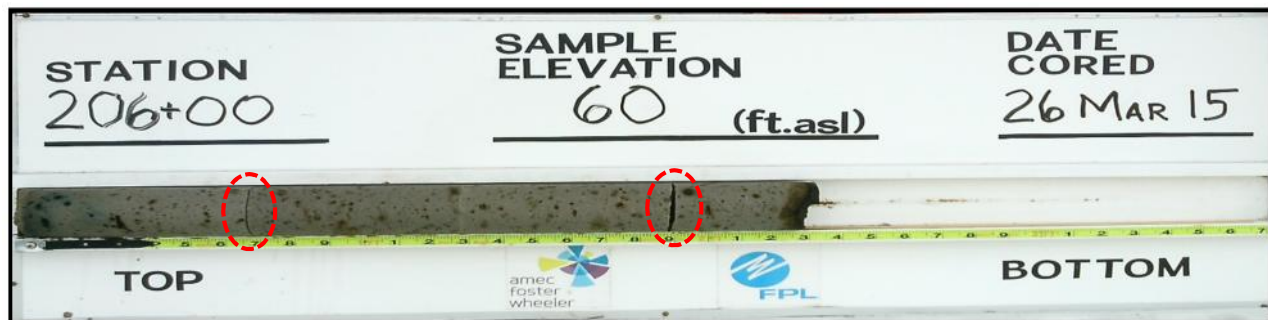
Location: STA 206+00

Core ID:	206+00 (middle)	Date Cored:	3/26/15
Core Elevation:	60' ASL	Date Photographed:	3/26/15
Recovered Length (ft):	2.25	SC Thickness (ft):	2.67
RQD (%):	100	Void Depth (ft):	N/A
Notes:

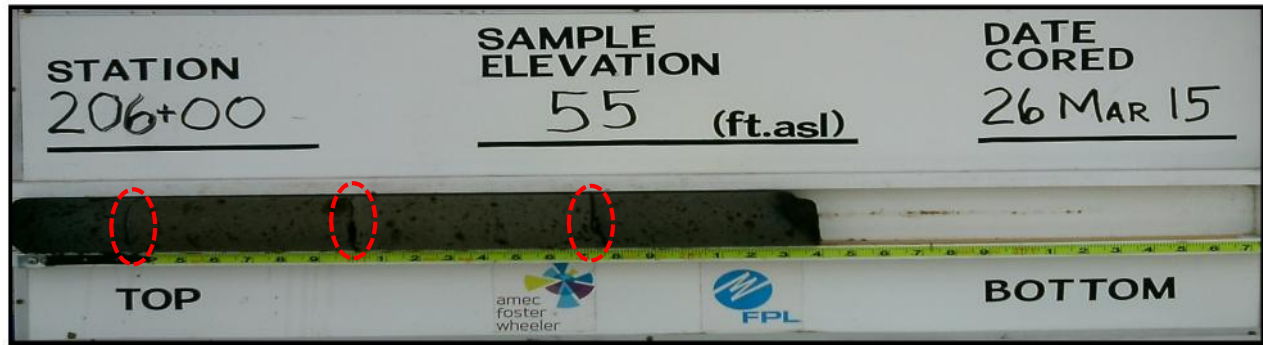
Location: STA 206+00

Core ID:	206+00 (bottom)	Date Cored:	3/26/15
Core Elevation:	55' ASL	Date Photographed:	3/26/15
Recovered Length (ft):	2.35	SC Thickness (ft):	2.83
RQD (%):	100	Void Depth (ft):	N/A
Notes:

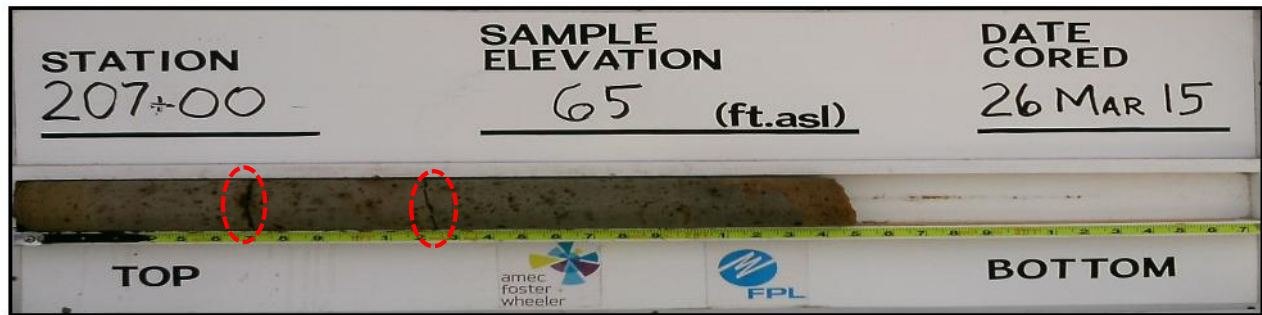
Location: STA 207+00

Core ID:	207+00 (top)	Date Cored:	3/26/15
Core Elevation:	65' ASL	Date Photographed:	3/26/15
Recovered Length (ft):	2.45	SC Thickness (ft):	3.0
RQD (%):	100	Void Depth (ft):	N/A
Notes:

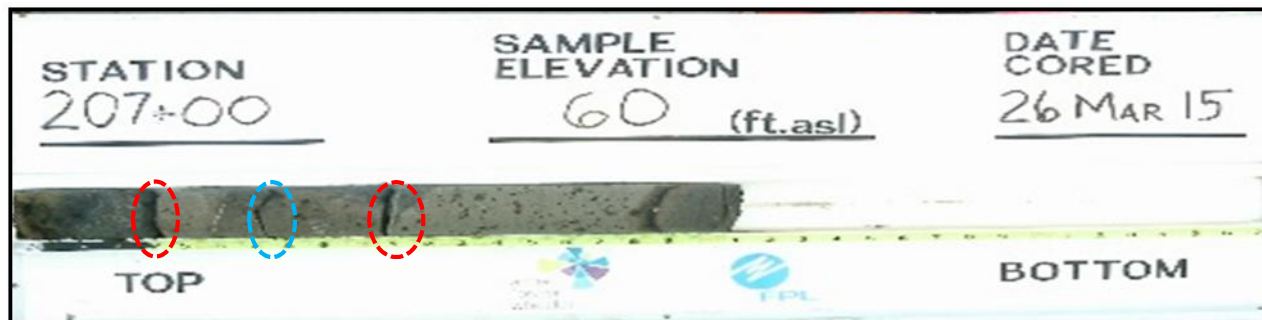
Location: STA 207+00

Core ID:	207+00 (middle)	Date Cored:	3/26/15
Core Elevation:	60' ASL	Date Photographed:	3/26/15
Recovered Length (ft):	2.05	SC Thickness (ft):	2.58
RQD (%):	84	Void Depth (ft):	N/A
Notes:	Very soft material from 0 to 0.4 feet.

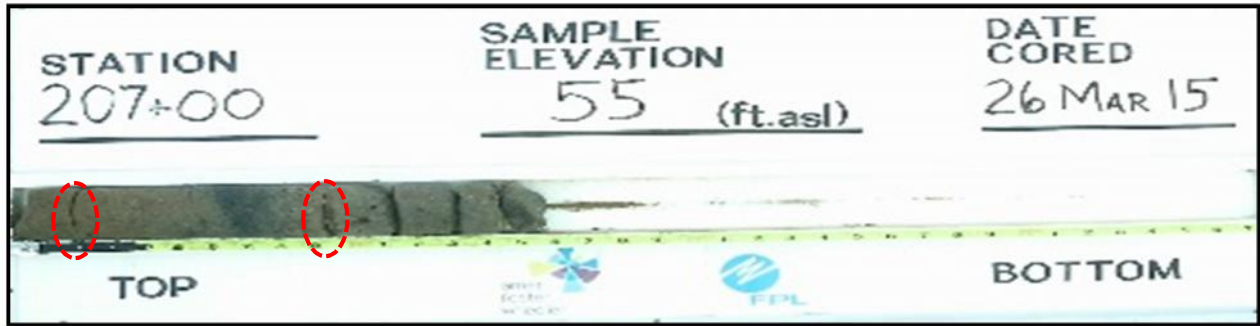
Location: STA 207+00

Core ID:	207+00 (bottom)	Date Cored:	3/26/15
Core Elevation:	55' ASL	Date Photographed:	3/26/15
Recovered Length (ft):	1.5	SC Thickness (ft):	1.92
RQD (%):	60	Void Depth (ft):	N/A
Notes:	Soft material and core fragments from 1.1 to 1.5 feet.

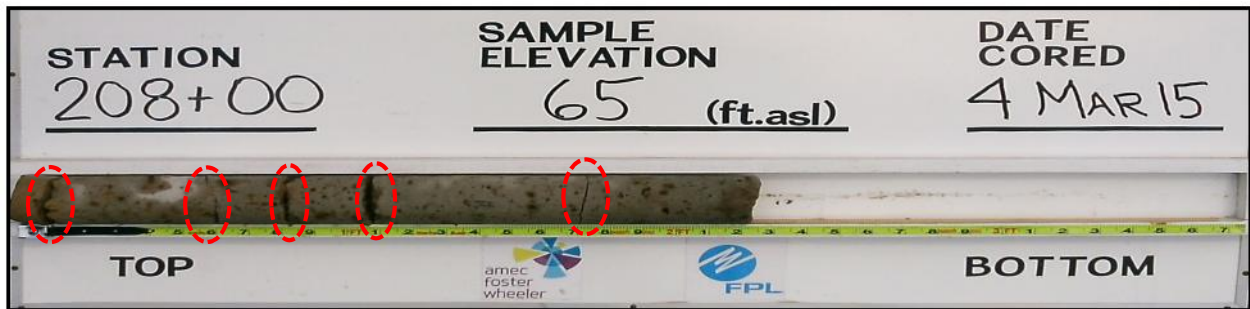
Location: STA 208+00

Core ID:	208+00 (top)	Date Cored:	3/4/15
Core Elevation:	65' ASL	Date Photographed:	3/4/15
Recovered Length (ft):	2.2	SC Thickness (ft):	2.2
RQD (%):	85	Void Depth (ft):	N/A
Notes:	Soft material from 0 to 0.1 feet

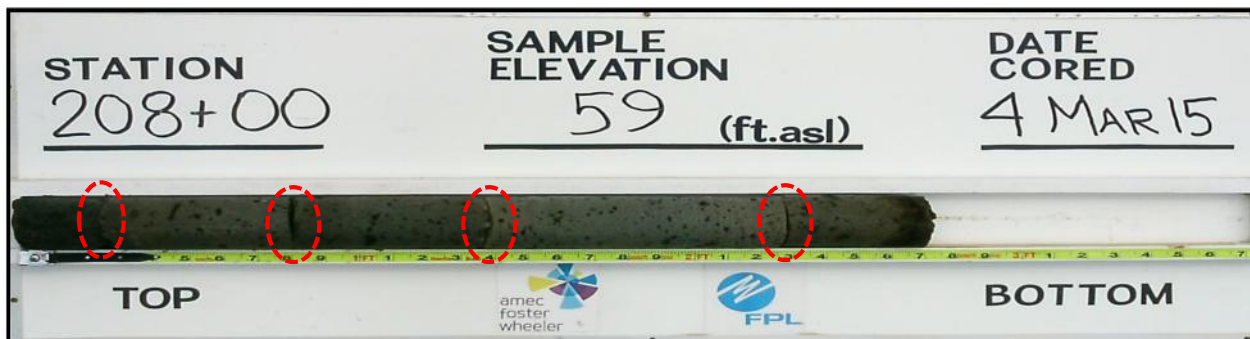
Location: STA 208+00

Core ID:	208+00 (middle)	Date Cored:	3/4/15
Core Elevation:	59' ASL	Date Photographed:	3/4/15
Recovered Length (ft):	2.7	SC Thickness (ft):	2.9
RQD (%):	91	Void Depth (ft):	N/A
Notes:	Soft material from 0 to 0.25 feet

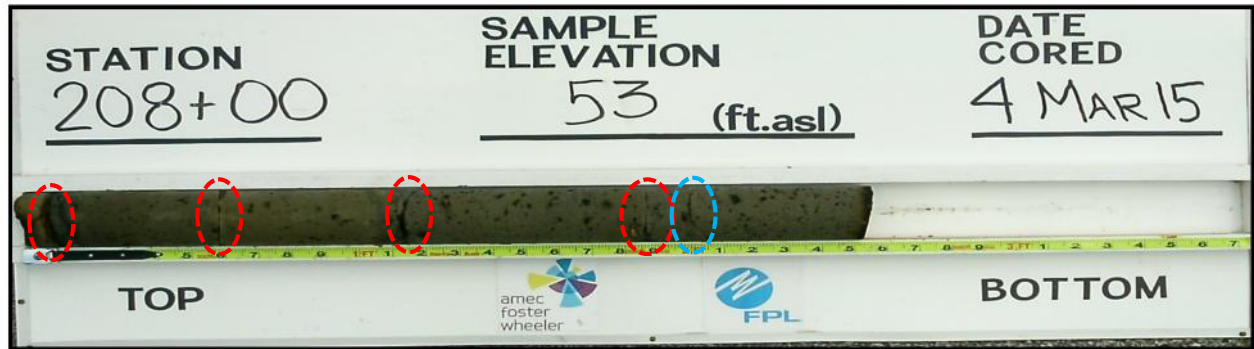
Location: STA 208+00

Core ID:	208+00 (bottom)	Date Cored:	3/4/15
Core Elevation:	53' ASL	Date Photographed:	3/4/15
Recovered Length (ft):	2.5	SC Thickness (ft):	2.92
RQD (%):	95	Void Depth (ft):	N/A
Notes:	Soft material from 0 to 0.1 feet

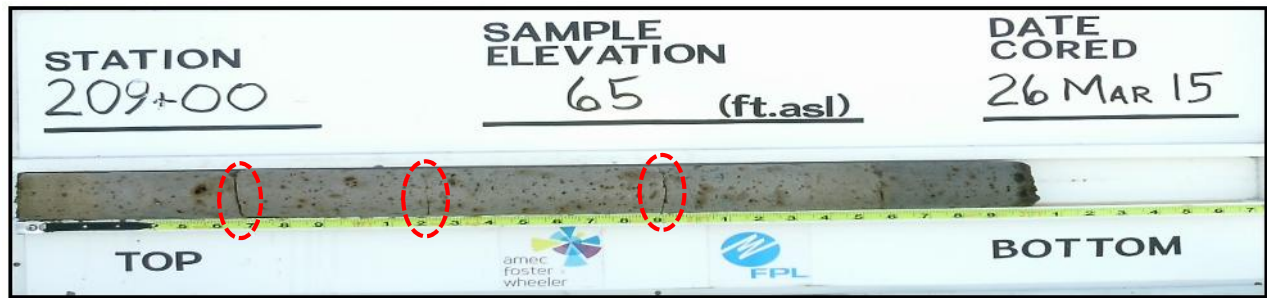
Location: STA 209+00

Core ID:	209+00 (top)	Date Cored:	3/26/15
Core Elevation:	65' ASL	Date Photographed:	3/26/15
Recovered Length (ft):	3.0	SC Thickness (ft):	3.25
RQD (%):	100	Void Depth (ft):	N/A
Notes:

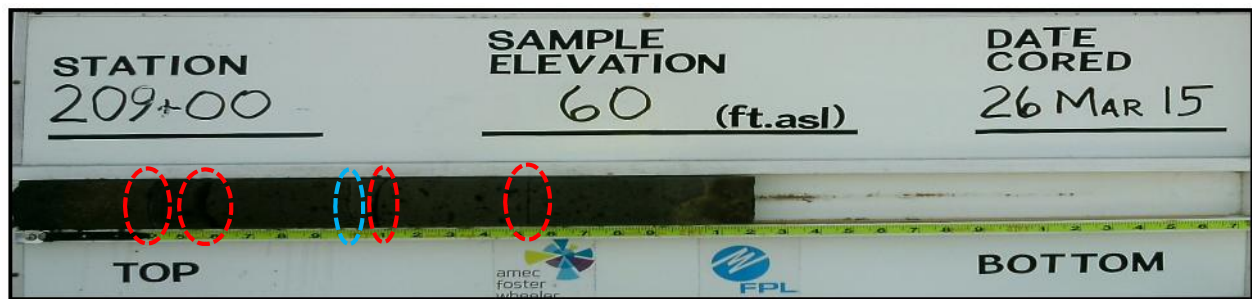
Location: STA 209+00

Core ID:	209+00 (middle)	Date Cored:	3/26/15
Core Elevation:	60' ASL	Date Photographed:	3/26/15
Recovered Length (ft):	2.2	SC Thickness (ft):	2.5
RQD (%):	69	Void Depth (ft):	N/A
Notes:

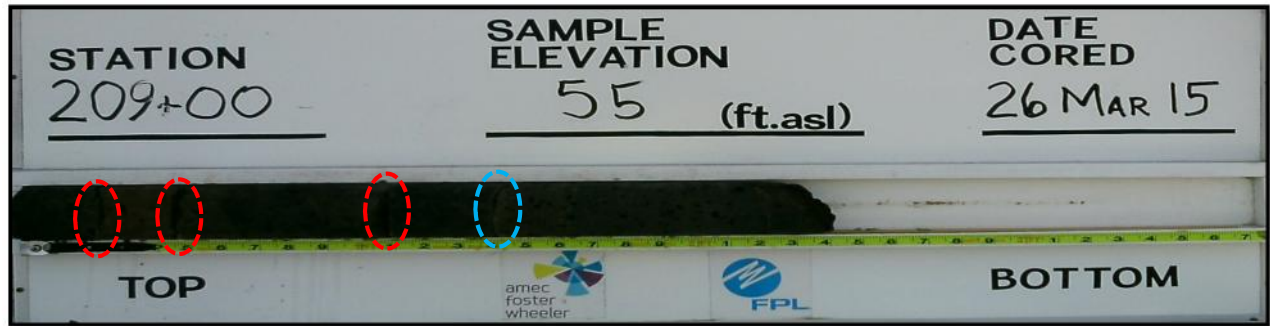
Location: STA 209+00

Core ID:	209+00 (bottom)	Date Cored:	3/26/15
Core Elevation:	55' ASL	Date Photographed:	3/26/15
Recovered Length (ft):	2.3	SC Thickness (ft):	2.83
RQD (%):	80	Void Depth (ft):	N/A
Notes:	Very soft material from 0 to 0.55 feet.

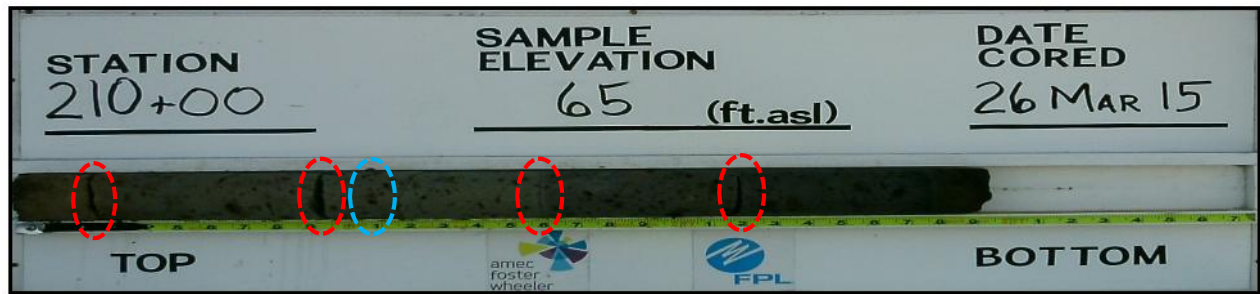
Location: STA 210+00

Core ID:	210+00 (top)	Date Cored:	3/26/15
Core Elevation:	65' ASL	Date Photographed:	3/26/15
Recovered Length (ft):	2.9	SC Thickness (ft):	3.0
RQD (%):	83	Void Depth (ft):	N/A
Notes:	Soft material from 0 to 0.25 feet.

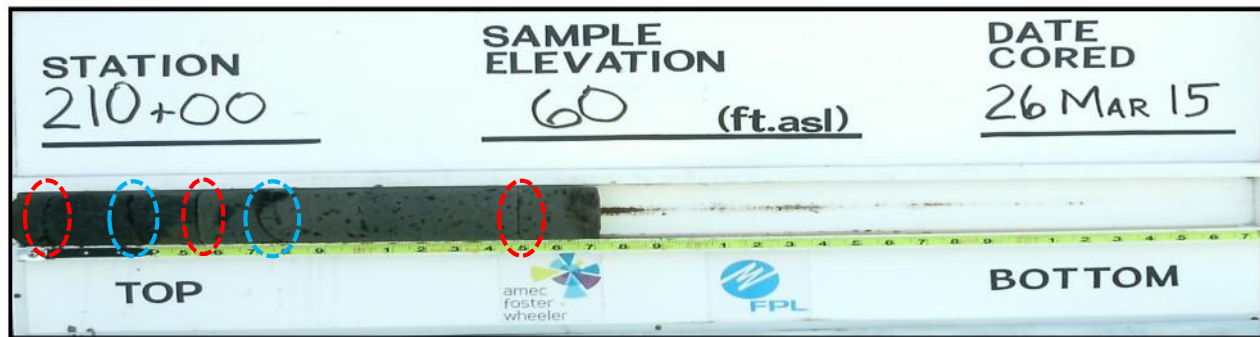
Location: STA 210+00

Core ID:	210+00 (middle)	Date Cored:	3/26/15
Core Elevation:	60' ASL	Date Photographed:	3/26/15
Recovered Length (ft):	1.7	SC Thickness (ft):	2.58
RQD (%):	42	Void Depth (ft):	N/A
Notes:

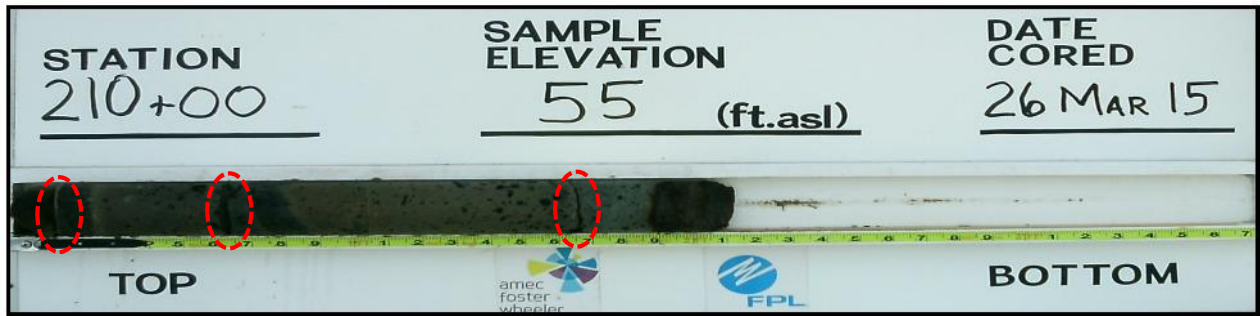
Location: STA 210+00

Core ID:	210+00 (bottom)	Date Cored:	3/26/15
Core Elevation:	55' ASL	Date Photographed:	3/26/15
Recovered Length (ft):	2.0	SC Thickness (ft):	2.42
RQD (%):	93	Void Depth (ft):	N/A
Notes:	Very soft material from 0 to 0.15 feet.

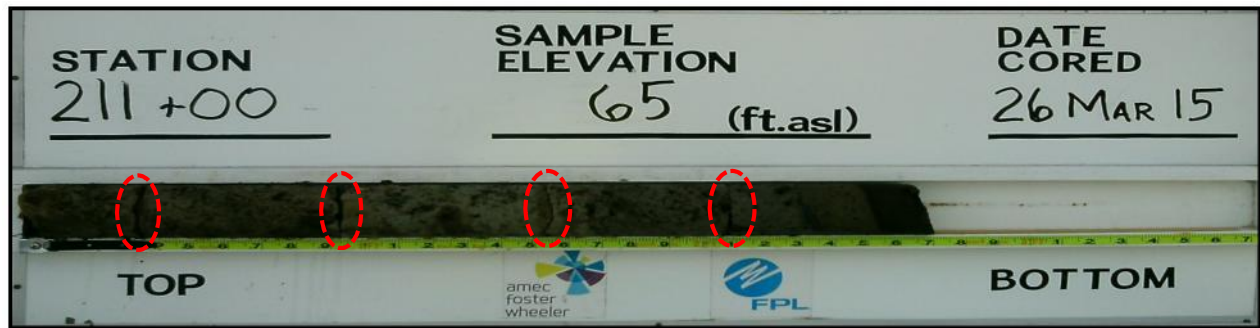
Location: STA 211+00

Core ID:	211+00 (top)	Date Cored:	3/26/15
Core Elevation:	65' ASL	Date Photographed:	3/26/15
Recovered Length (ft):	2.65	SC Thickness (ft):	3.0
RQD (%):	100	Void Depth (ft):	N/A
Notes:

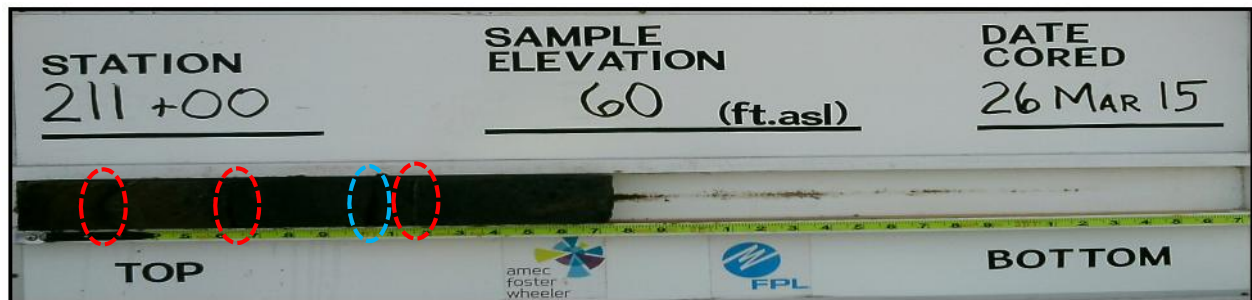
Location: STA 211+00

Core ID:	211+00 (middle)	Date Cored:	3/26/15
Core Elevation:	60' ASL	Date Photographed:	3/26/15
Recovered Length (ft):	1.7	SC Thickness (ft):	1.83
RQD (%):	74	Void Depth (ft):	N/A
Notes:

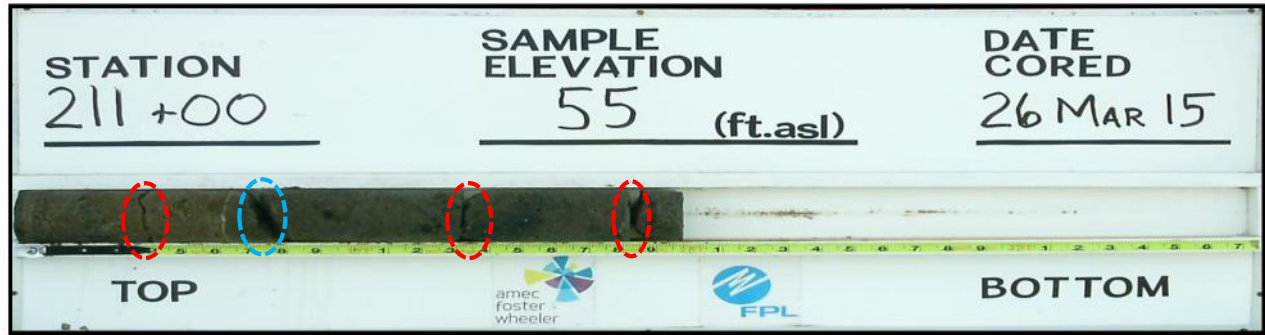
Location: STA 211+00

Core ID:	211+00 (bottom)	Date Cored:	3/26/15
Core Elevation:	55' ASL	Date Photographed:	3/26/15
Recovered Length (ft):	1.95	SC Thickness (ft):	2.5
RQD (%):	93	Void Depth (ft):	N/A
Notes:

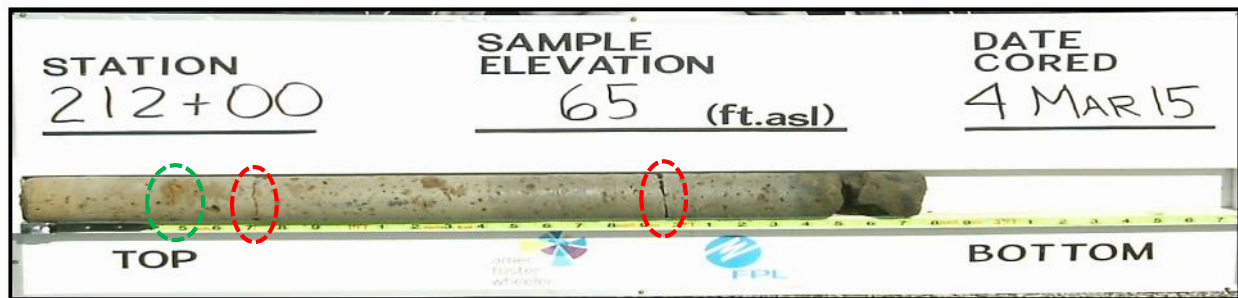
Location: STA 212+00

Core ID:	212+00 (top)	Date Cored:	3/4/15
Core Elevation:	65' ASL	Date Photographed:	3/4/15
Recovered Length (ft):	2.5	SC Thickness (ft):	2.83
RQD (%):	100	Void Depth (ft):	N/A
Notes:	Plant debris at 0.45 feet. Soft soil 2.5 to 2.75 feet.

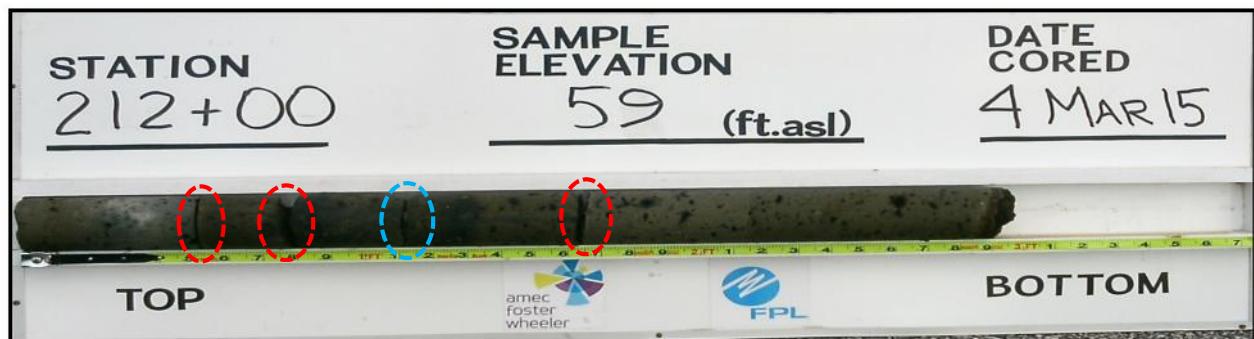
Location: STA 212+00

Core ID:	212+00 (middle)	Date Cored:	3/4/15
Core Elevation:	59' ASL	Date Photographed:	3/4/15
Recovered Length (ft):	2.9	SC Thickness (ft):	3.0
RQD (%):	79	Void Depth (ft):	N/A
Notes:

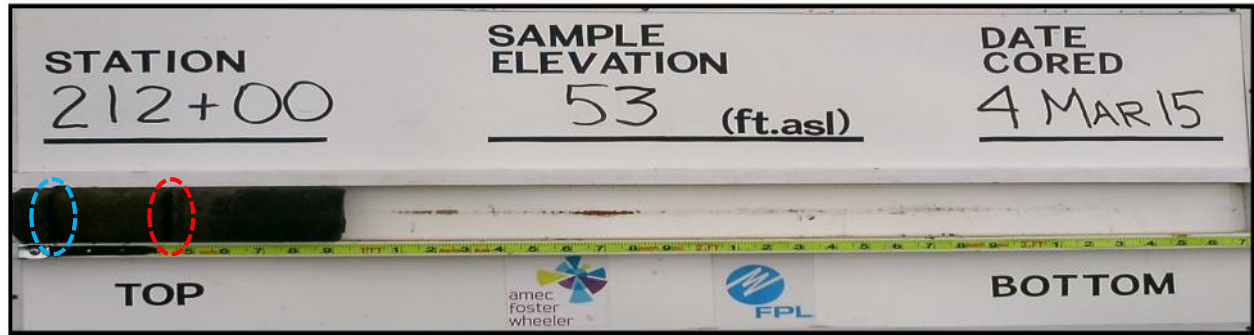
Location: STA 212+00

Core ID:	212+00 (bottom)	Date Cored:	3/4/15
Core Elevation:	53' ASL	Date Photographed:	3/4/15
Recovered Length (ft):	0.9	SC Thickness (ft):	2.0
RQD (%):	88	Void Depth (ft):	N/A
Notes:	Soft material 0 to 0.1 feet.

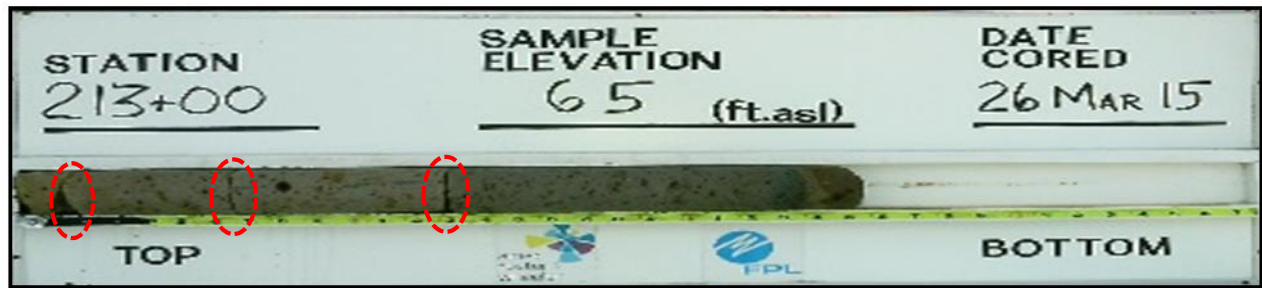
Location: STA 213+00

Core ID:	213+00 (top)	Date Cored:	3/26/15
Core Elevation:	65' ASL	Date Photographed:	3/26/15
Recovered Length (ft):	2.45	SC Thickness (ft):	2.75
RQD (%):	92	Void Depth (ft):	N/A
Notes:	Very soft material from 0 to 0.2 feet.

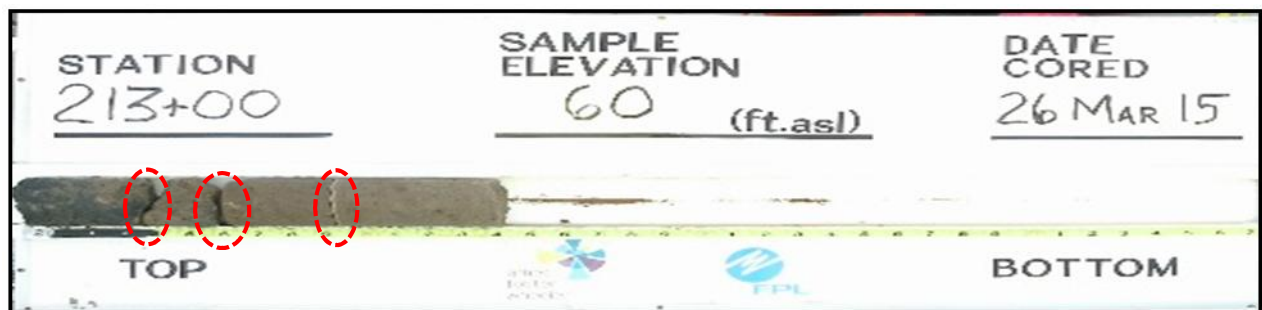
Location: STA 213+00

Core ID:	213+00 (middle)	Date Cored:	3/26/15
Core Elevation:	60' ASL	Date Photographed:	3/26/15
Recovered Length (ft):	1.4	SC Thickness (ft):	1.83
RQD (%):	34	Void Depth (ft):	N/A
Notes:	Soft material from 0 to 0.35 feet. A very soft half section of core recovered from 0.35 to 0.6 feet..

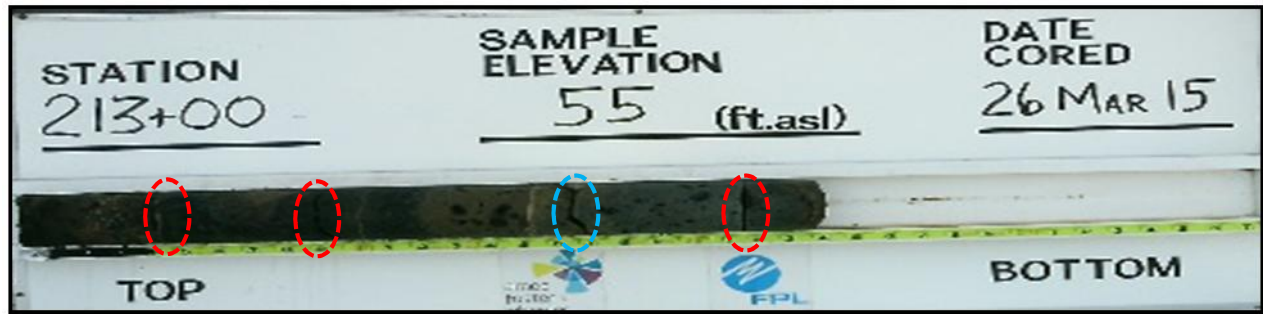
Location: STA 213+00

Core ID:	213+00 (bottom)	Date Cored:	3/26/15
Core Elevation:	55' ASL	Date Photographed:	3/26/15
Recovered Length (ft):	2.35	SC Thickness (ft):	2.33
RQD (%):	91	Void Depth (ft):	N/A
Notes:

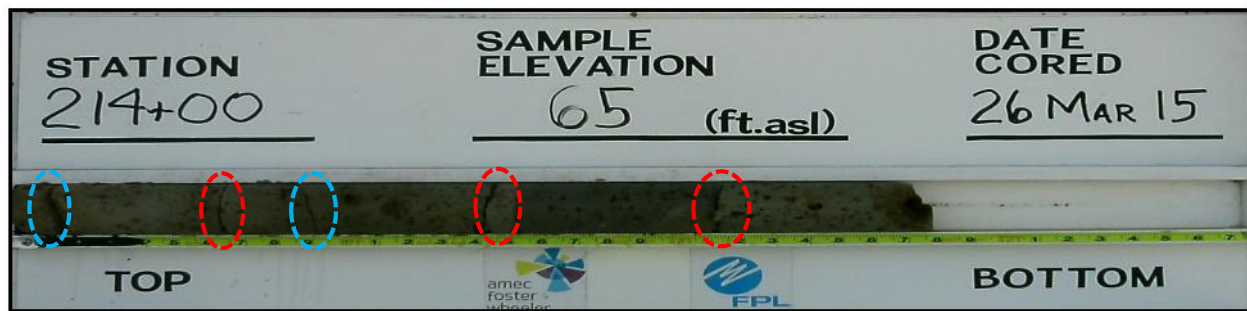
Location: STA 214+00

Core ID:	214+00 (top)	Date Cored:	3/26/15
Core Elevation:	65' ASL	Date Photographed:	3/26/15
Recovered Length (ft):	2.7	SC Thickness (ft):	2.83
RQD (%):	94	Void Depth (ft):	N/A
Notes:

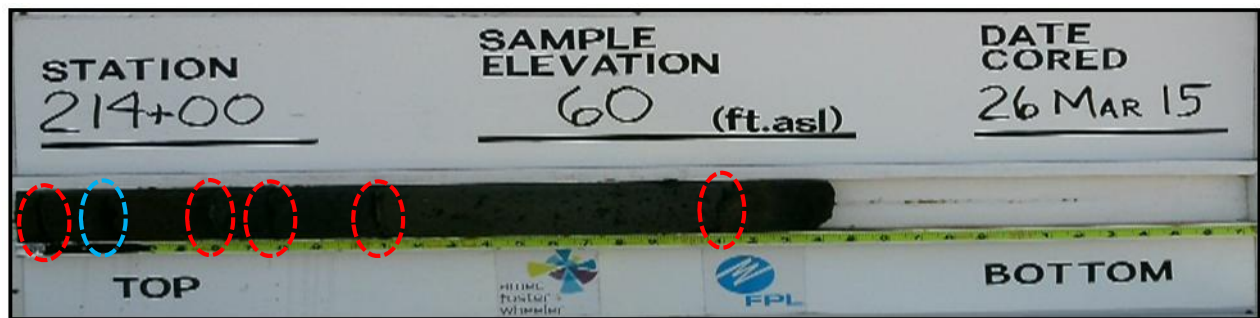
Location: STA 214+00

Core ID:	214+00 (middle)	Date Cored:	3/26/15
Core Elevation:	60' ASL	Date Photographed:	3/26/15
Recovered Length (ft):	2.35	SC Thickness (ft):	2.58
RQD (%):	56	Void Depth (ft):	N/A
Notes:	Variably soft to very soft material from 0 to 1.1 feet.

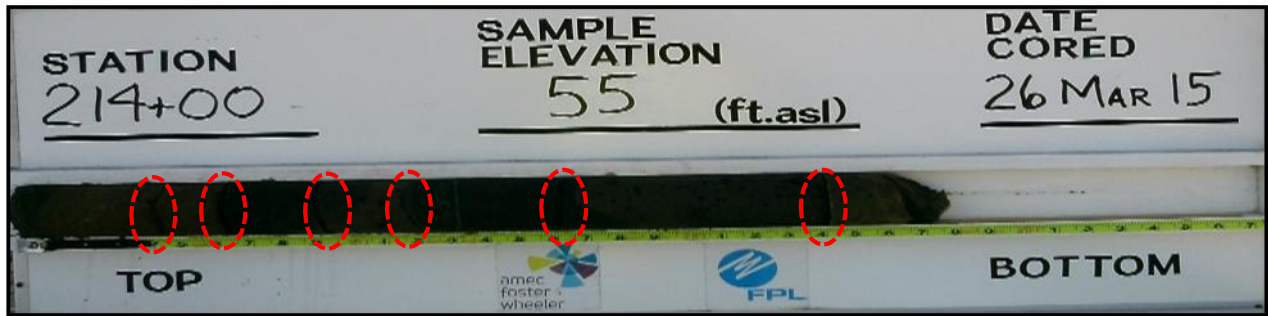
Location: STA 214+00

Core ID:	214+00 (bottom)	Date Cored:	3/26/15
Core Elevation:	55' ASL	Date Photographed:	3/26/15
Recovered Length (ft):	2.6	SC Thickness (ft):	2.75
RQD (%):	74	Void Depth (ft):	N/A
Notes:	Soft material from 0 to 1.6 feet.

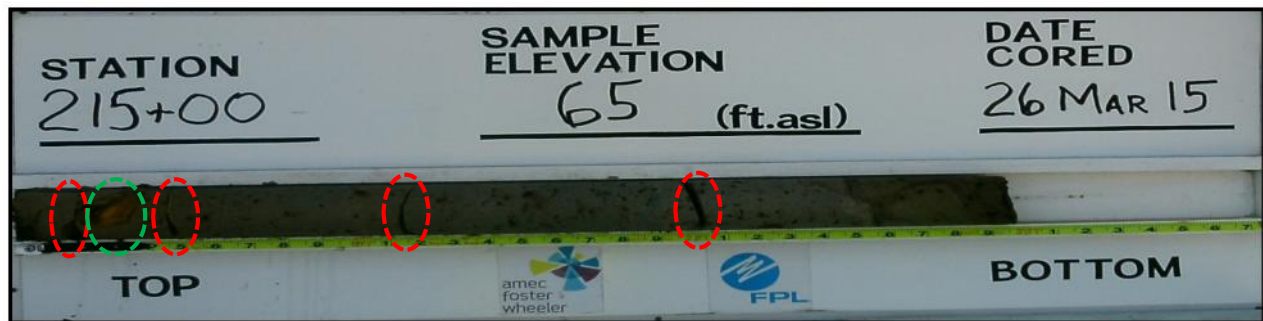
Location: STA 215+00

Core ID:	215+00 (top)	Date Cored:	3/26/15
Core Elevation:	65' ASL	Date Photographed:	3/26/15
Recovered Length (ft):	2.95	SC Thickness (ft):	3.08
RQD (%):	80	Void Depth (ft):	N/A
Notes:	Soft material from 0 to 0.2 feet. Wood piece at 0.3 feet.

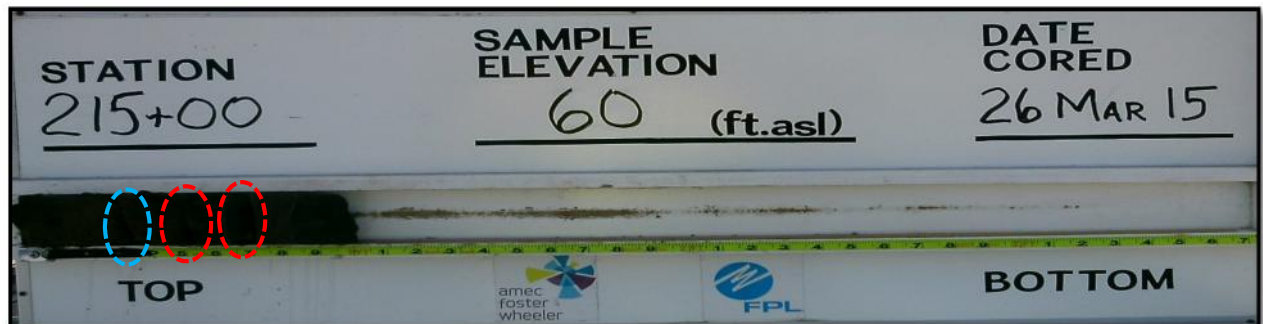
Location: STA 215+00

Core ID:	215+00 (middle)	Date Cored:	3/26/15
Core Elevation:	60' ASL	Date Photographed:	3/26/15
Recovered Length (ft):	1.0	SC Thickness (ft):	1.25
RQD (%):	65	Void Depth (ft):	N/A
Notes:	Very soft material from 0 to 0.53 feet. Soft material between 0.53 to 0.7 feet.
