**Assessment and Design Report
Soil-Cement Condition Assessment and Design Project
Manatee Plant Cooling Pond Dam
Parrish, Florida
Project Number 300906**

To: Mr. Lewis Rounds, P.E.
FPL Manatee Plant

Date: June 2015

From: Jeff Beriswill
Amec Foster Wheeler Environment & Infrastructure, Inc.

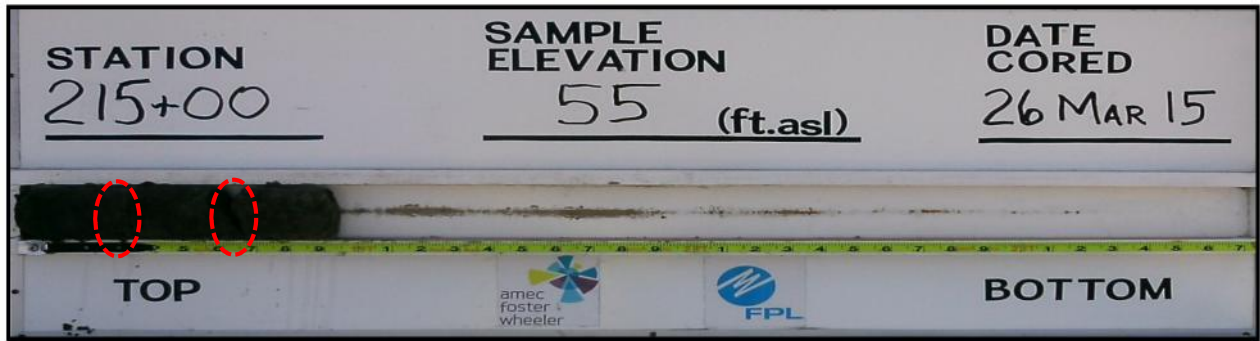
Location: STA 215+00

Core ID:	215+00 (bottom)	Date Cored:	3/26/15
Core Elevation:	55' ASL	Date Photographed:	3/26/15
Recovered Length (ft):	0.92	SC Thickness (ft):	1.83
RQD (%):	38	Void Depth (ft):	N/A
Notes:	Very soft material from 0 to 0.92 feet.

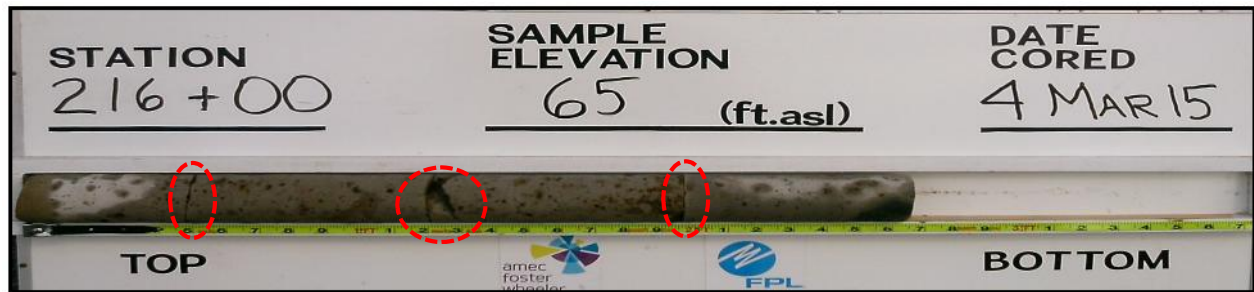
Location: STA 216+00

Core ID:	216+00 (top)	Date Cored:	3/4/15
Core Elevation:	65' ASL	Date Photographed:	3/4/15
Recovered Length (ft):	2.65	SC Thickness (ft):	2.83
RQD (%):	100	Void Depth (ft):	N/A
Notes:	Broken/missing piece at 1.25 feet.

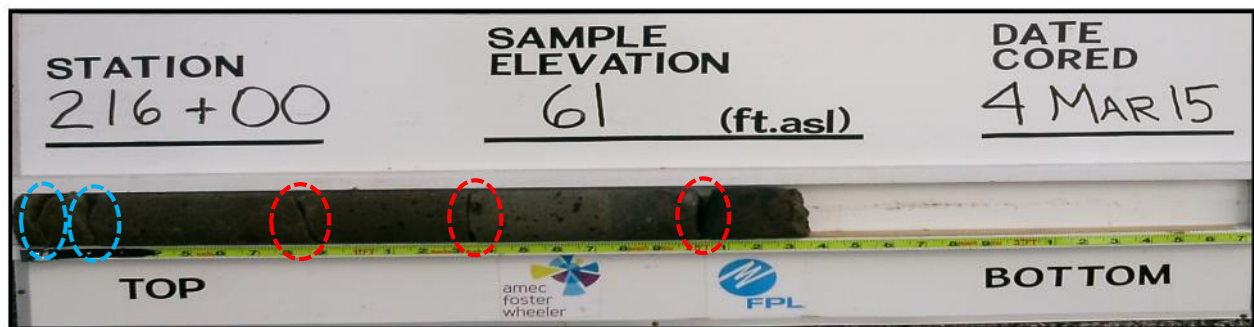
Location: STA 216+00

Core ID:	216+00 (middle)	Date Cored:	3/4/15
Core Elevation:	61' ASL	Date Photographed:	3/4/15
Recovered Length (ft):	2.33	SC Thickness (ft):	2.58
RQD (%):	98	Void Depth (ft):	N/A
Notes:	Soft material from 0 to 0.2 feet.

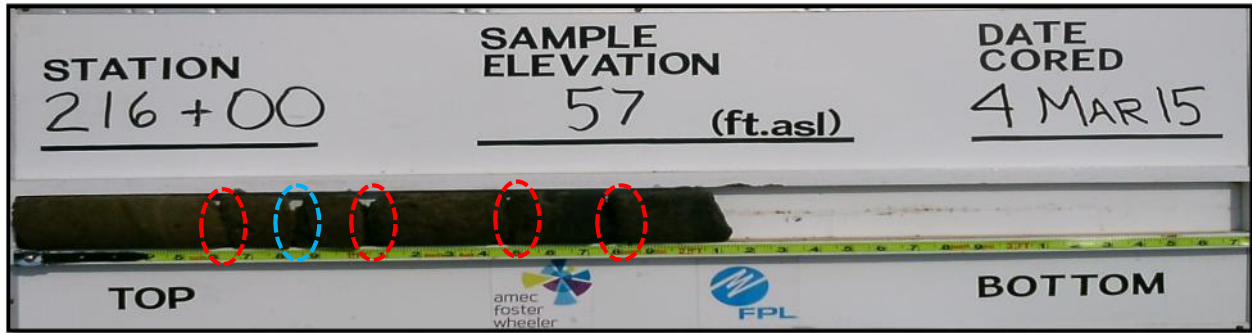
Location: STA 216+00

Core ID:	216+00 (bottom)	Date Cored:	3/4/15
Core Elevation:	57' ASL	Date Photographed:	3/4/15
Recovered Length (ft):	2.1	SC Thickness (ft):	2.33
RQD (%):	45	Void Depth (ft):	N/A
Notes:	Soft material from 0 to 0.6 feet. Very soft and friable material from 0.6 to 1.75 feet. Soft material from 1.75 to 2.1 feet.

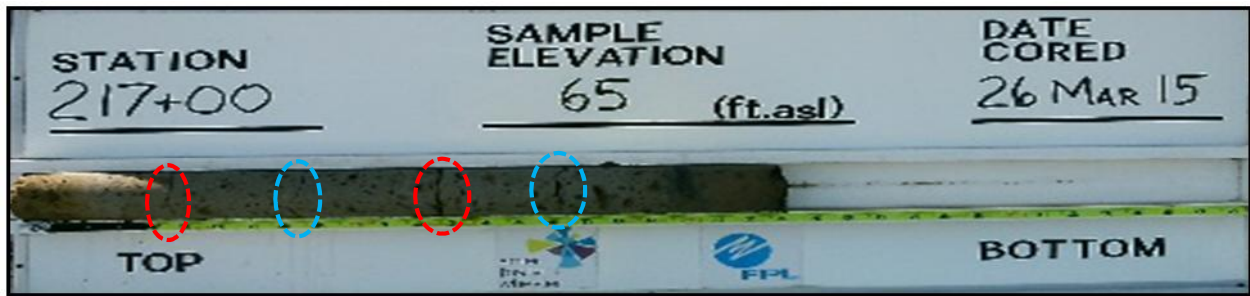
Location: STA 217+00

Core ID:	217+00 (top)	Date Cored:	3/26/15
Core Elevation:	65' ASL	Date Photographed:	3/26/15
Recovered Length (ft):	2.27	SC Thickness (ft):	2.67
RQD (%):	100	Void Depth (ft):	N/A
Notes:

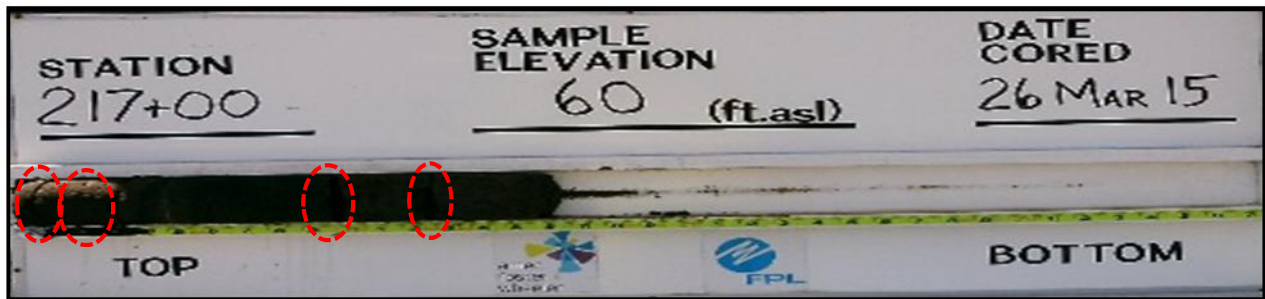
Location: STA 217+00

Core ID:	217+00 (middle)	Date Cored:	3/26/15
Core Elevation:	60' ASL	Date Photographed:	3/26/15
Recovered Length (ft):	1.55	SC Thickness (ft):	2.0
RQD (%):	39	Void Depth (ft):	N/A
Notes:	Entire core variably soft to very soft.

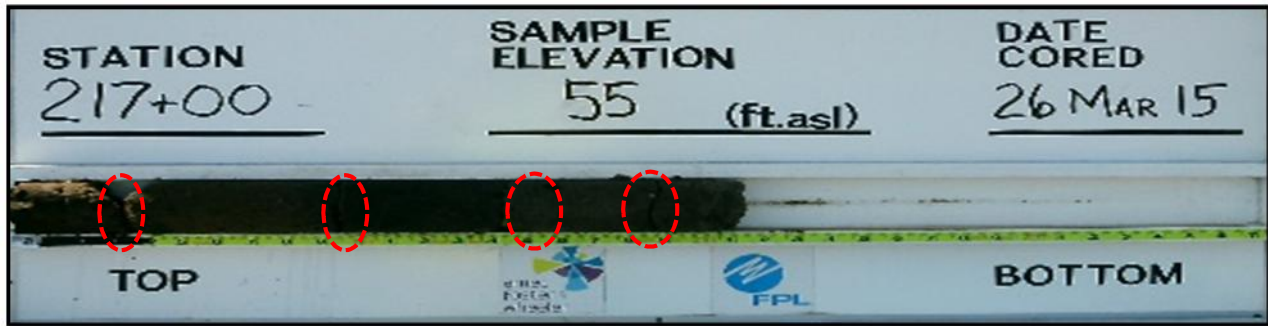
Location: STA 217+00

Core ID:	217+00 (bottom)	Date Cored:	3/26/15
Core Elevation:	55' ASL	Date Photographed:	3/26/15
Recovered Length (ft):	2.1	SC Thickness (ft):	2.33
RQD (%):	100	Void Depth (ft):	N/A
Notes:	Very soft from 0 to 0.35 feet. Soft from 0.35 to 0.95 feet.

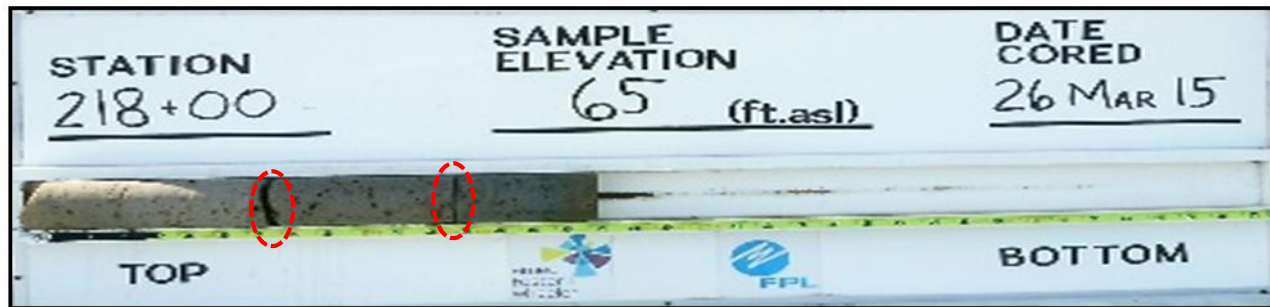
Location: STA 218+00

Core ID:	218+00 (top)	Date Cored:	3/26/15
Core Elevation:	65' ASL	Date Photographed:	3/26/15
Recovered Length (ft):	1.66	SC Thickness (ft):	3.25
RQD (%):	100	Void Depth (ft):	N/A
Notes:

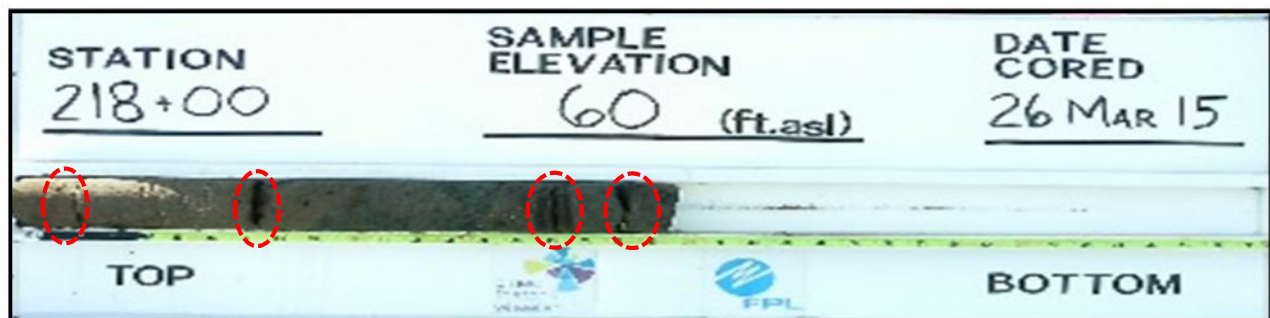
Location: STA 218+00

Core ID:	218+00 (middle)	Date Cored:	3/26/15
Core Elevation:	60' ASL	Date Photographed:	3/26/15
Recovered Length (ft):	1.91	SC Thickness (ft):	2.5
RQD (%):	73	Void Depth (ft):	N/A
Notes:	Very soft material from 0 to 0.85 feet. Soft material from 0.85 to 1.6 feet.

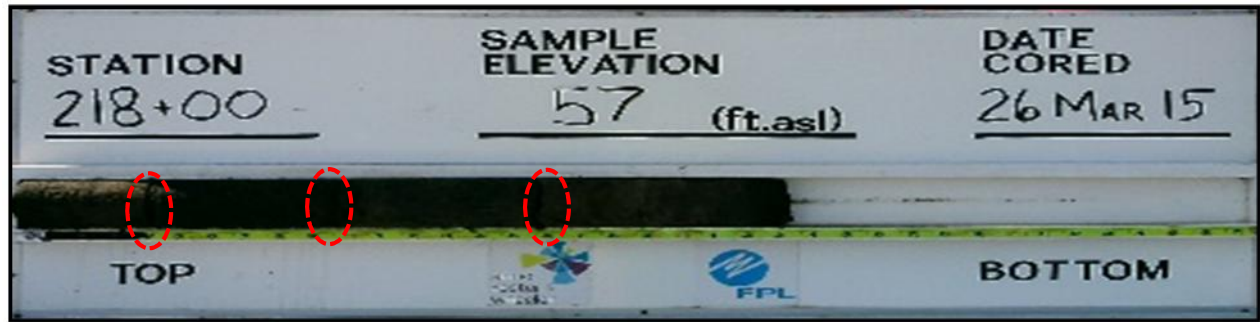
Location: STA 218+00

Core ID:	218+00 (bottom)	Date Cored:	3/26/15
Core Elevation:	57' ASL	Date Photographed:	3/26/15
Recovered Length (ft):	2.3	SC Thickness (ft):	2.58
RQD (%):	67	Void Depth (ft):	N/A
Notes:	Very soft from 0 to 0.4 feet. Lateral fracture from 1.55 to 2.3 feet.

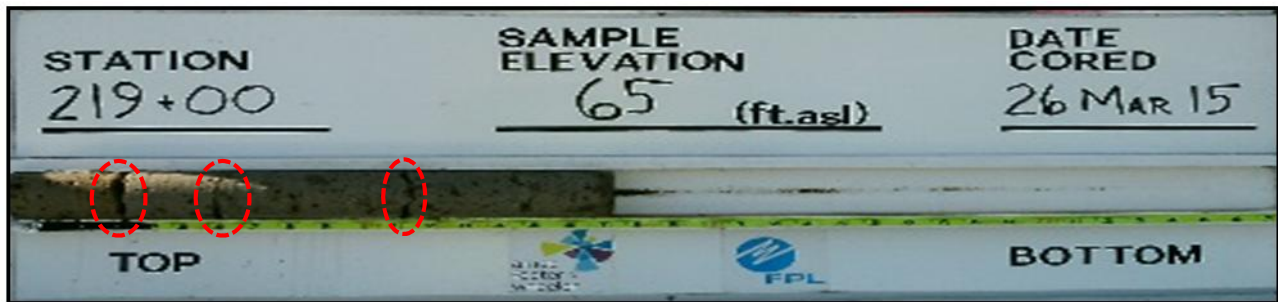
Location: STA 219+00

Core ID:	219+00 (top)	Date Cored:	3/26/15
Core Elevation:	65' ASL	Date Photographed:	3/26/15
Recovered Length (ft):	1.7	SC Thickness (ft):	2.33
RQD (%):	82	Void Depth (ft):	N/A
Notes:	Very soft material from 0 to 0.3 feet.

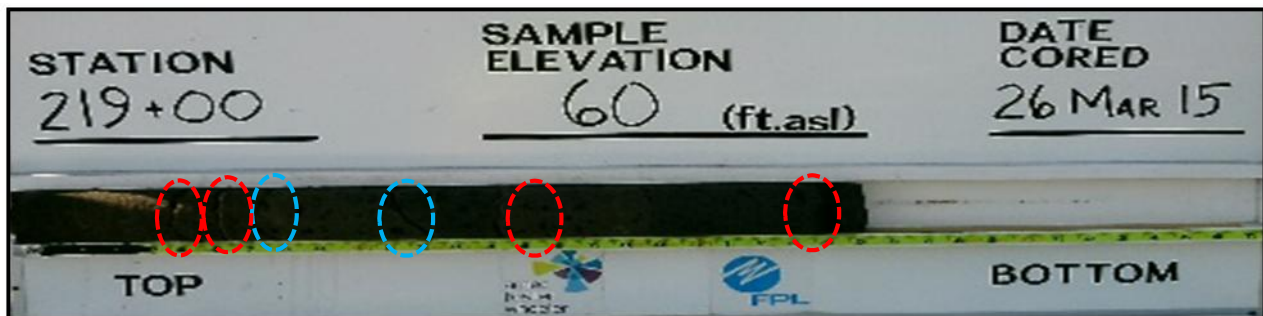
Location: STA 219+00

Core ID:	219+00 (middle)	Date Cored:	3/26/15
Core Elevation:	60' ASL	Date Photographed:	3/26/15
Recovered Length (ft):	2.45	SC Thickness (ft):	2.83
RQD (%):	70	Void Depth (ft):	N/A
Notes:	Very soft material from 0 to 0.75 feet. Soft material 0.75 feet to 1.42 feet.

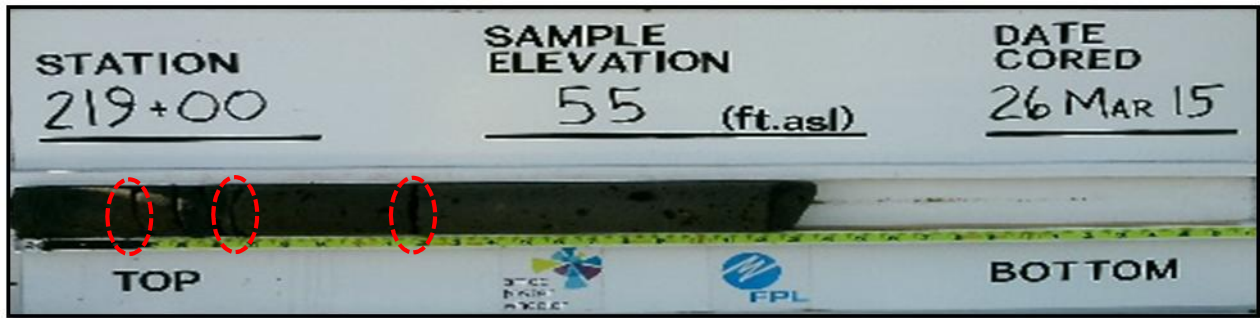
Location: STA 219+00

Core ID:	219+00 (bottom)	Date Cored:	3/26/15
Core Elevation:	55' ASL	Date Photographed:	3/26/15
Recovered Length (ft):	2.3	SC Thickness (ft):	2.58
RQD (%):	91	Void Depth (ft):	N/A
Notes:	Very soft material from 0 to 0.67 feet. Broken core pieces between 0.38 to 0.67 feet.

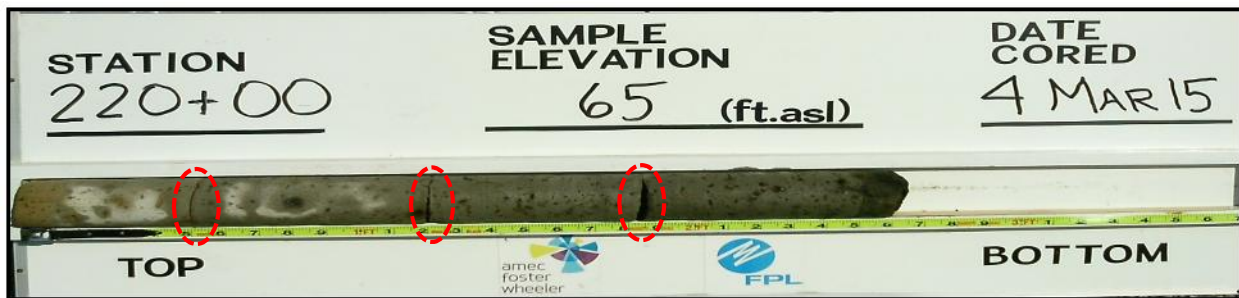
Location: STA 220+00

Core ID:	220+00 (top)	Date Cored:	3/4/15
Core Elevation:	65' ASL	Date Photographed:	3/4/15
Recovered Length (ft):	2.6	SC Thickness (ft):	2.6
RQD (%):	100	Void Depth (ft):	N/A
Notes:

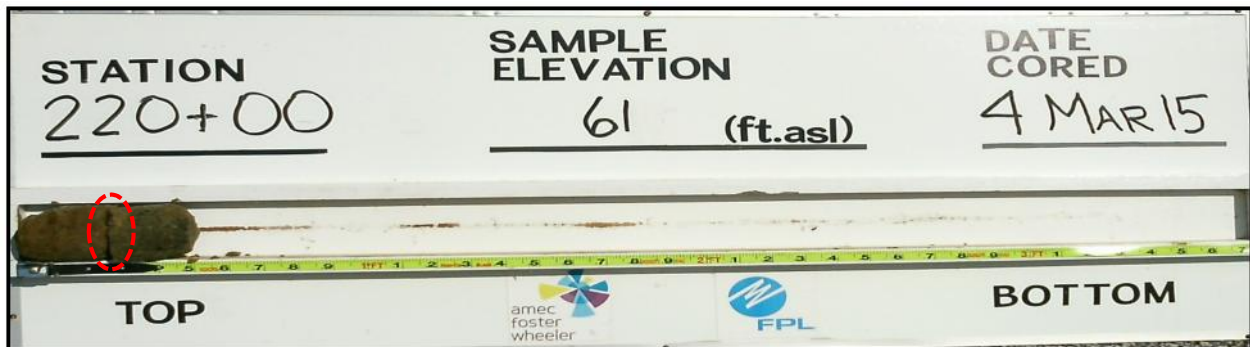
Location: STA 220+00

Core ID:	220+00 (middle)	Date Cored:	3/4/15
Core Elevation:	61' ASL	Date Photographed:	3/4/15
Recovered Length (ft):	0.5	SC Thickness (ft):	3.0
RQD (%):	0	Void Depth (ft):	N/A
Notes:	Recovered sample very soft and friable.

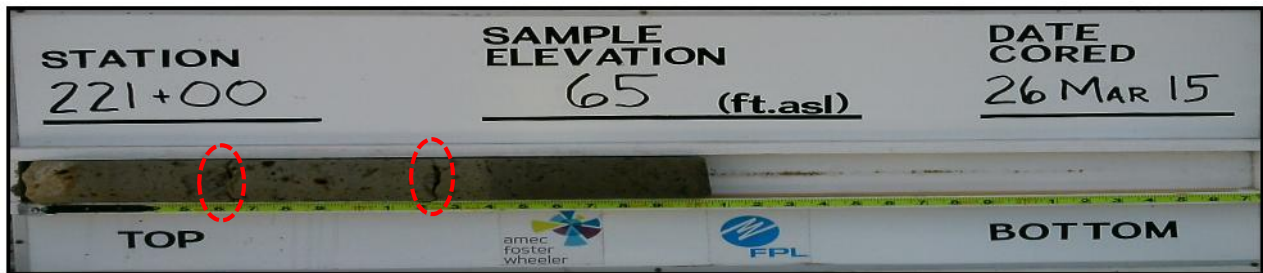
Location: STA 221+00

Core ID:	221+00 (top)	Date Cored:	3/26/15
Core Elevation:	65' ASL	Date Photographed:	3/26/15
Recovered Length (ft):	2.05	SC Thickness (ft):	2.5
RQD (%):	100	Void Depth (ft):	N/A
Notes:

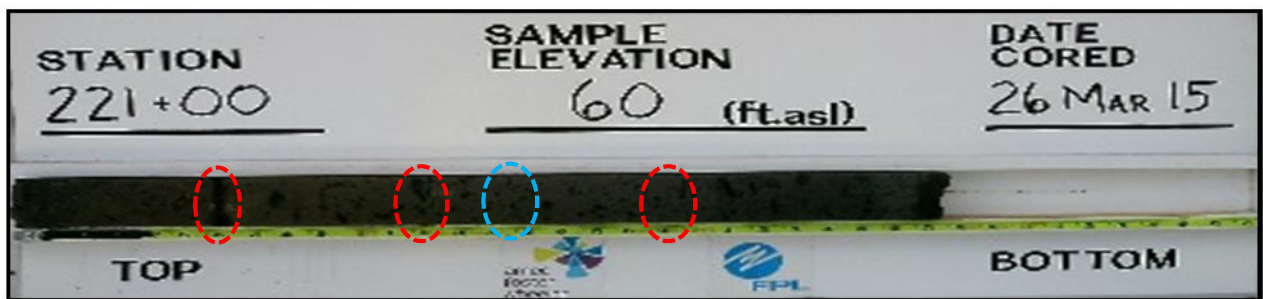
Location: STA 221+00

Core ID:	221+00 (middle)	Date Cored:	3/26/15
Core Elevation:	60' ASL	Date Photographed:	3/26/15
Recovered Length (ft):	2.7	SC Thickness (ft):	3.0
RQD (%):	91	Void Depth (ft):	N/A
Notes:	Soft material from 0 to 0.6 feet.

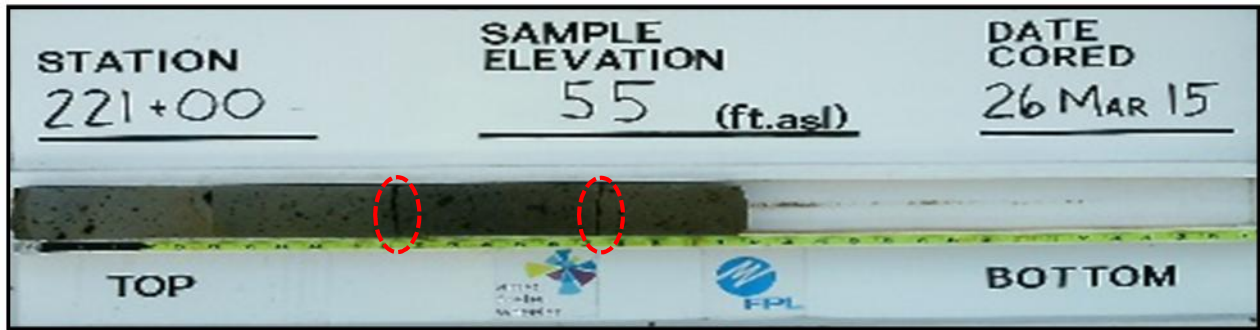
Location: STA 221+00

Core ID:	221+00 (bottom)	Date Cored:	3/26/15
Core Elevation:	55' ASL	Date Photographed:	3/26/15
Recovered Length (ft):	2.13	SC Thickness (ft):	2.33
RQD (%):	100	Void Depth (ft):	N/A
Notes:

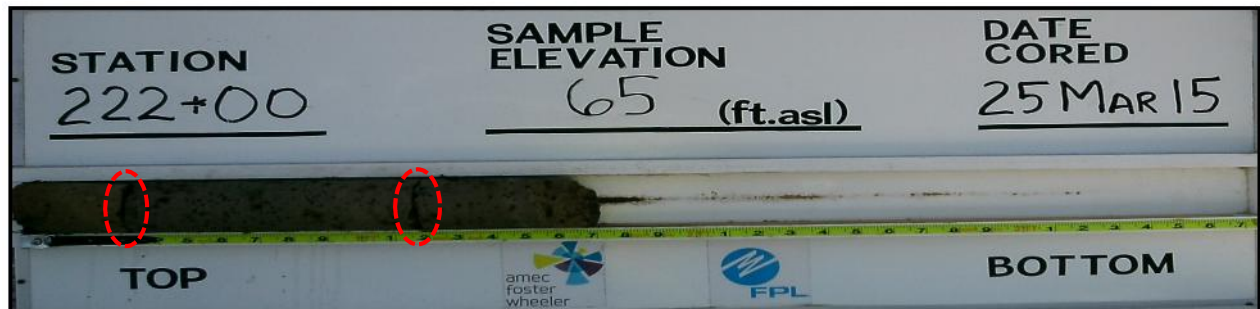
Location: STA 222+00

Core ID:	222+00 (top)	Date Cored:	3/25/15
Core Elevation:	65' ASL	Date Photographed:	3/25/15
Recovered Length (ft):	1.65	SC Thickness (ft):	2.0
RQD (%):	100	Void Depth (ft):	N/A
Notes:	Soft material from 0 to 0.35 feet and from 1.55 to 1.65 feet.

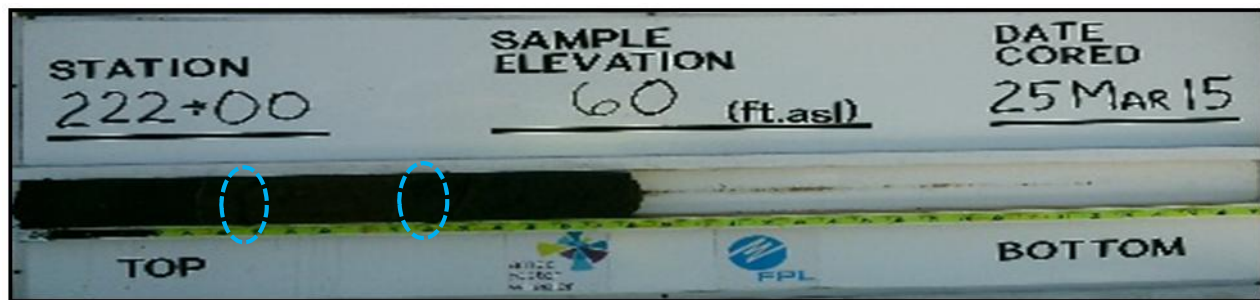
Location: STA 222+00

Core ID:	222+00 (middle)	Date Cored:	3/25/15
Core Elevation:	60' ASL	Date Photographed:	3/25/15
Recovered Length (ft):	1.7	SC Thickness (ft):	2.0
RQD (%):	100	Void Depth (ft):	N/A
Notes:	Very soft material from 0 to 1.25 feet and soft material from 1.25 to 1.79 feet.

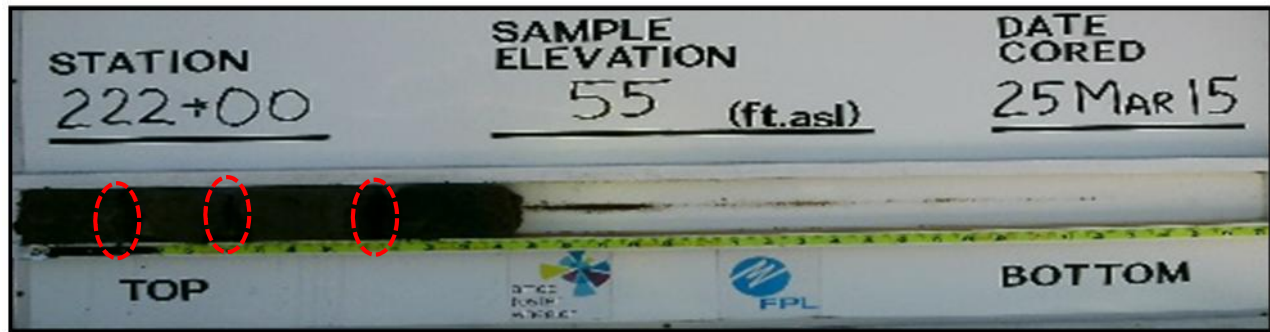
Location: STA 222+00

Core ID:	222+00 (bottom)	Date Cored:	3/25/15
Core Elevation:	55' ASL	Date Photographed:	3/25/15
Recovered Length (ft):	1.42	SC Thickness (ft):	2.0
RQD (%):	79	Void Depth (ft):	N/A
Notes:	Very soft material from 0 to 1.0 feet. Soft material from 1.0 to 1.42 feet.

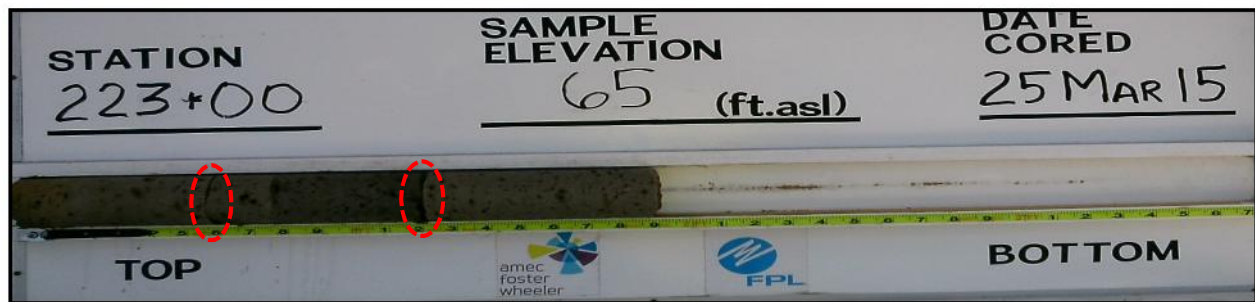
Location: STA 223+00

Core ID:	223+00 (top)	Date Cored:	3/25/15
Core Elevation:	65' ASL	Date Photographed:	3/25/15
Recovered Length (ft):	1.87	SC Thickness (ft):	2.33
RQD (%):	100	Void Depth (ft):	N/A
Notes:

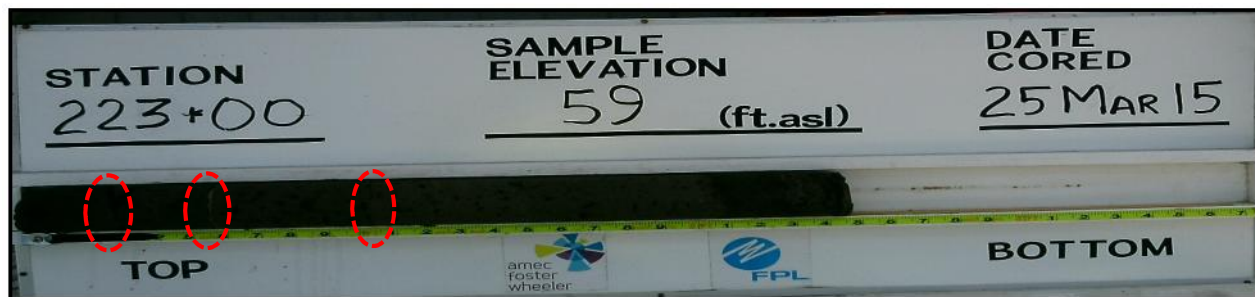
Location: STA 223+00

Core ID:	223+00 (middle)	Date Cored:	3/25/15
Core Elevation:	59' ASL	Date Photographed:	3/25/15
Recovered Length (ft):	2.05	SC Thickness (ft):	2.67
RQD (%):	100	Void Depth (ft):	N/A
Notes:	Soft material from 0.3 to 0.58 feet. Insitu soil from 2.05 to 2.45 feet.

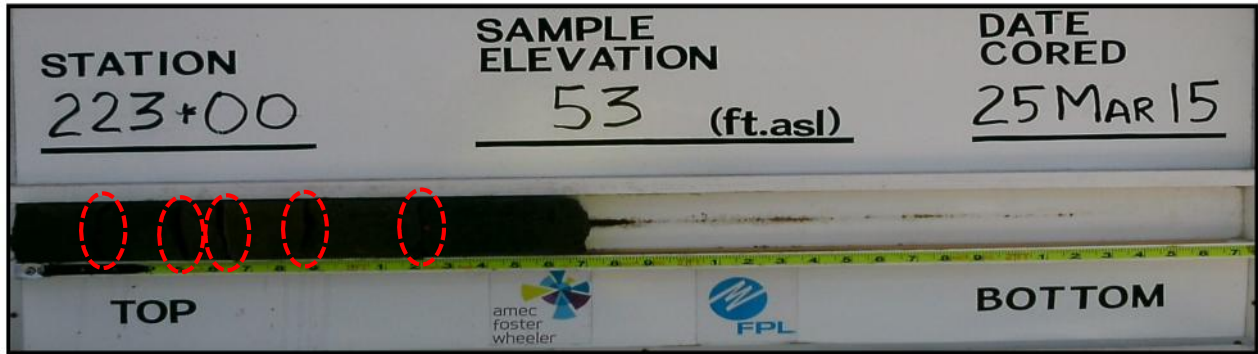
Location: STA 223+00

Core ID:	223+00 (bottom)	Date Cored:	3/25/15
Core Elevation:	53' ASL	Date Photographed:	3/25/15
Recovered Length (ft):	1.7	SC Thickness (ft):	2.0
RQD (%):	50	Void Depth (ft):	N/A
Notes:	Core sample ranged variably from soft to very soft.

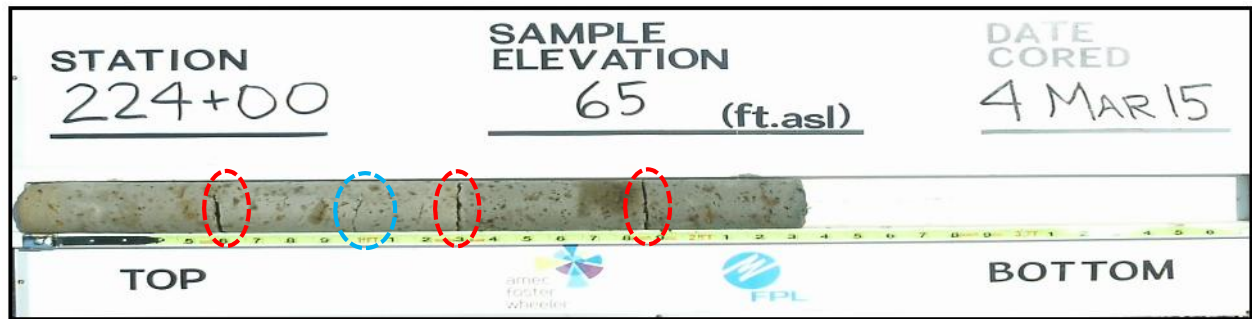
Location: STA 224+00

Core ID:	224+00 (top)	Date Cored:	3/4/15
Core Elevation:	65' ASL	Date Photographed:	3/4/15
Recovered Length (ft):	2.3	SC Thickness (ft):	2.5
RQD (%):	87	Void Depth (ft):	N/A
Notes:

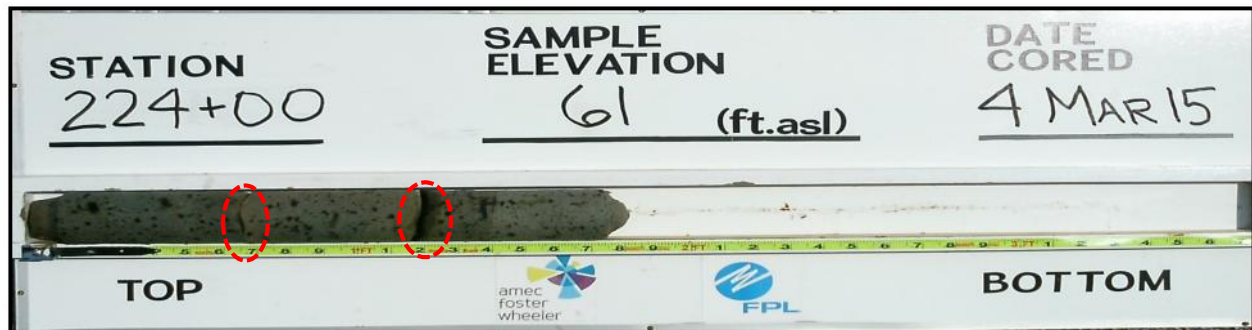
Location: STA 224+00

Core ID:	224+00 (middle)	Date Cored:	3/4/15
Core Elevation:	61' ASL	Date Photographed:	3/4/15
Recovered Length (ft):	1.75	SC Thickness (ft):	2.83
RQD (%):	100	Void Depth (ft):	N/A
Notes:	Soft material between 0.67 and 1.2 feet.

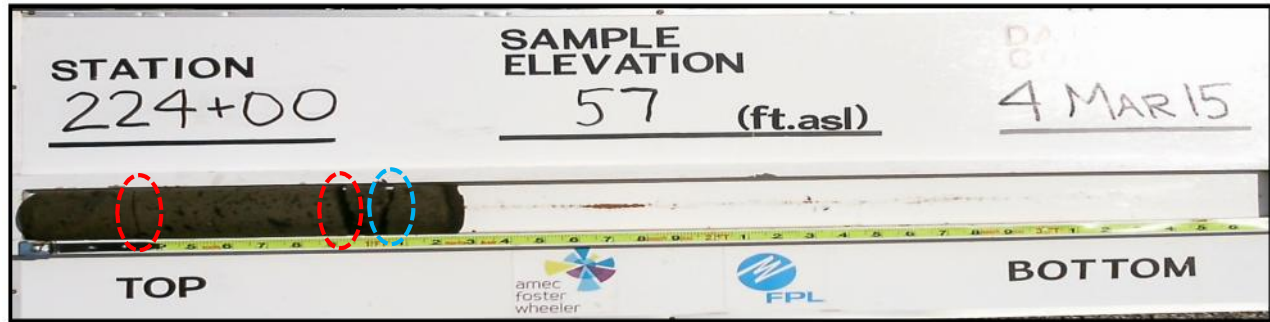
Location: STA 224+00

Core ID:	224+00 (bottom)	Date Cored:	3/4/15
Core Elevation:	57' ASL	Date Photographed:	3/4/15
Recovered Length (ft):	1.25	SC Thickness (ft):	2.5
RQD (%):	44	Void Depth (ft):	N/A
Notes:	Soft material from 0 to 0.35 feet.

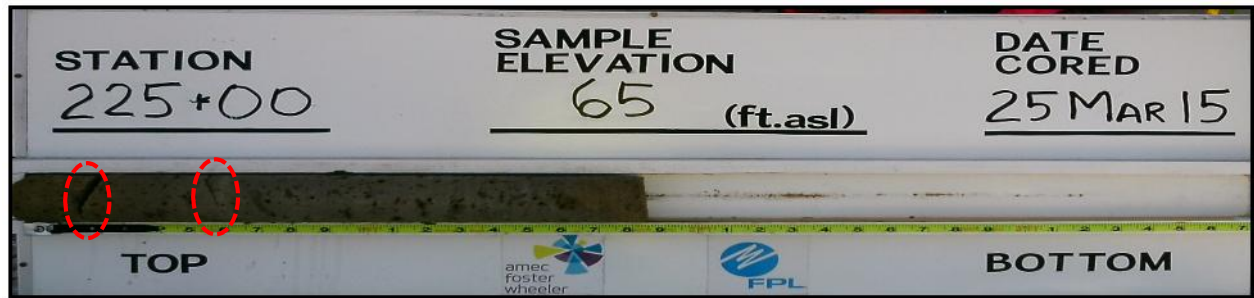
Location: STA 225+00

Core ID:	225+00 (top)	Date Cored:	3/25/15
Core Elevation:	65' ASL	Date Photographed:	3/25/15
Recovered Length (ft):	1.85	SC Thickness (ft):	2.08
RQD (%):	89	Void Depth (ft):	N/A
Notes:

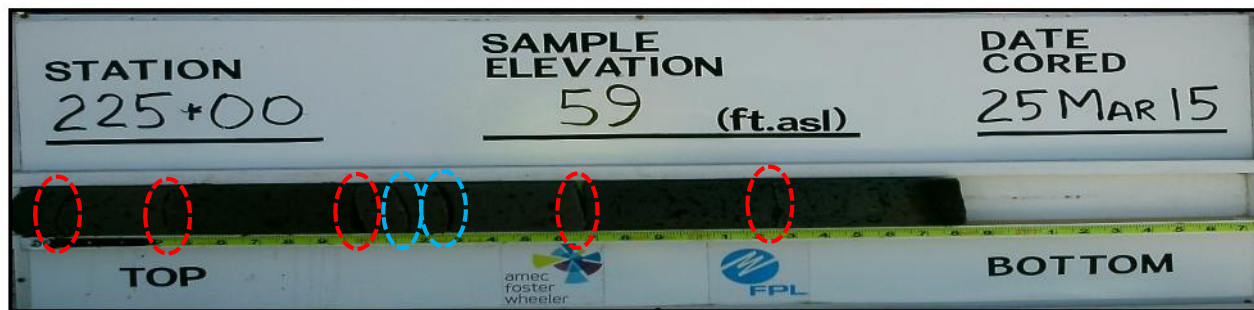
Location: STA 225+00

Core ID:	225+00 (middle)	Date Cored:	3/25/15
Core Elevation:	59' ASL	Date Photographed:	3/25/15
Recovered Length (ft):	2.8	SC Thickness (ft):	3.0
RQD (%):	75	Void Depth (ft):	N/A
Notes:

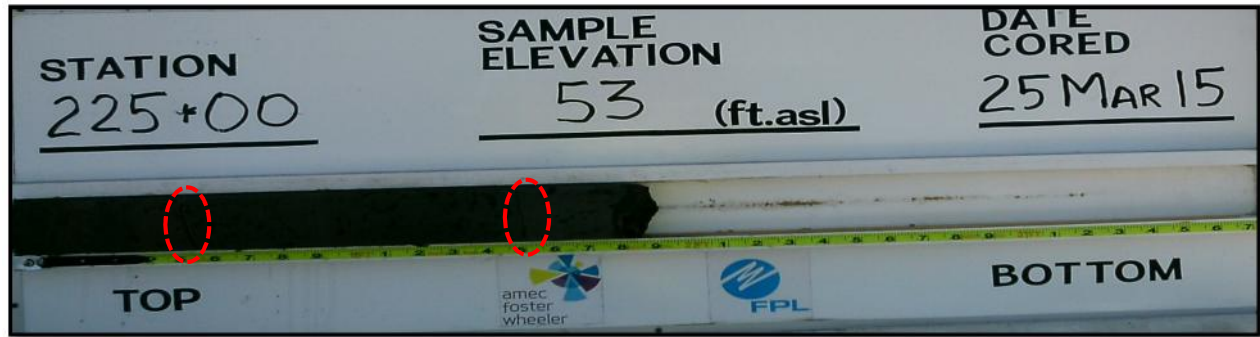
Location: STA 225+00

Core ID:	225+00 (bottom)	Date Cored:	3/25/15
Core Elevation:	53' ASL	Date Photographed:	3/25/15
Recovered Length (ft):	1.8	SC Thickness (ft):	2.67
RQD (%):	100	Void Depth (ft):	N/A
Notes:	Soft material from 0 to 0.4 feet. Insitu soil from 1.8 to 1.85 feet.

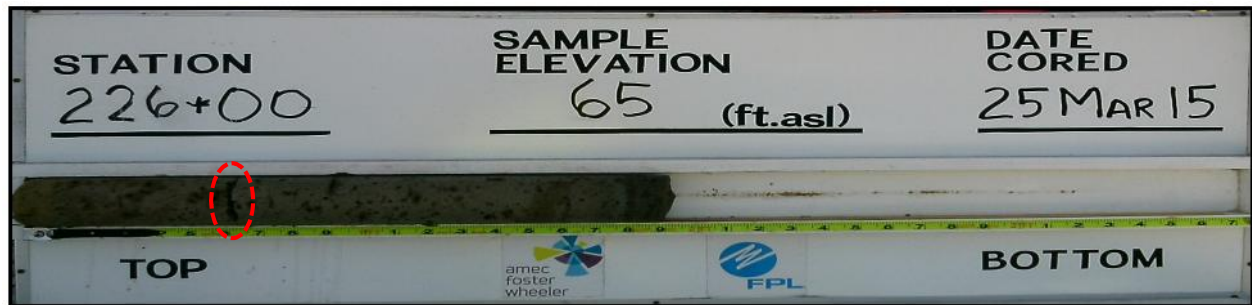
Location: STA 226+00

Core ID:	226+00 (top)	Date Cored:	3/25/15
Core Elevation:	65' ASL	Date Photographed:	3/25/15
Recovered Length (ft):	1.9	SC Thickness (ft):	2.42
RQD (%):	100	Void Depth (ft):	N/A
Notes:

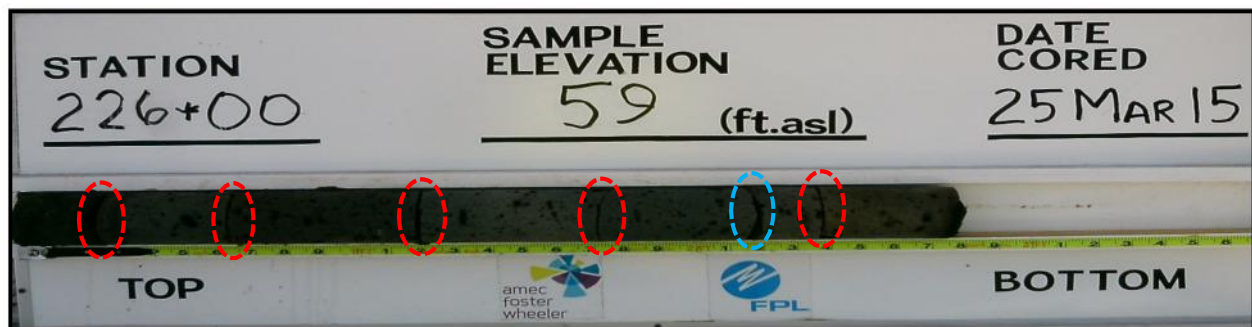
Location: STA 226+00

Core ID:	226+00 (middle)	Date Cored:	3/25/15
Core Elevation:	59' ASL	Date Photographed:	3/25/15
Recovered Length (ft):	2.75	SC Thickness (ft):	2.92
RQD (%):	84	Void Depth (ft):	N/A
Notes:	Soft material from 0 to 0.25 feet.

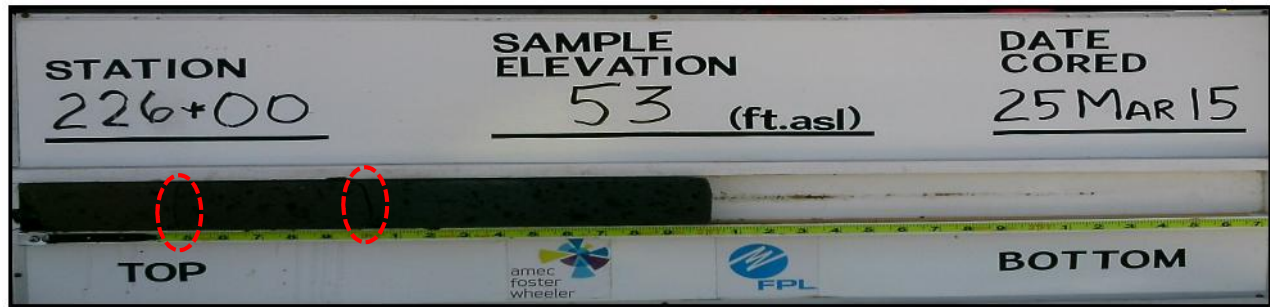
Location: STA 226+00

Core ID:	226+00 (bottom)	Date Cored:	3/25/15
Core Elevation:	53' ASL	Date Photographed:	3/25/15
Recovered Length (ft):	2.0	SC Thickness (ft):	2.8
RQD (%):	100	Void Depth (ft):	N/A
Notes:

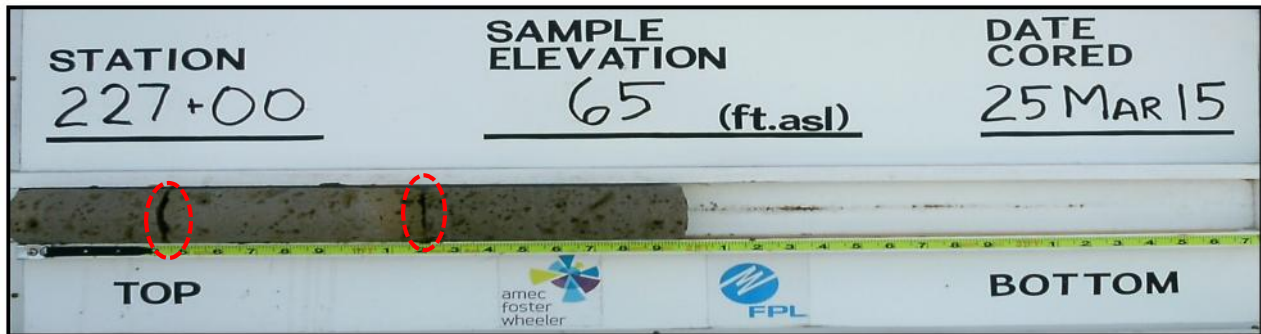
Location: STA 227+00

Core ID:	227+00 (top)	Date Cored:	3/25/15
Core Elevation:	65' ASL	Date Photographed:	3/25/15
Recovered Length (ft):	1.95	SC Thickness (ft):	2.25
RQD (%):	100	Void Depth (ft):	N/A
Notes:

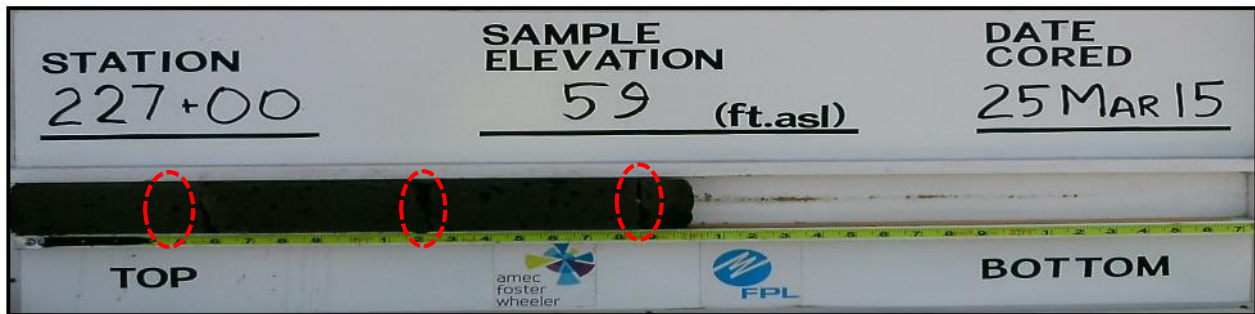
Location: STA 227+00

Core ID:	227+00 (middle)	Date Cored:	3/25/15
Core Elevation:	59' ASL	Date Photographed:	3/25/15
Recovered Length (ft):	2.0	SC Thickness (ft):	2.5
RQD (%):	100	Void Depth (ft):	N/A
Notes:

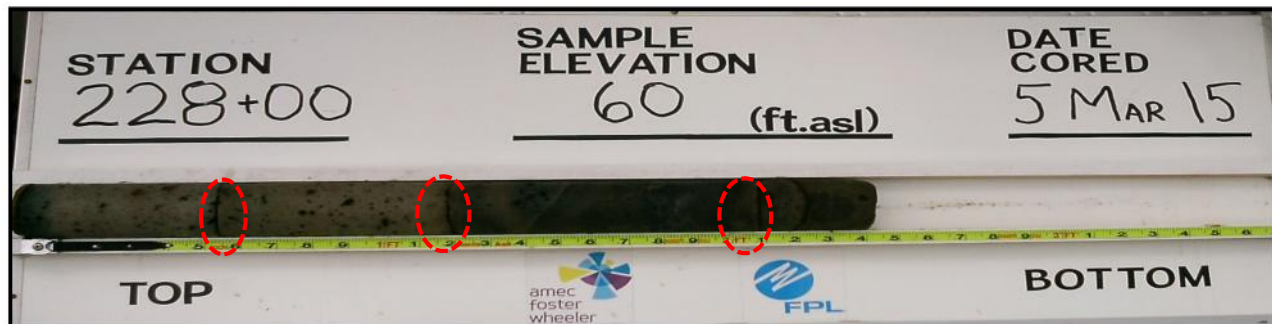
Location: STA 228+00

Core ID:	228+00 (middle)	Date Cored:	3/5/15
Core Elevation:	60' ASL	Date Photographed:	3/5/15
Recovered Length (ft):	2.4	SC Thickness (ft):	3.5
RQD (%):	100	Void Depth (ft):	N/A
Notes:

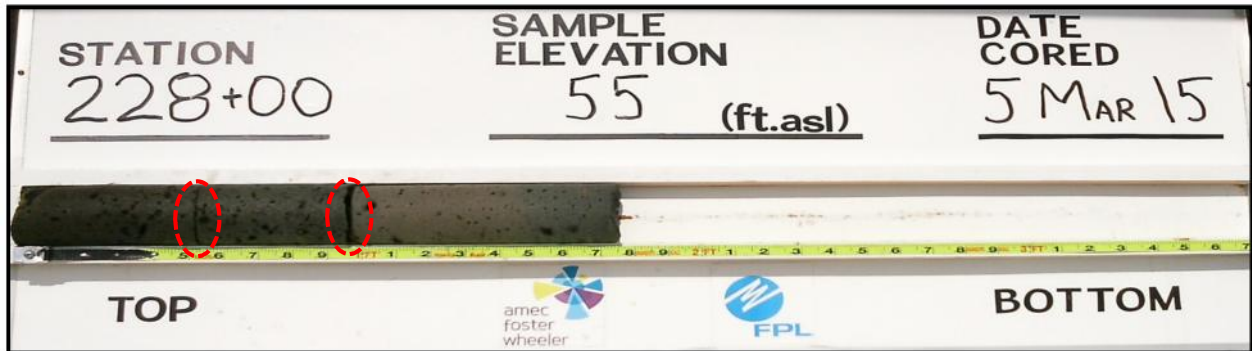
Location: STA 228+00

Core ID:	228+00 (bottom)	Date Cored:	3/5/15
Core Elevation:	55' ASL	Date Photographed:	3/5/15
Recovered Length (ft):	1.75	SC Thickness (ft):	2.83
RQD (%):	100	Void Depth (ft):	N/A
Notes:

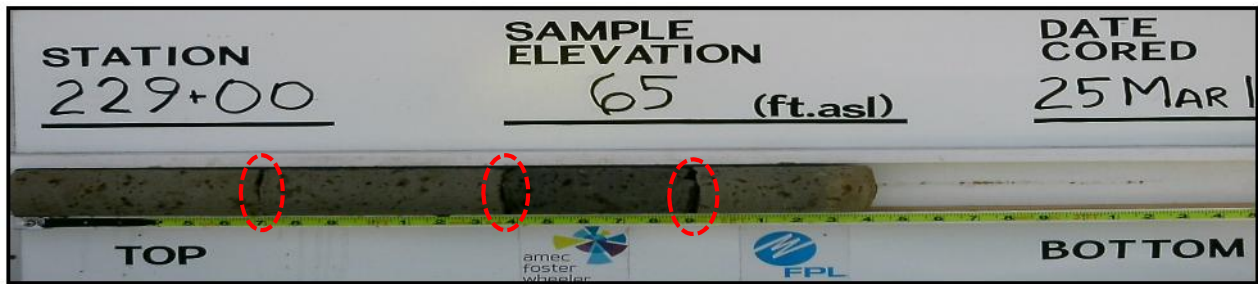
Location: STA 229+00

Core ID:	229+00 (top)	Date Cored:	3/25/15
Core Elevation:	65' ASL	Date Photographed:	3/25/15
Recovered Length (ft):	2.37	SC Thickness (ft):	2.5
RQD (%):	100	Void Depth (ft):	N/A
Notes:

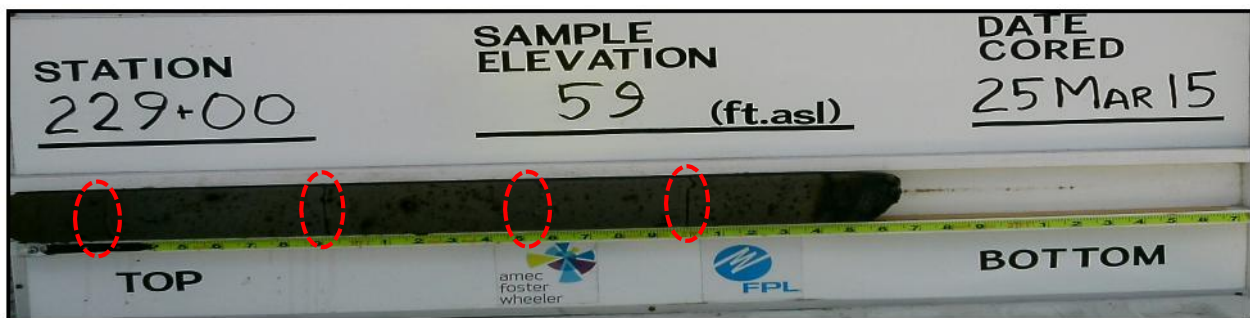
Location: STA 229+00

Core ID:	229+00 (middle)	Date Cored:	3/25/15
Core Elevation:	59' ASL	Date Photographed:	3/25/15
Recovered Length (ft):	2.4	SC Thickness (ft):	2.83
RQD (%):	87	Void Depth (ft):	N/A
Notes:	Insitu soil from 2.4 to 2.55 feet.

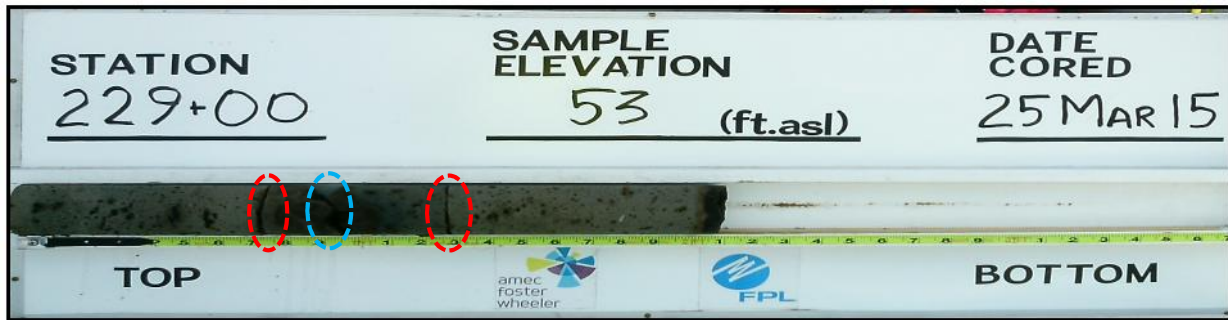
Location: STA 229+00

Core ID:	229+00 (bottom)	Date Cored:	3/25/15
Core Elevation:	53' ASL	Date Photographed:	3/25/15
Recovered Length (ft):	2.05	SC Thickness (ft):	2.5
RQD (%):	73	Void Depth (ft):	N/A
Notes:

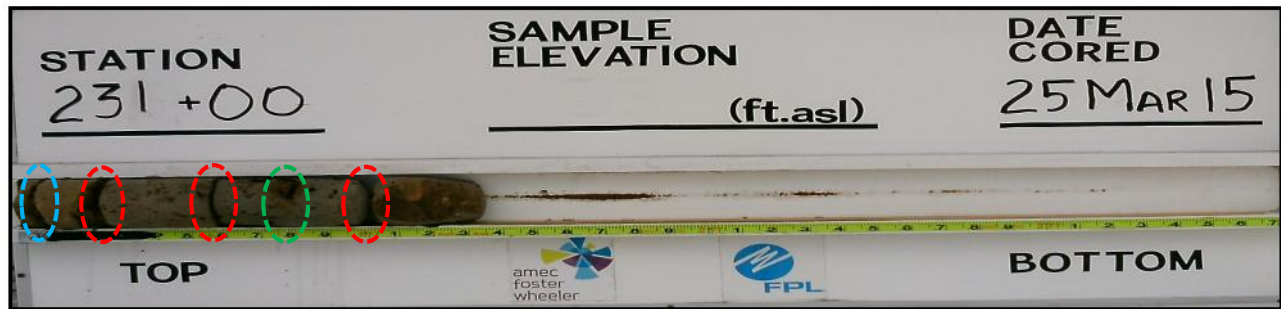
Location: STA 231+00

Core ID:	231+00 (top)	Date Cored:	3/25/15
Core Elevation:	65' ASL	Date Photographed:	3/25/15
Recovered Length (ft):	1.35	SC Thickness (ft):	2.33
RQD (%):	73	Void Depth (ft):	N/A
Notes:	Soft material from 0 to 0.25 feet. Wood piece at 0.8 feet. Core fractured laterally from 1.0 to 1.35 feet.

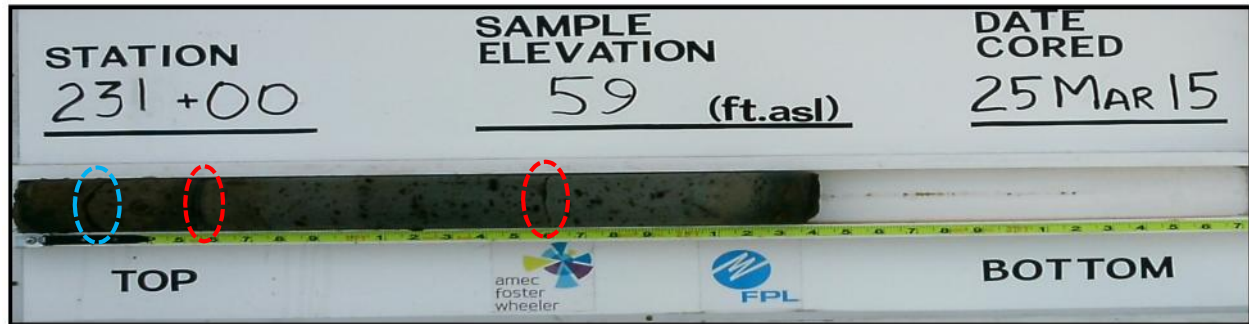
Location: STA 231+00

Core ID:	231+00 (middle)	Date Cored:	3/25/15
Core Elevation:	59' ASL	Date Photographed:	3/25/15
Recovered Length (ft):	2.35	SC Thickness (ft):	2.67
RQD (%):	87	Void Depth (ft):	N/A
Notes:	Soft material from 0 to 0.55 feet. Insitu soil from 2.2 to 2.35 feet.

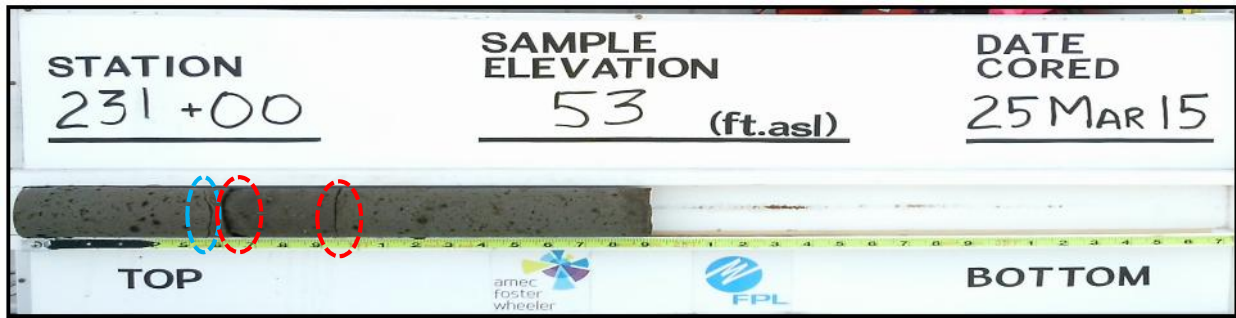
Location: STA 231+00

Core ID:	231+00 (bottom)	Date Cored:	3/25/15
Core Elevation:	53' ASL	Date Photographed:	3/25/15
Recovered Length (ft):	1.9	SC Thickness (ft):	2.0
RQD (%):	100	Void Depth (ft):	N/A
Notes:	Soft material from 0 to 0.7 feet.

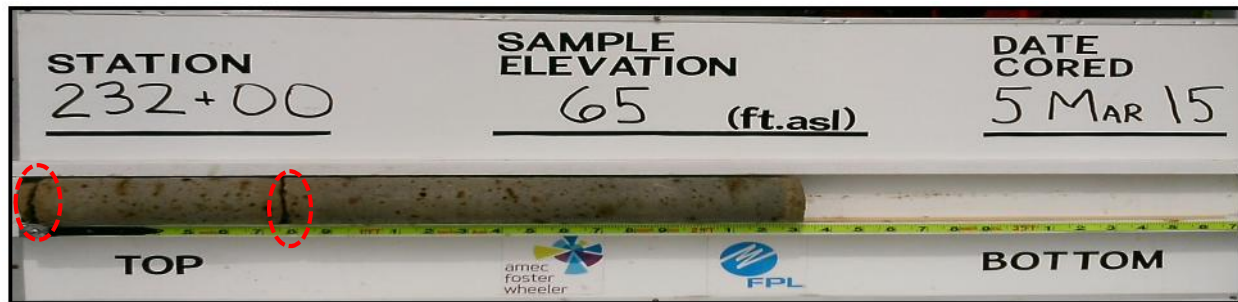
Location: STA 232+00

Core ID:	232+00 (top)	Date Cored:	3/5/15
Core Elevation:	65' ASL	Date Photographed:	3/5/15
Recovered Length (ft):	2.3	SC Thickness (ft):	2.3
RQD (%):	100	Void Depth (ft):	N/A
Notes:	Very soft material from 0 to 0.1 feet.

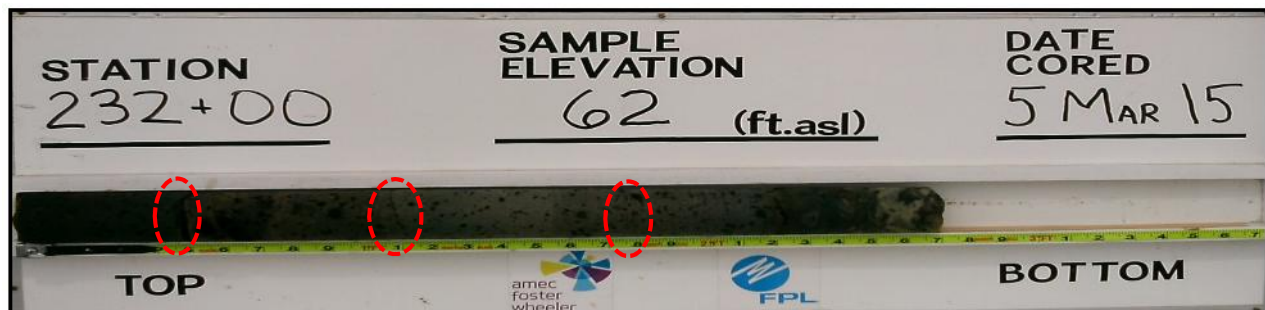
Location: STA 232+00

Core ID:	232+00 (middle)	Date Cored:	3/5/15
Core Elevation:	62' ASL	Date Photographed:	3/5/15
Recovered Length (ft):	2.17	SC Thickness (ft):	3.0
RQD (%):	100	Void Depth (ft):	N/A
Notes:	Two voids noted at 0.6 feet. In-situ soil from 2.17 to 2.7 feet.

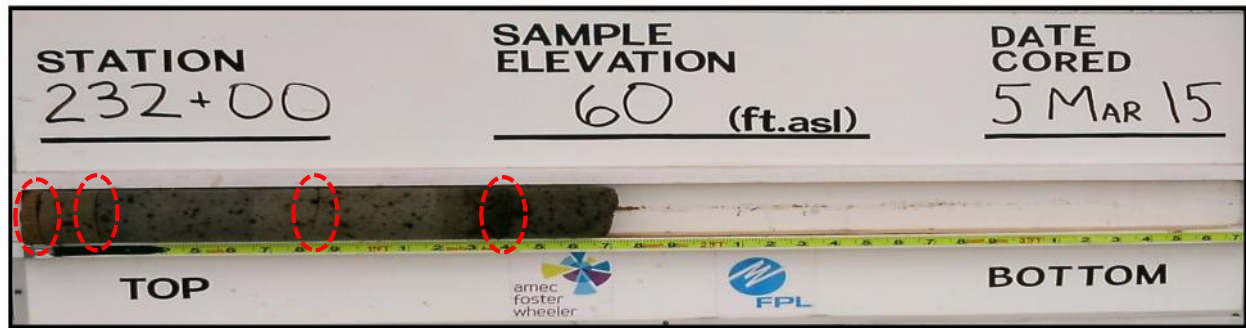
Location: STA 232+00

Core ID:	232+00 (bottom)	Date Cored:	3/5/15
Core Elevation:	60' ASL	Date Photographed:	3/5/15
Recovered Length (ft):	1.7	SC Thickness (ft):	3.0
RQD (%):	82	Void Depth (ft):	N/A
Notes:	Soft material from 0 to 0.1 feet.

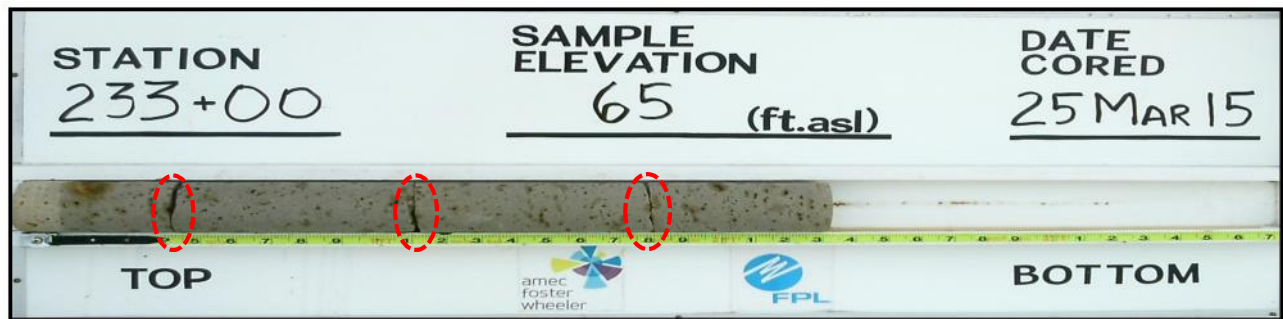
Location: STA 233+00

Core ID:	233+00 (top)	Date Cored:	3/25/15
Core Elevation:	65' ASL	Date Photographed:	3/25/15
Recovered Length (ft):	2.3	SC Thickness (ft):	2.83
RQD (%):	100	Void Depth (ft):	N/A
Notes:

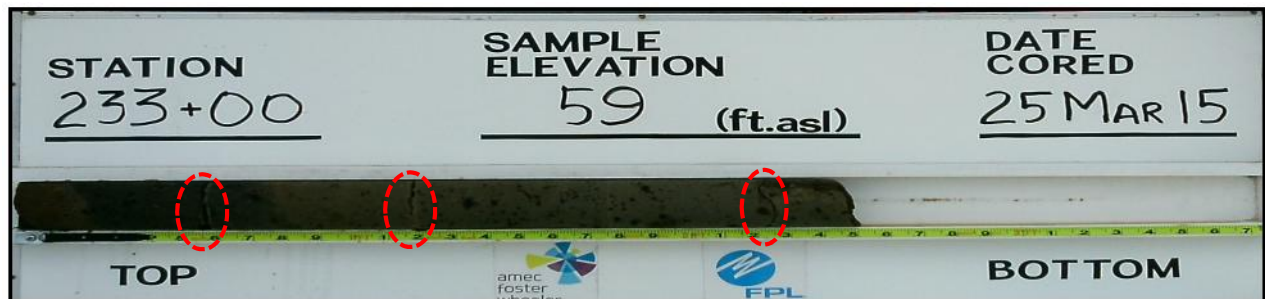
Location: STA 233+00

Core ID:	233+00 (middle)	Date Cored:	3/25/15
Core Elevation:	59' ASL	Date Photographed:	3/25/15
Recovered Length (ft):	2.45	SC Thickness (ft):	3.0
RQD (%):	92	Void Depth (ft):	N/A
Notes:	Soft material from 0 to 0.4 feet.

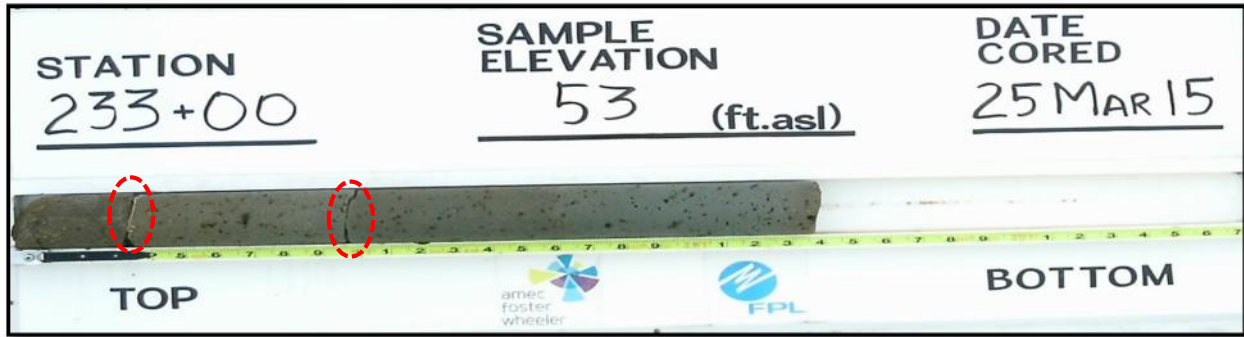
Location: STA 233+00

Core ID:	233+00 (bottom)	Date Cored:	3/25/15
Core Elevation:	53' ASL	Date Photographed:	3/25/15
Recovered Length (ft):	2.35	SC Thickness (ft):	3.0
RQD (%):	100	Void Depth (ft):	N/A
Notes:	Soft material from 0 to 0.35 feet.
