**Assessment and Design Report
Soil-Cement Condition Assessment and Design Project
Manatee Plant Cooling Pond Dam
Parrish, Florida
Project Number 300906**

To: Mr. Lewis Rounds, P.E.
FPL Manatee Plant

Date: June 2015

From: Jeff Beriswill
Amec Foster Wheeler Environment & Infrastructure, Inc.

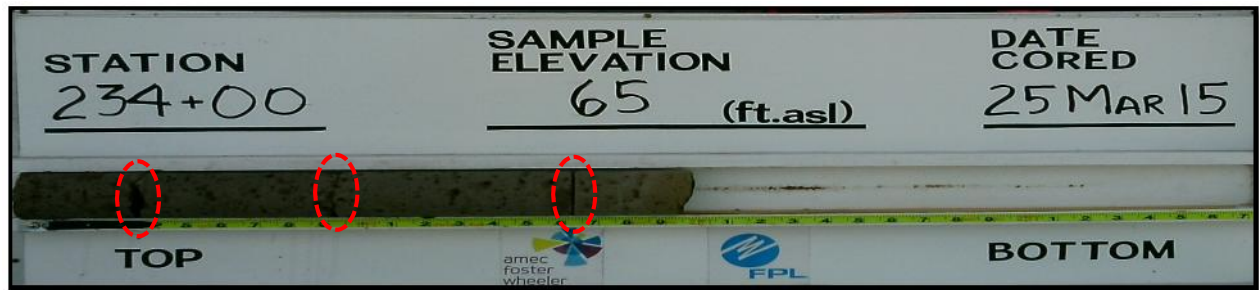
Location: STA 234+00

Core ID:	234+00 (top)	Date Cored:	3/25/15
Core Elevation:	65' ASL	Date Photographed:	3/25/15
Recovered Length (ft):	1.95	SC Thickness (ft):	2.0
RQD (%):	100	Void Depth (ft):	N/A
Notes:

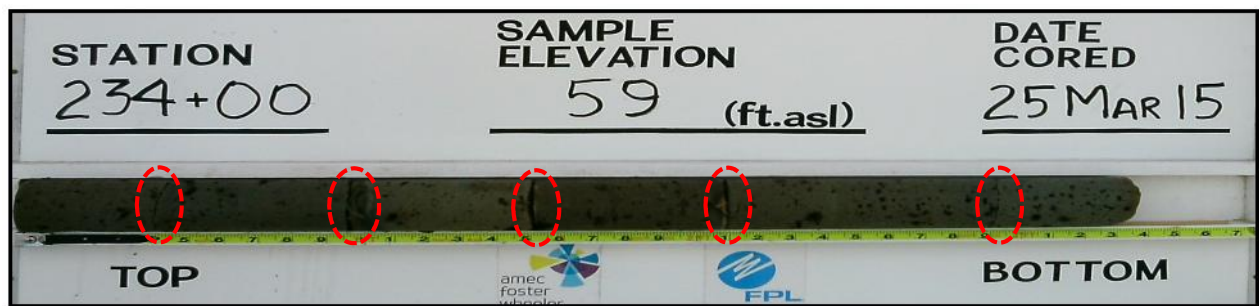
Location: STA 234+00

Core ID:	234+00 (middle)	Date Cored:	3/25/15
Core Elevation:	59' ASL	Date Photographed:	3/25/15
Recovered Length (ft):	3.3	SC Thickness (ft):	3.67
RQD (%):	100	Void Depth (ft):	N/A
Notes:

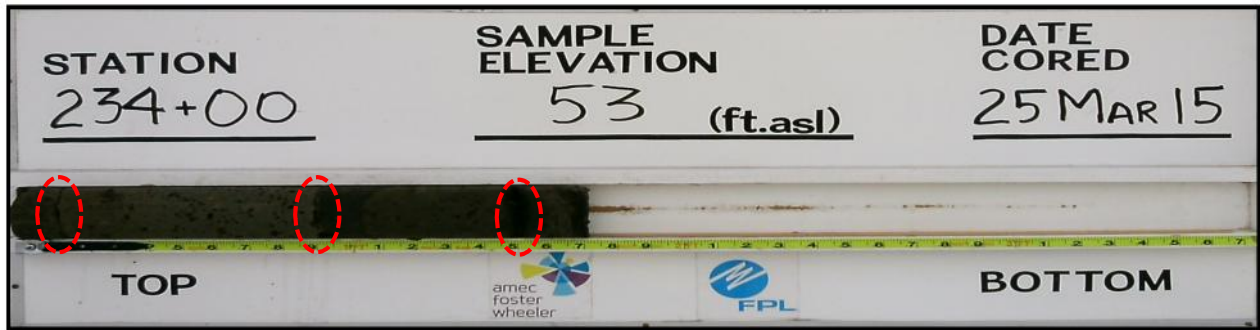
Location: STA 234+00

Core ID:	234+00 (bottom)	Date Cored:	3/25/15
Core Elevation:	53' ASL	Date Photographed:	3/25/15
Recovered Length (ft):	1.5	SC Thickness (ft):	2.165
RQD (%):	90	Void Depth (ft):	N/A
Notes:	Soft material from 0 to 0.15 feet. Insitu soil from 1.5 to 1.7 feet.

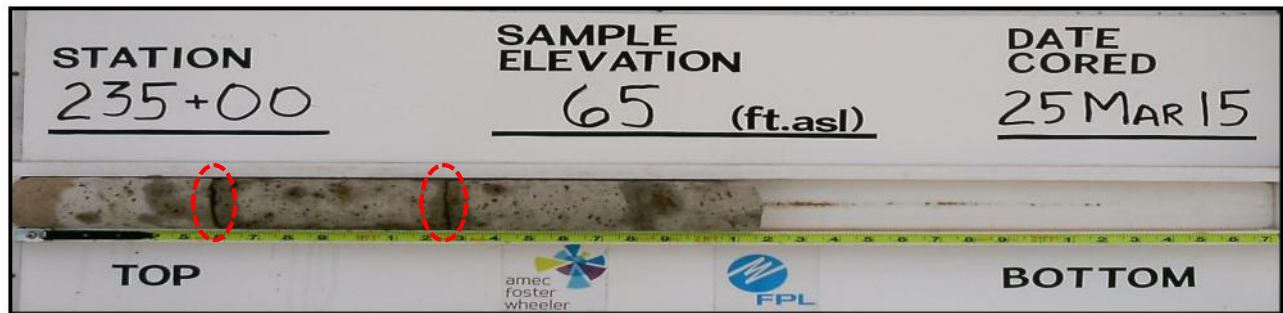
Location: STA 235+00

Core ID:	235+00 (top)	Date Cored:	3/25/15
Core Elevation:	65' ASL	Date Photographed:	3/25/15
Recovered Length (ft):	2.15	SC Thickness (ft):	2.33
RQD (%):	100	Void Depth (ft):	N/A
Notes:

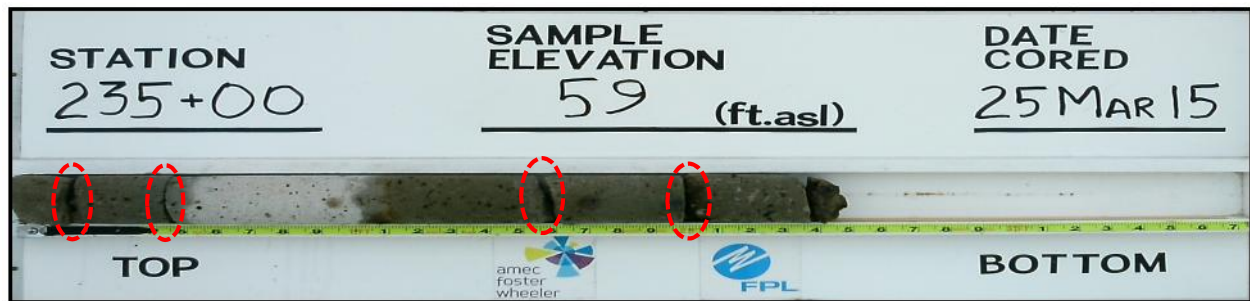
Location: STA 235+00

Core ID:	235+00 (middle)	Date Cored:	3/25/15
Core Elevation:	59' ASL	Date Photographed:	3/25/15
Recovered Length (ft):	2.35	SC Thickness (ft):	3.5
RQD (%):	91	Void Depth (ft):	N/A
Notes:

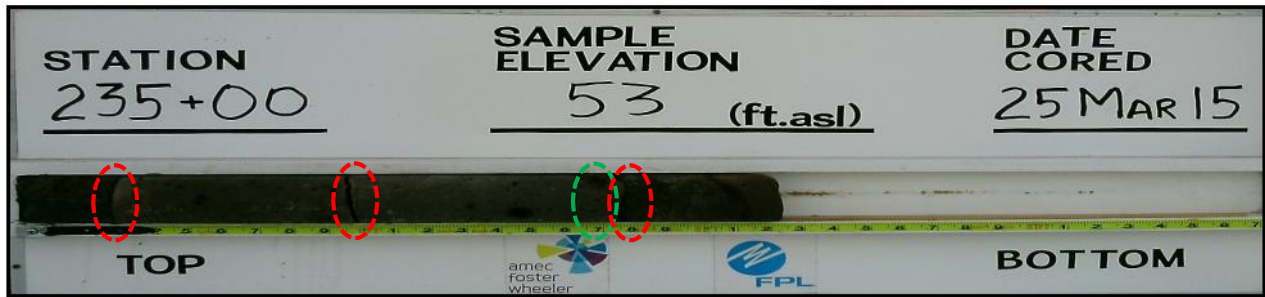
Location: STA 235+00

Core ID:	235+00 (bottom)	Date Cored:	3/25/15
Core Elevation:	53' ASL	Date Photographed:	3/25/15
Recovered Length (ft):	2.2	SC Thickness (ft):	2.5
RQD (%):	86	Void Depth (ft):	N/A
Notes:	Soft material from 0 to 0.3 feet. Piece of wood at 1.65 feet.

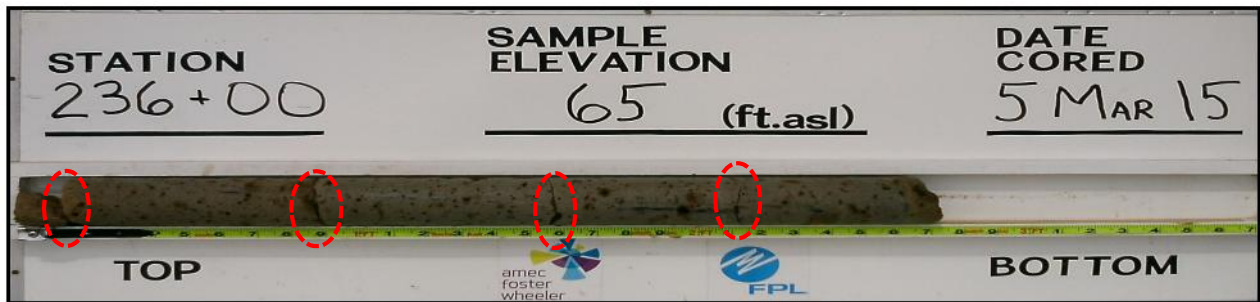
Location: STA 236+00

Core ID:	236+00 (top)	Date Cored:	3/5/15
Core Elevation:	65' ASL	Date Photographed:	3/5/15
Recovered Length (ft):	2.7	SC Thickness (ft):	2.92
RQD (%):	99	Void Depth (ft):	N/A
Notes:	Soft material from 0 to 0.2 feet.

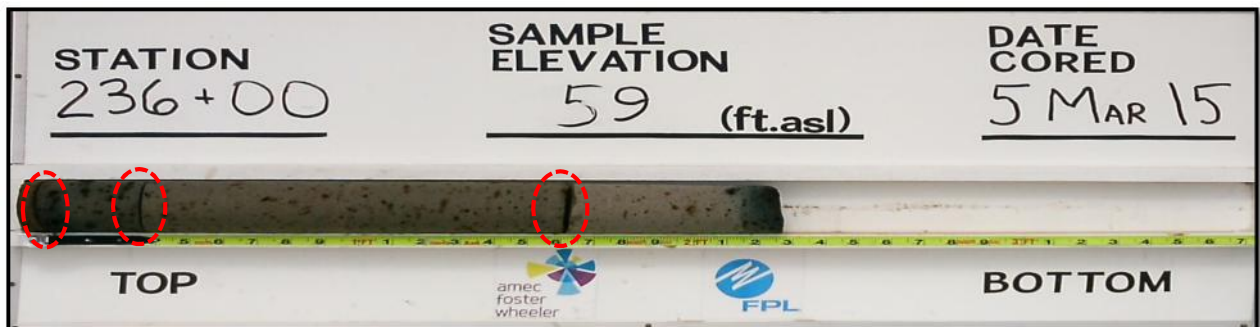
Location: STA 236+00

Core ID:	236+00 (middle)	Date Cored:	3/5/15
Core Elevation:	59' ASL	Date Photographed:	3/5/15
Recovered Length (ft):	2.25	SC Thickness (ft):	2.58
RQD (%):	99	Void Depth (ft):	N/A
Notes:	Soft material from 0 to 0.1 feet.

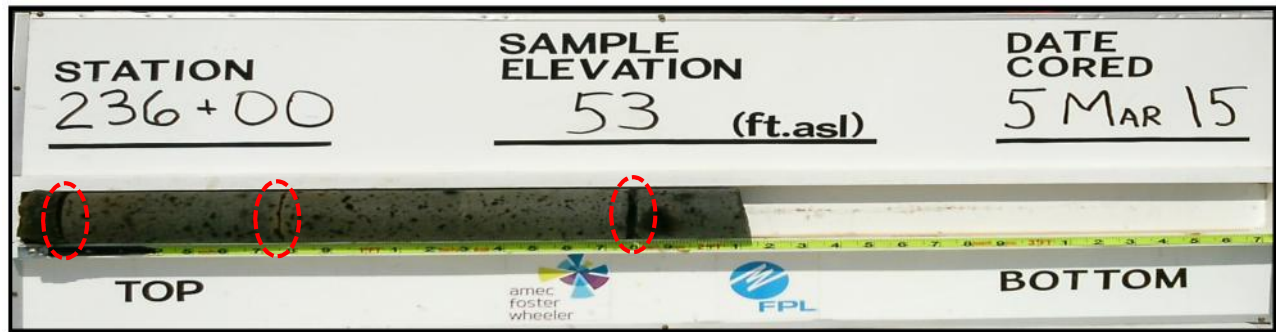
Location: STA 236+00

Core ID:	236+00 (bottom)	Date Cored:	3/5/15
Core Elevation:	53' ASL	Date Photographed:	3/5/15
Recovered Length (ft):	2.1	SC Thickness (ft):	2.58
RQD (%):	93	Void Depth (ft):	N/A
Notes:	Soft material from 0 to 0.15 feet.

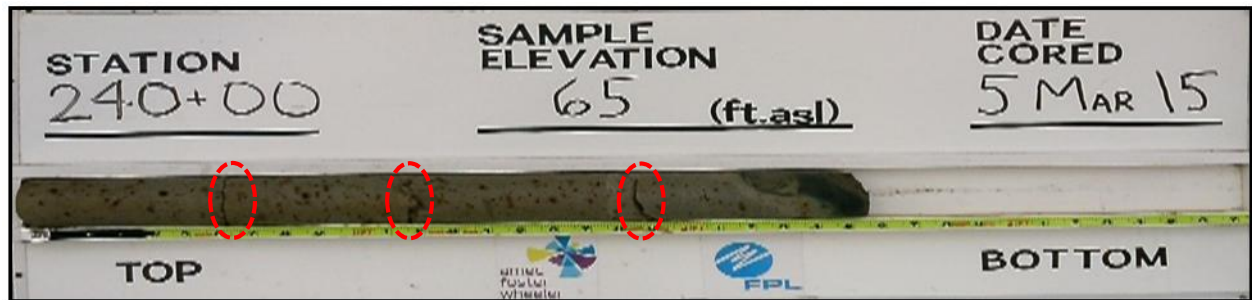
Location: STA 240+00

Core ID:	240+00 (top)	Date Cored:	3/5/15
Core Elevation:	65' ASL	Date Photographed:	3/5/15
Recovered Length (ft):	2.5	SC Thickness (ft):	2.83
RQD (%):	100	Void Depth (ft):	N/A
Notes:

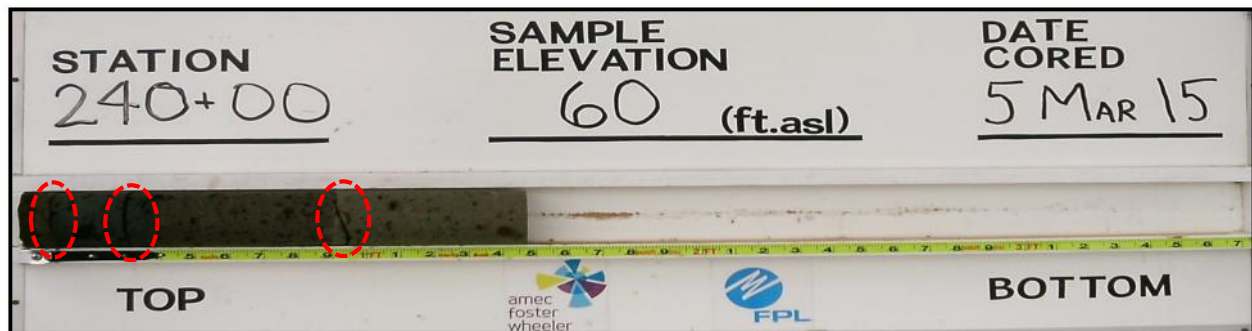
Location: STA 240+00

Core ID:	240+00 (middle)	Date Cored:	3/5/15
Core Elevation:	60' ASL	Date Photographed:	3/5/15
Recovered Length (ft):	1.47	SC Thickness (ft):	2.5
RQD (%):	93	Void Depth (ft):	N/A
Notes:

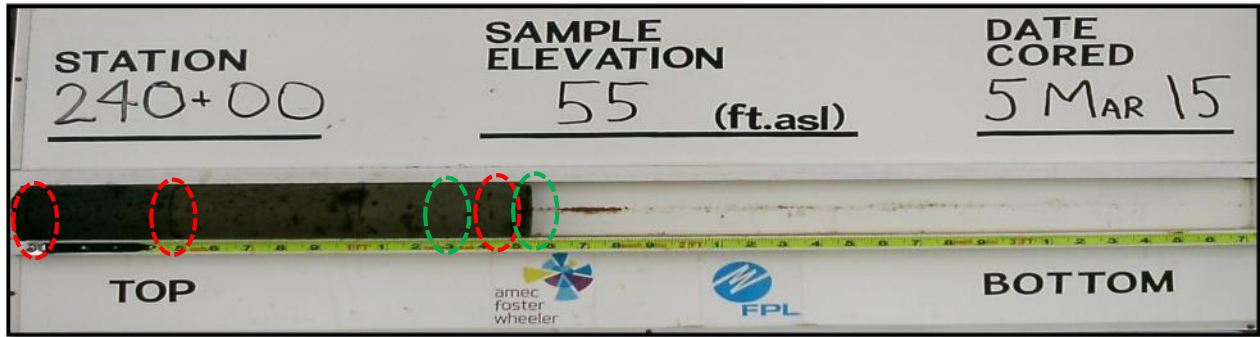
Location: STA 240+00

Core ID:	240+00 (bottom)	Date Cored:	3/5/15
Core Elevation:	55' ASL	Date Photographed:	3/5/15
Recovered Length (ft):	1.52	SC Thickness (ft):	2.83
RQD (%):	99	Void Depth (ft):	N/A
Notes:	Wood branches at 1.3 and 1.52 feet.

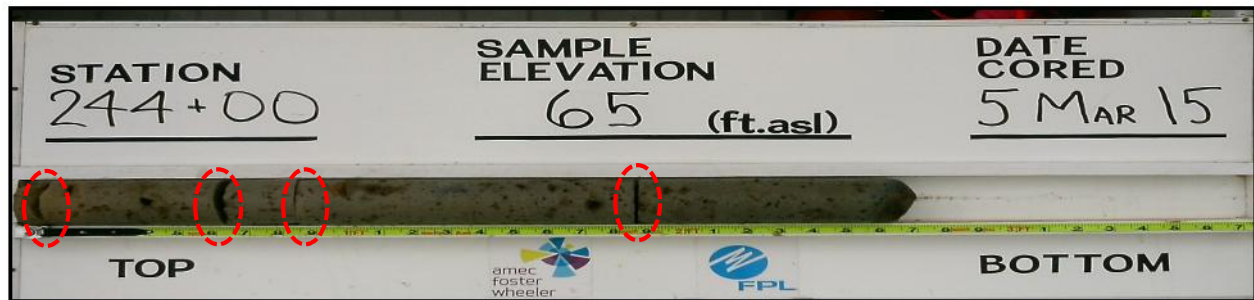
Location: STA 244+00

Core ID:	244+00 (top)	Date Cored:	3/5/15
Core Elevation:	65' ASL	Date Photographed:	3/5/15
Recovered Length (ft):	2.65	SC Thickness (ft):	2.75
RQD (%):	88	Void Depth (ft):	N/A
Notes:	Soft material from 0 to 0.1 feet.

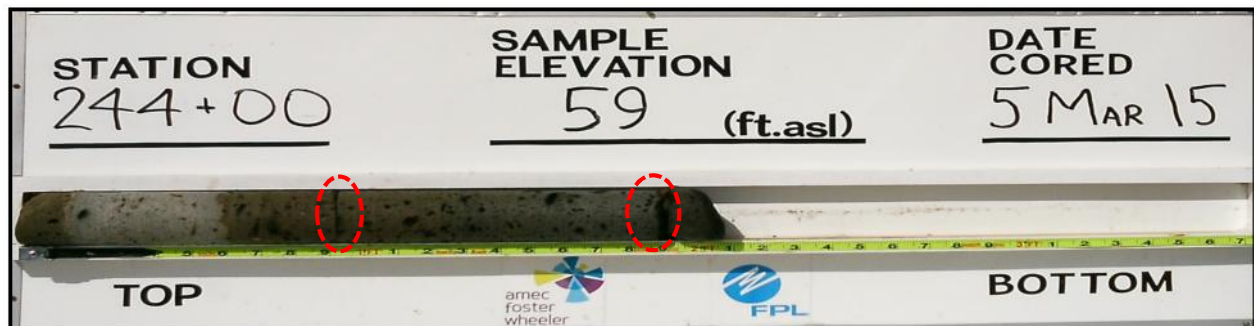
Location: STA 244+00

Core ID:	244+00 (middle)	Date Cored:	3/5/15
Core Elevation:	59' ASL	Date Photographed:	3/5/15
Recovered Length (ft):	2.05	SC Thickness (ft):	2.58
RQD (%):	90	Void Depth (ft):	N/A
Notes:	Wood stick located at break at 1.85 feet.

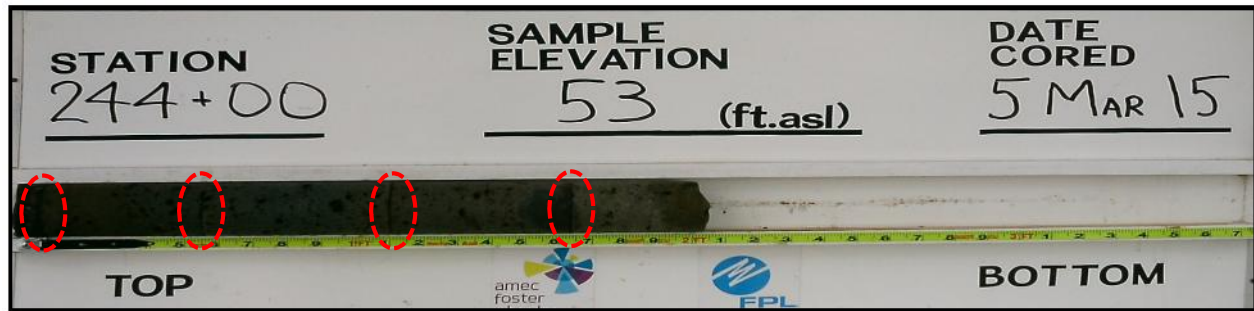
Location: STA 244+00

Core ID:	244+00 (bottom)	Date Cored:	3/5/15
Core Elevation:	53' ASL	Date Photographed:	3/5/15
Recovered Length (ft):	2.0	SC Thickness (ft):	2.5
RQD (%):	100	Void Depth (ft):	N/A
Notes:

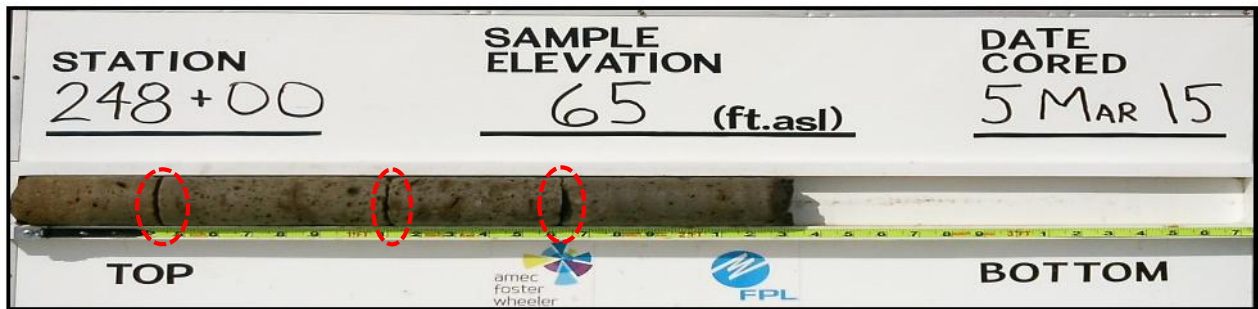
Location: STA 248+00

Core ID:	248+00 (top)	Date Cored:	3/5/15
Core Elevation:	65' ASL	Date Photographed:	3/5/15
Recovered Length (ft):	2.3	SC Thickness (ft):	2.3
RQD (%):	100	Void Depth (ft):	N/A
Notes:

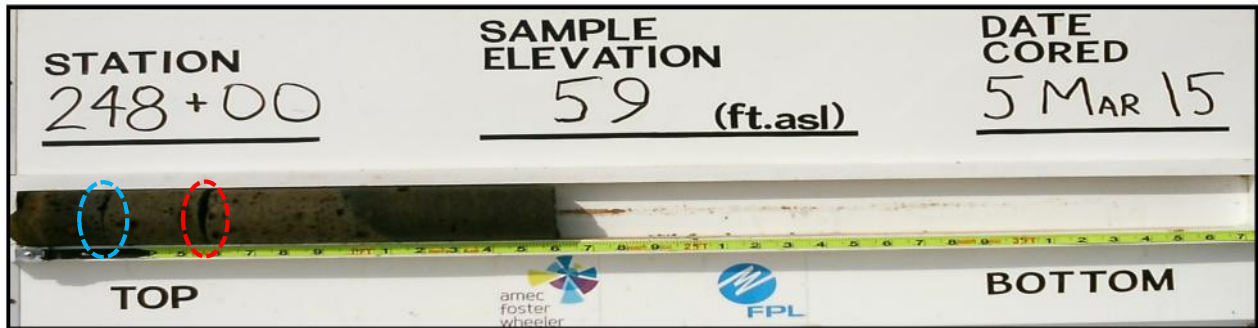
Location: STA 248+00

Core ID:	248+00 (middle)	Date Cored:	3/5/15
Core Elevation:	59' ASL	Date Photographed:	3/5/15
Recovered Length (ft):	1.6	SC Thickness (ft):	2.16
RQD (%):	64	Void Depth (ft):	N/A
Notes:

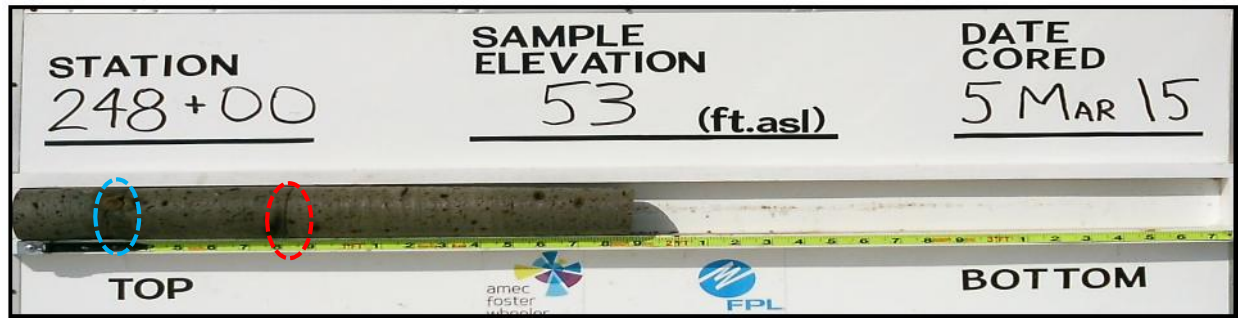
Location: STA 248+00

Core ID:	248+00 (bottom)	Date Cored:	3/5/15
Core Elevation:	53' ASL	Date Photographed:	3/5/15
Recovered Length (ft):	1.85	SC Thickness (ft):	2.67
RQD (%):	84	Void Depth (ft):	N/A
Notes:	Wood stick located in fracture at 0.3 feet.

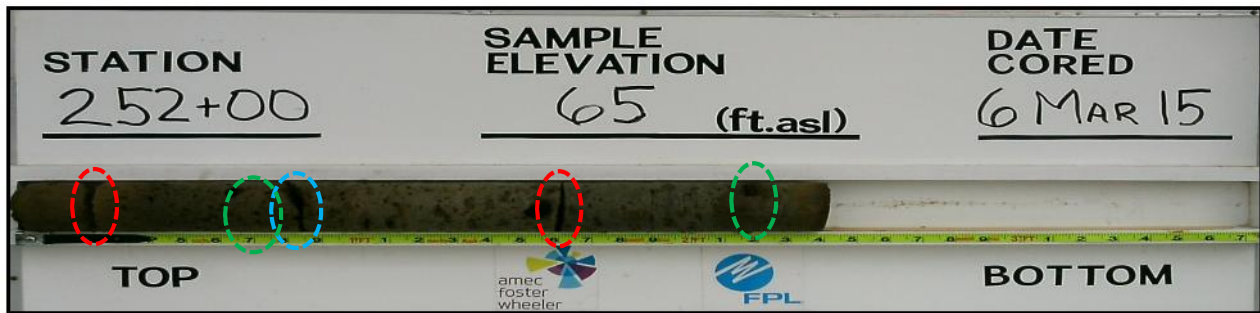
Location: STA 252+00

Core ID:	252+00 (top)	Date Cored:	3/6/15
Core Elevation:	65' ASL	Date Photographed:	3/6/15
Recovered Length (ft):	2.4	SC Thickness (ft):	2.5
RQD (%):	90	Void Depth (ft):	N/A
Notes:	Soft material from 0 to 0.25 feet. Small void at 0.65 feet. Wood plant part in break at 0.85 feet. Wood plant part at 2.15 feet.

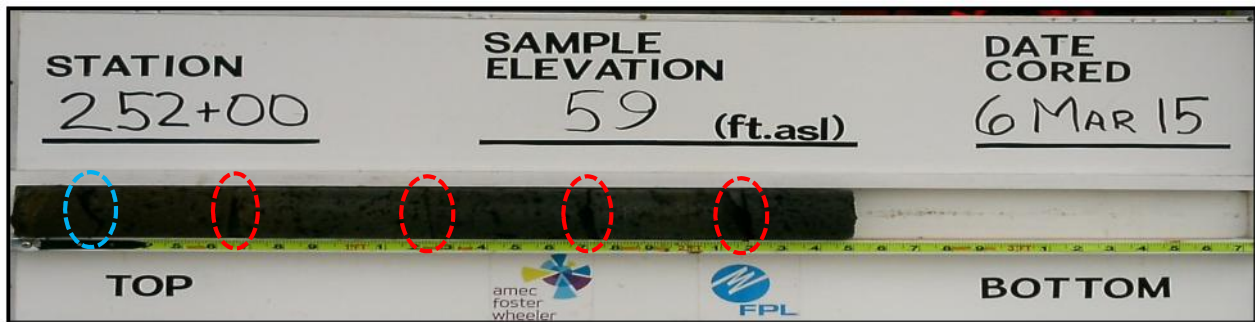
Location: STA 252+00

Core ID:	68+00 (middle)	Date Cored:	3/6/15
Core Elevation:	59' ASL	Date Photographed:	3/6/15
Recovered Length (ft):	2.5	SC Thickness (ft):	2.58
RQD (%):	92	Void Depth (ft):	N/A
Notes:	Soft material from 0 to 0.2 feet. Pitting noted on the exterior of the core only.

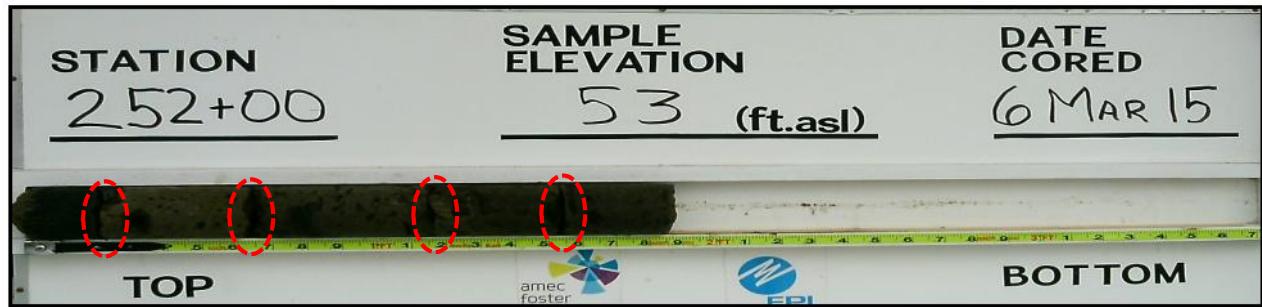
Location: STA 252+00

Core ID:	252+00 (bottom)	Date Cored:	3/6/15
Core Elevation:	53' ASL	Date Photographed:	3/6/15
Recovered Length (ft):	1.85	SC Thickness (ft):	2.0
RQD (%):	89	Void Depth (ft):	N/A
Notes:	Entire core sample is soft. Wood plant part in break at 0.2 feet.

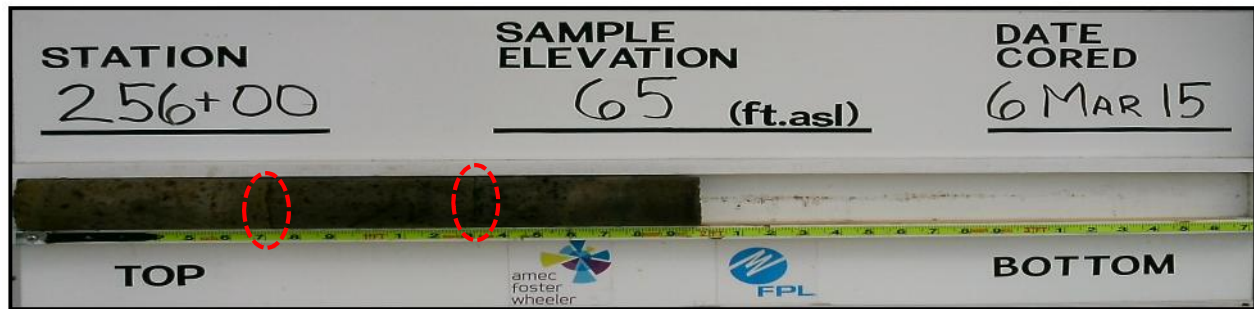
Location: STA 256+00

Core ID:	256+00 (top)	Date Cored:	3/6/15
Core Elevation:	65' ASL	Date Photographed:	3/6/15
Recovered Length (ft):	1.96	SC Thickness (ft):	2.0
RQD (%):	100	Void Depth (ft):	N/A
Notes:

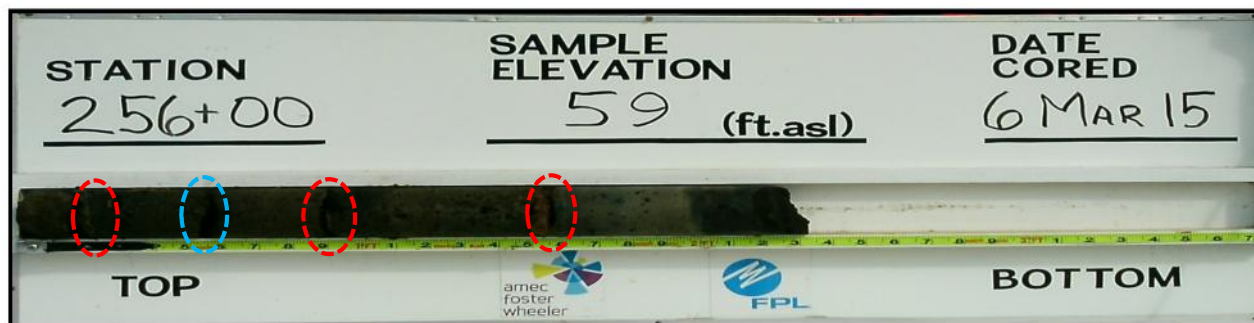
Location: STA 256+00

Core ID:	256+00 (middle)	Date Cored:	3/6/15
Core Elevation:	59' ASL	Date Photographed:	3/6/15
Recovered Length (ft):	2.0	SC Thickness (ft):	2.67
RQD (%):	65	Void Depth (ft):	N/A
Notes:	Soft material from 0 to 0.2 feet and from 0.55 to 0.9 feet. Wood plant part noted in break at 1.55 feet. In-situ soil from 2.0 to 2.3 feet.

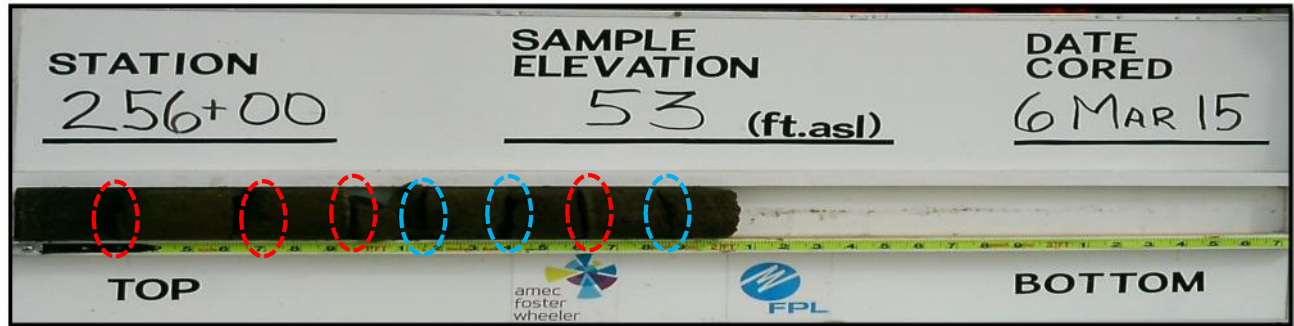
Location: STA 256+00

Core ID:	256+00 (bottom)	Date Cored:	3/6/15
Core Elevation:	53' ASL	Date Photographed:	3/6/15
Recovered Length (ft):	2.0	SC Thickness (ft):	2.25
RQD (%):	0	Void Depth (ft):	N/A
Notes:	Complete recovered core soft to very soft.

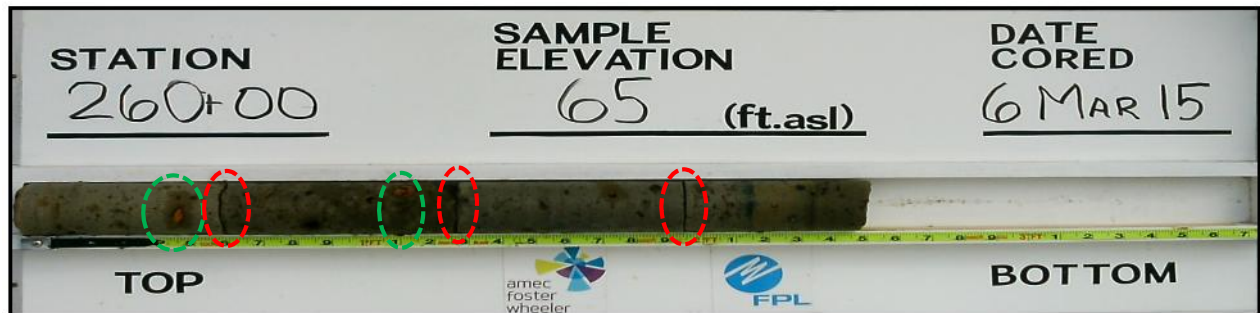
Location: STA 260+00

Core ID:	260+00 (top)	Date Cored:	3/6/15
Core Elevation:	65' ASL	Date Photographed:	3/6/15
Recovered Length (ft):	2.45	SC Thickness (ft):	2.8
RQD (%):	100	Void Depth (ft):	N/A
Notes:	Wood noted at 0.47 and 1.1 feet.

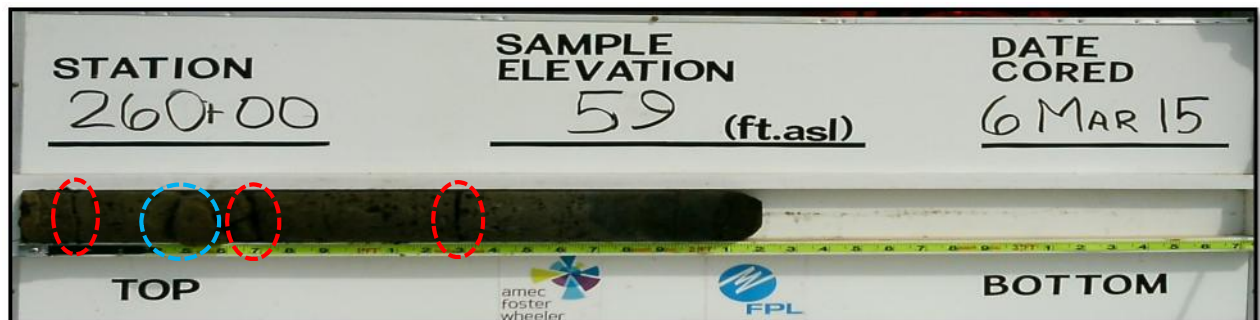
Location: STA 260+00

Core ID:	260+00 (middle)	Date Cored:	3/6/15
Core Elevation:	59' ASL	Date Photographed:	3/6/15
Recovered Length (ft):	2.1	SC Thickness (ft):	2.25
RQD (%):	76	Void Depth (ft):	N/A
Notes:	Soft material from 0 to 0.5 feet.

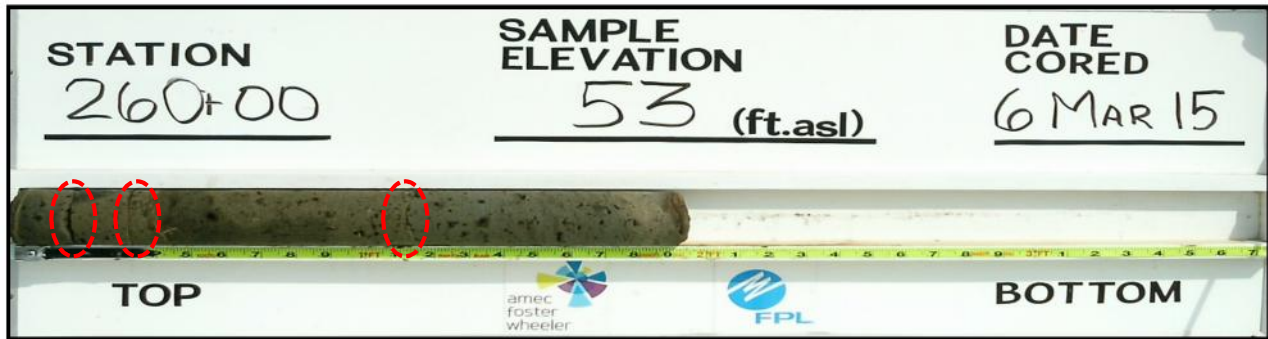
Location: STA 260+00

Core ID:	260+00 (bottom)	Date Cored:	3/6/15
Core Elevation:	53' ASL	Date Photographed:	3/6/15
Recovered Length (ft):	1.9	SC Thickness (ft):	2.165
RQD (%):	83	Void Depth (ft):	N/A
Notes:	Soft material from 0 to 0.32 feet.

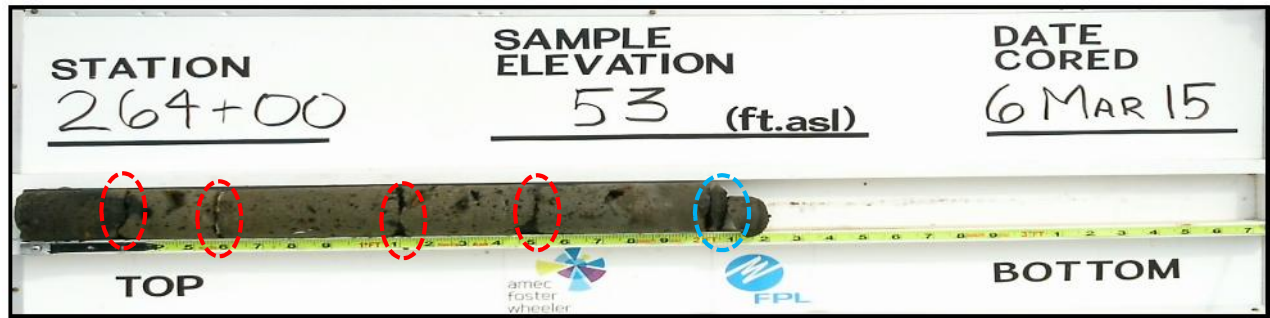
Location: STA 260+00

Core ID:	260+00 (bottom)	Date Cored:	3/6/15
Core Elevation:	59' ASL	Date Photographed:	3/6/15
Recovered Length (ft):	2.0	SC Thickness (ft):	2.165
RQD (%):	85	Void Depth (ft):	N/A
Notes:	Complete recovered core is soft.

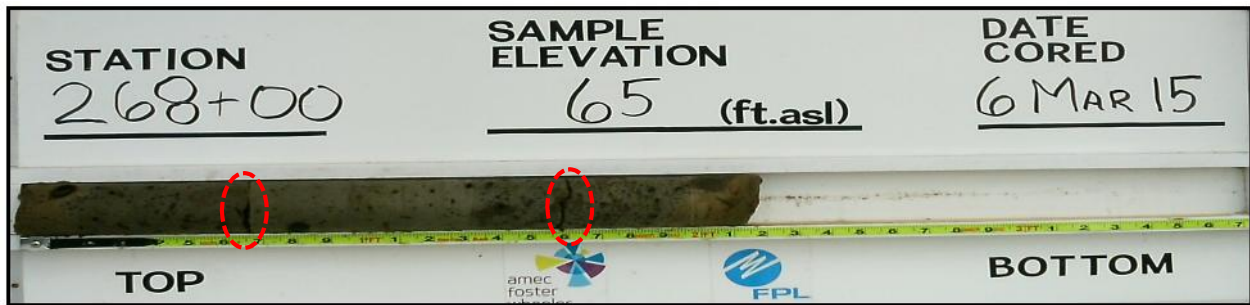
Location: STA 268+00

Core ID:	268+00 (top)	Date Cored:	3/6/15
Core Elevation:	65' ASL	Date Photographed:	3/6/15
Recovered Length (ft):	2.13	SC Thickness (ft):	2.33
RQD (%):	100	Void Depth (ft):	N/A
Notes:

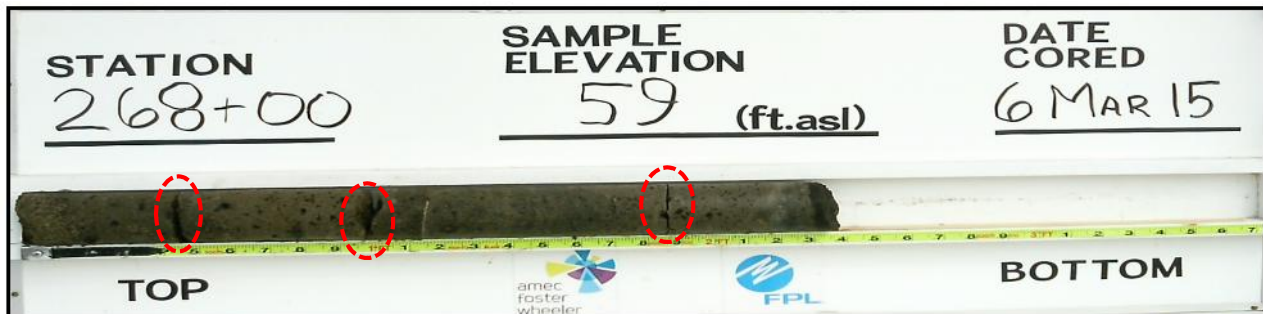
Location: STA 268+00

Core ID:	268+00 (middle)	Date Cored:	3/6/15
Core Elevation:	59' ASL	Date Photographed:	3/6/15
Recovered Length (ft):	2.35	SC Thickness (ft):	2.5
RQD (%):	100	Void Depth (ft):	N/A
Notes:

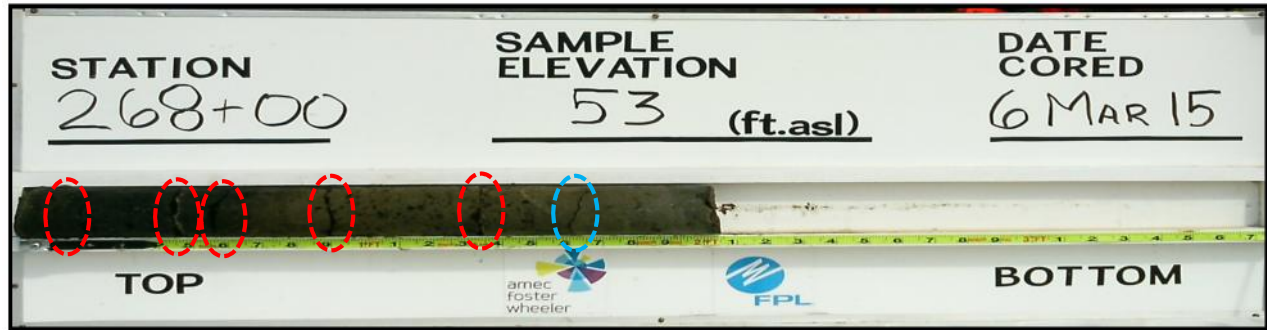
Location: STA 268+00

Core ID:	268+00 (bottom)	Date Cored:	3/6/15
Core Elevation:	53' ASL	Date Photographed:	3/6/15
Recovered Length (ft):	2.05	SC Thickness (ft):	2.05
RQD (%):	63	Void Depth (ft):	N/A
Notes:	Soft material from 0 to 0.9 feet.

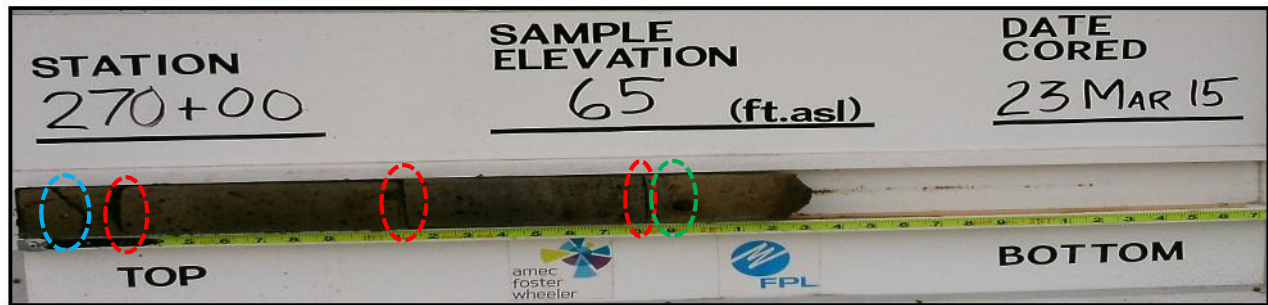
Location: STA 270+00

Core ID:	270+00 (top)	Date Cored:	3/23/15
Core Elevation:	65' ASL	Date Photographed:	3/23/15
Recovered Length (ft):	2.2	SC Thickness (ft):	2.33
RQD (%):	86	Void Depth (ft):	N/A
Notes:	Soft material from 0 to 0.1 feet. Fractured pieces from 1.9 to 2.45 feet.

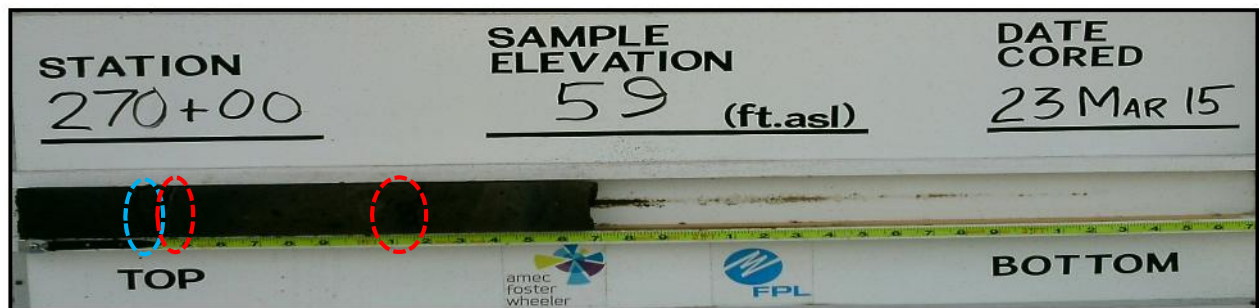
Location: STA 270+00

Core ID:	270+00 (middle)	Date Cored:	3/23/15
Core Elevation:	59' ASL	Date Photographed:	3/23/15
Recovered Length (ft):	1.65	SC Thickness (ft):	1.75
RQD (%):	97	Void Depth (ft):	N/A
Notes:	Soft material from 0 to 0.7 feet.

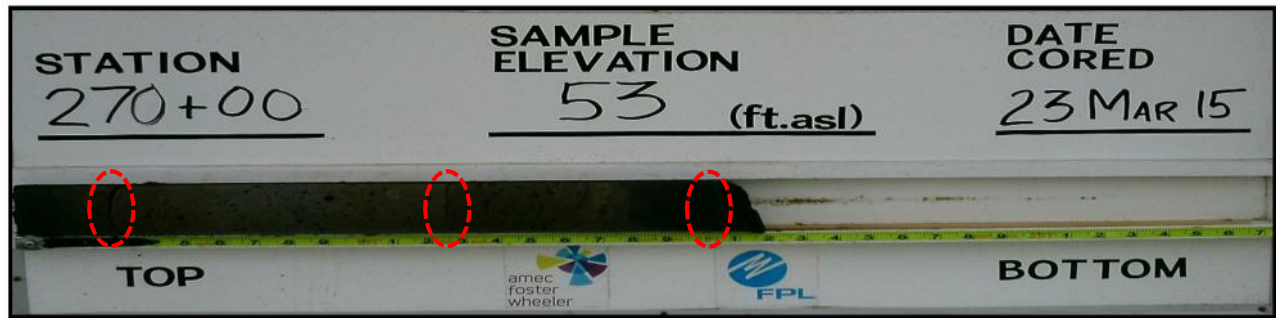
Location: STA 270+00

Core ID:	270+00 (bottom)	Date Cored:	3/23/15
Core Elevation:	53' ASL	Date Photographed:	3/23/15
Recovered Length (ft):	2.05	SC Thickness (ft):	2.42
RQD (%):	99	Void Depth (ft):	N/A
Notes:	Insitu soil 2.05 to 2.13 feet.

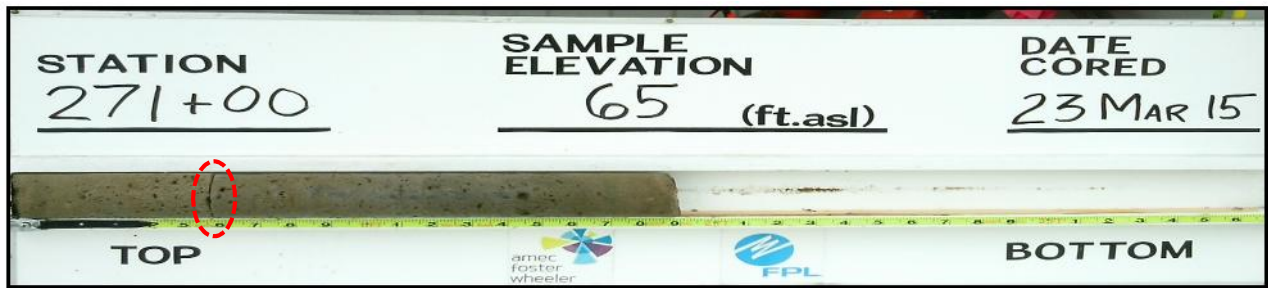
Location: STA 271+00

Core ID:	271+00 (top)	Date Cored:	3/23/15
Core Elevation:	65' ASL	Date Photographed:	3/23/15
Recovered Length (ft):	1.88	SC Thickness (ft):	2.0
RQD (%):	100	Void Depth (ft):	N/A
Notes:	Soft material from 0 to 0.1 feet. Fractured pieces from 1.9 to 2.45 feet.

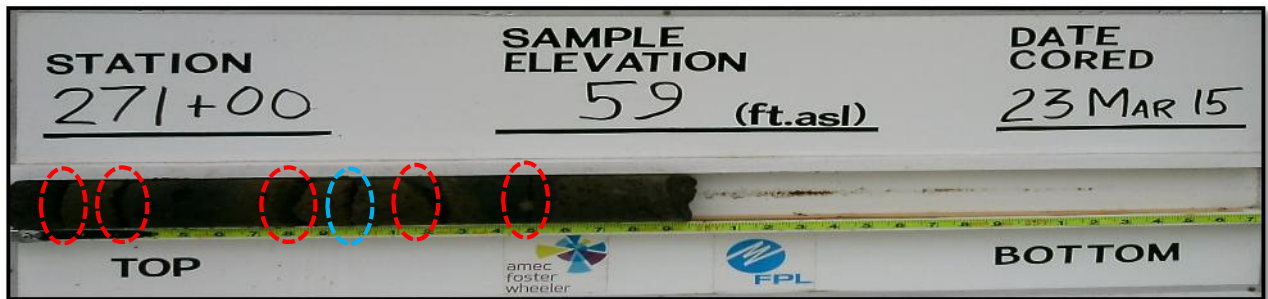
Location: STA 271+00

Core ID:	271+00 (middle)	Date Cored:	3/23/15
Core Elevation:	59' ASL	Date Photographed:	3/23/15
Recovered Length (ft):	1.92	SC Thickness (ft):	2.08
RQD (%):	49	Void Depth (ft):	N/A
Notes:	Very soft material from 0 to 1.48 feet.

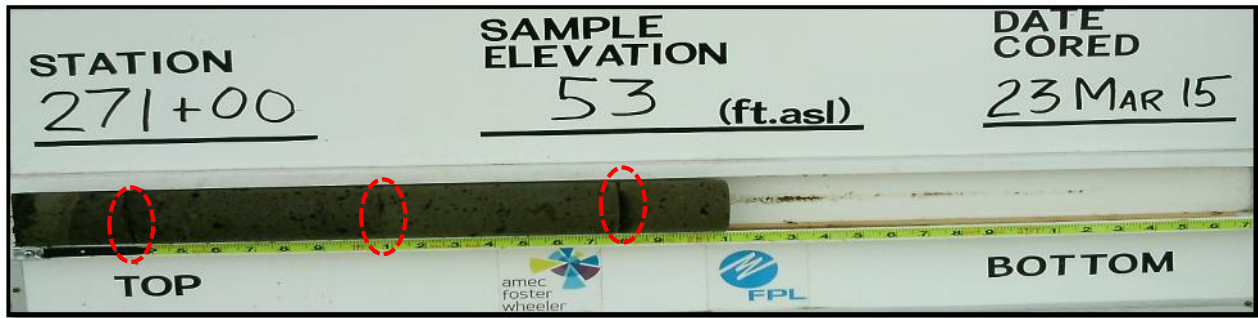
Location: STA 271+00

Core ID:	271+00 (bottom)	Date Cored:	3/23/15
Core Elevation:	53' ASL	Date Photographed:	3/23/15
Recovered Length (ft):	2.08	SC Thickness (ft):	3.0
RQD (%):	100	Void Depth (ft):	N/A
Notes:

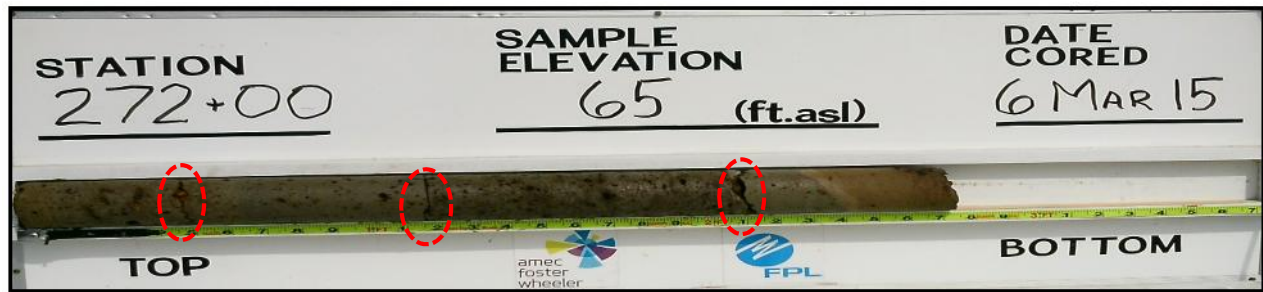
Location: STA 272+00

Core ID:	272+00 (top)	Date Cored:	3/6/15
Core Elevation:	65' ASL	Date Photographed:	3/6/15
Recovered Length (ft):	2.7	SC Thickness (ft):	2.7
RQD (%):	100	Void Depth (ft):	N/A
Notes:	Wood noted in break at 0.5 feet.

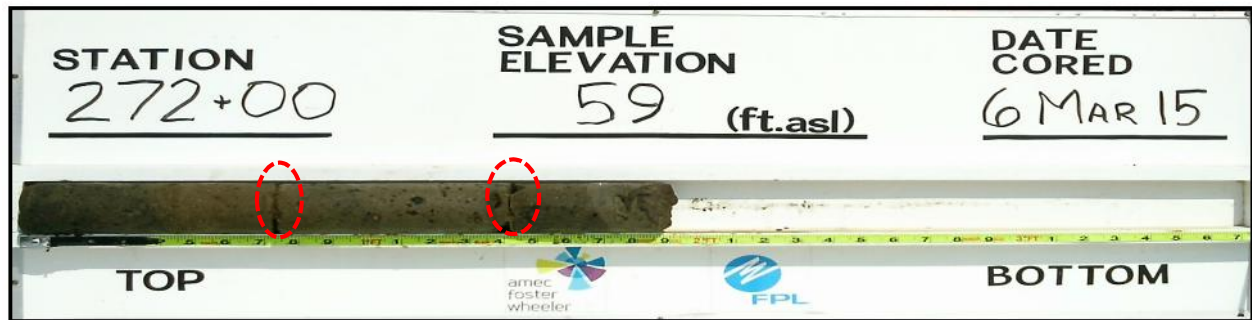
Location: STA 272+00

Core ID:	272+00 (middle)	Date Cored:	3/6/15
Core Elevation:	59' ASL	Date Photographed:	3/6/15
Recovered Length (ft):	1.87	SC Thickness (ft):	2.0
RQD (%):	100	Void Depth (ft):	N/A
Notes:

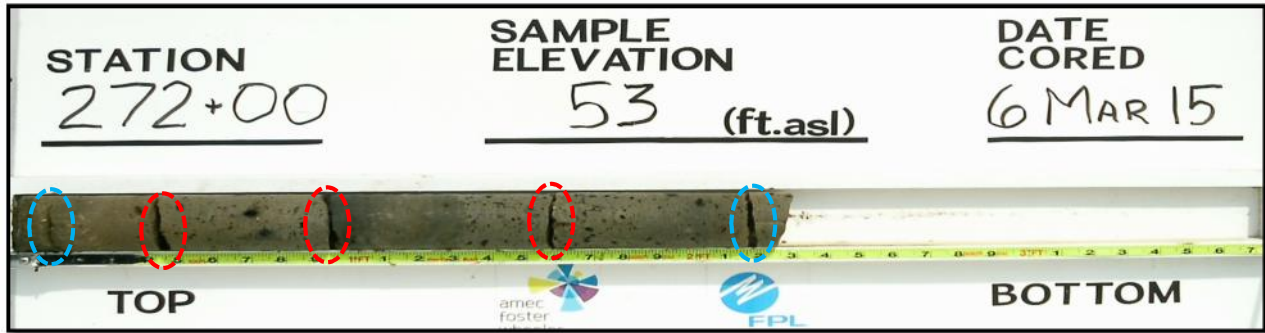
Location: STA 272+00

Core ID:	272+00 (bottom)	Date Cored:	3/6/15
Core Elevation:	53' ASL	Date Photographed:	3/6/15
Recovered Length (ft):	2.25	SC Thickness (ft):	2.25
RQD (%):	75	Void Depth (ft):	N/A
Notes:

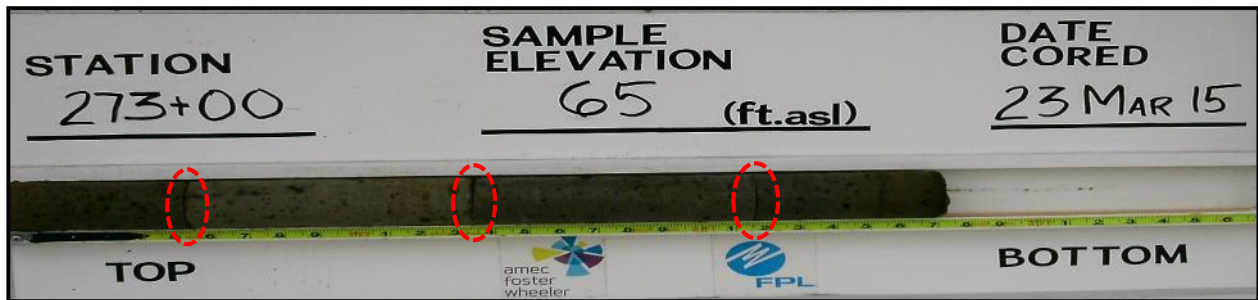
Location: STA 273+00

Core ID:	273+00 (top)	Date Cored:	3/23/15
Core Elevation:	65' ASL	Date Photographed:	3/23/15
Recovered Length (ft):	2.7	SC Thickness (ft):	2.83
RQD (%):	100	Void Depth (ft):	N/A
Notes:

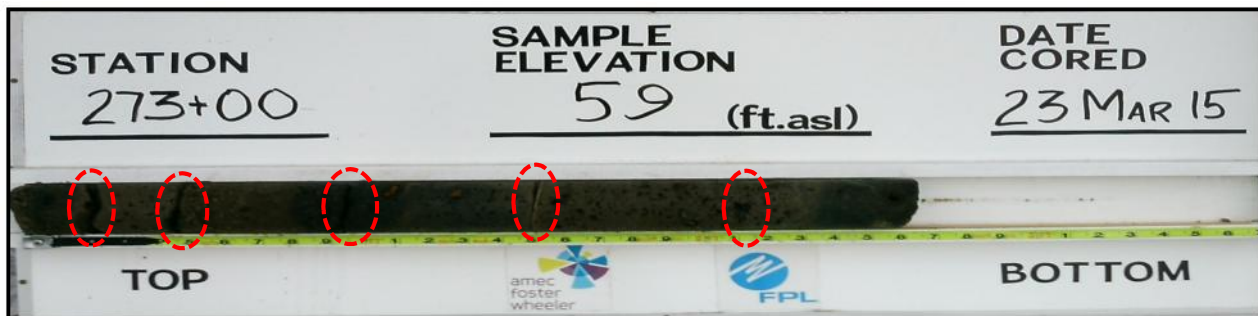
Location: STA 273+00

Core ID:	273+00 (middle)	Date Cored:	3/23/15
Core Elevation:	59' ASL	Date Photographed:	3/23/15
Recovered Length (ft):	2.57	SC Thickness (ft):	2.67
RQD (%):	82	Void Depth (ft):	N/A
Notes:	Very soft material from 0 to 0.2 feet and from 0.45 to 1.1 feet. Soft material between 0.2 to 0.45 feet.

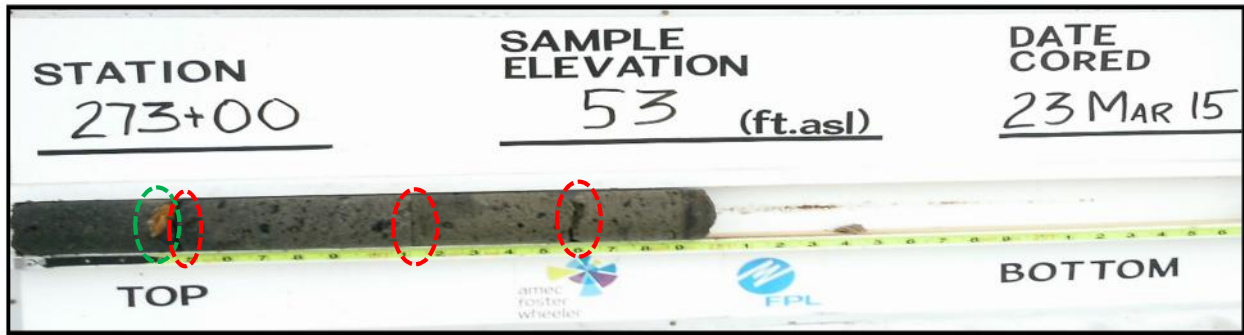
Location: STA 273+00

Core ID:	273+00 (bottom)	Date Cored:	3/23/15
Core Elevation:	53' ASL	Date Photographed:	3/23/15
Recovered Length (ft):	1.95	SC Thickness (ft):	2.5
RQD (%):	100	Void Depth (ft):	N/A
Notes:

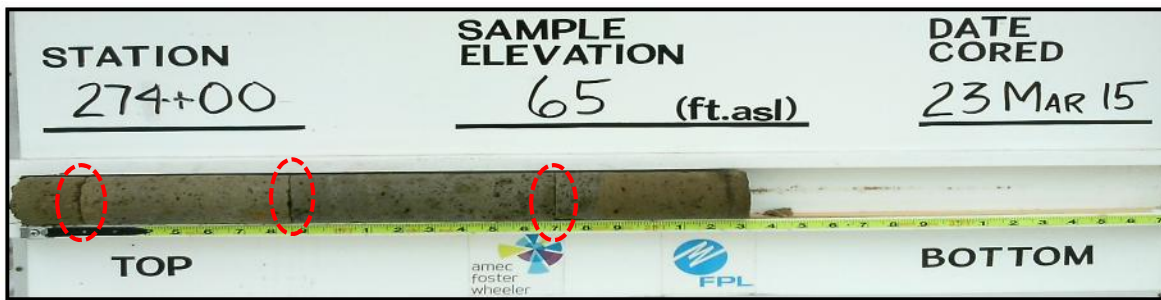
Location: STA 274+00

Core ID:	274+00 (top)	Date Cored:	3/23/15
Core Elevation:	65' ASL	Date Photographed:	3/23/15
Recovered Length (ft):	2.3	SC Thickness (ft):	2.5
RQD (%):	91	Void Depth (ft):	N/A
Notes:	Soft material from 0 to 0.2 feet.

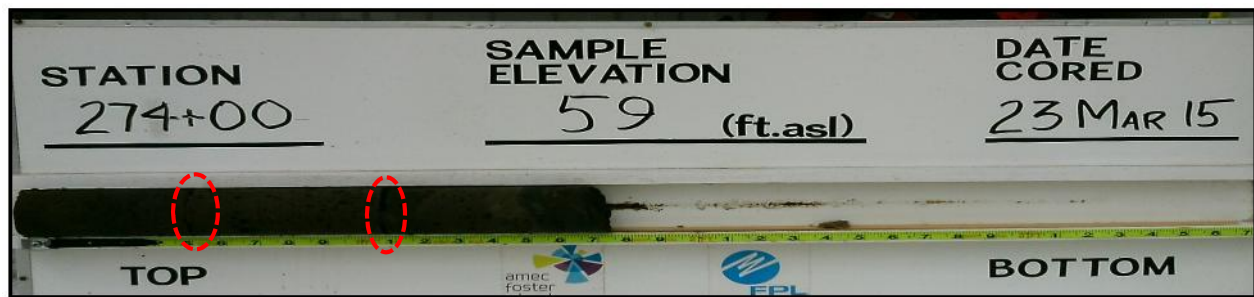
Location: STA 274+00

Core ID:	274+00 (middle)	Date Cored:	3/23/15
Core Elevation:	59' ASL	Date Photographed:	3/23/15
Recovered Length (ft):	1.7	SC Thickness (ft):	2.0
RQD (%):	100	Void Depth (ft):	N/A
Notes:	Soft material from 0 to 0.1 feet. Soft fill material between 1.05 and 1.1 feet.

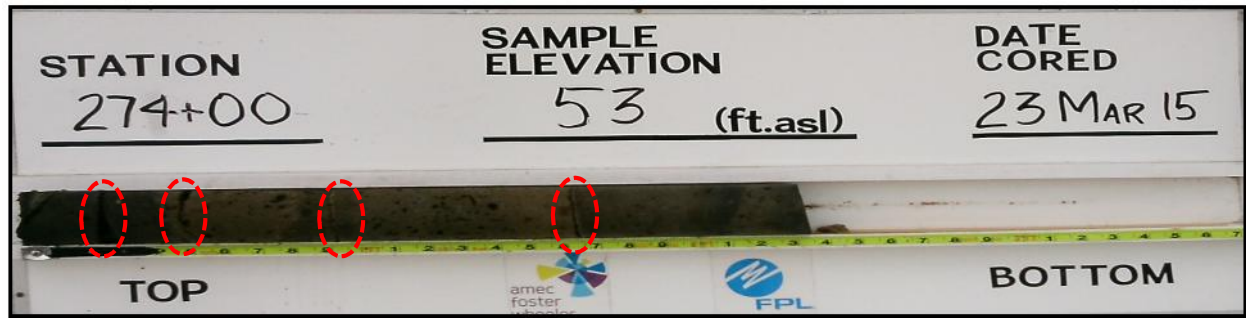
Location: STA 274+00

Core ID:	274+00 (bottom)	Date Cored:	3/23/15
Core Elevation:	53' ASL	Date Photographed:	3/23/15
Recovered Length (ft):	2.3	SC Thickness (ft):	2.5
RQD (%):	78	Void Depth (ft):	N/A
Notes:

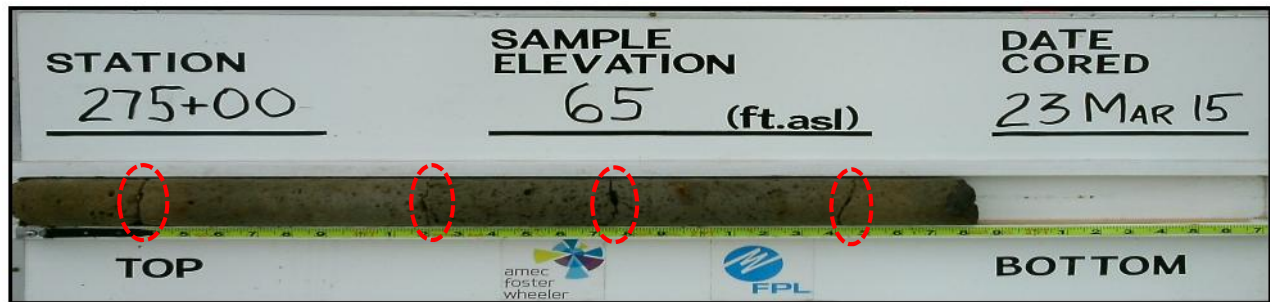
Location: STA 275+00

Core ID:	275+00 (top)	Date Cored:	3/23/15
Core Elevation:	65' ASL	Date Photographed:	3/23/15
Recovered Length (ft):	2.8	SC Thickness (ft):	3.33
RQD (%):	100	Void Depth (ft):	N/A
Notes:	Soft material from 0 to 0.38 feet.

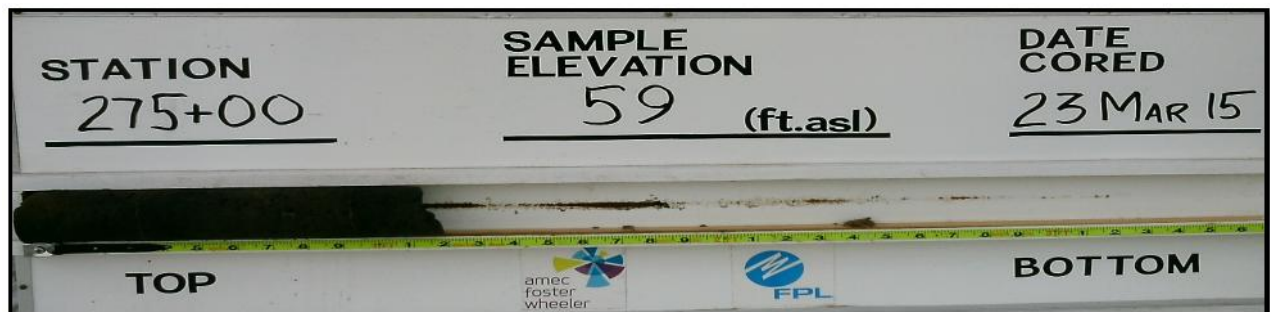
Location: STA 275+00

Core ID:	275+00 (middle)	Date Cored:	3/23/15
Core Elevation:	59' ASL	Date Photographed:	3/23/15
Recovered Length (ft):	1.15	SC Thickness (ft):	1.5
RQD (%):	100	Void Depth (ft):	N/A
Notes:

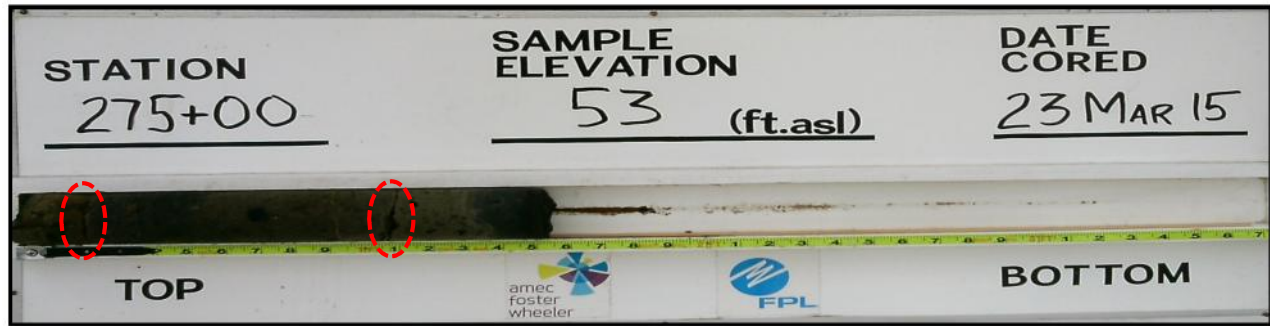
Location: STA 275+00

Core ID:	275+00 (bottom)	Date Cored:	3/23/15
Core Elevation:	53' ASL	Date Photographed:	3/23/15
Recovered Length (ft):	1.5	SC Thickness (ft):	2.0
RQD (%):	87	Void Depth (ft):	N/A
Notes:	Very soft material from 0 to 0.2 feet. Soft material from 0.2 to 1.08 feet.
