**Assessment and Design Report
Soil-Cement Condition Assessment and Design Project
Manatee Plant Cooling Pond Dam
Parrish, Florida
Project Number 300906**

To: Mr. Lewis Rounds, P.E.
FPL Manatee Plant

Date: June 2015

From: Jeff Beriswill
Amec Foster Wheeler Environment & Infrastructure, Inc.

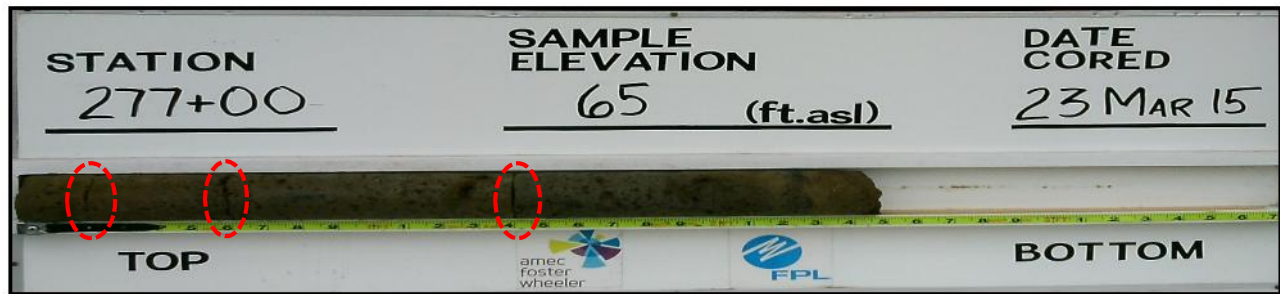
Location: STA 277+00

Core ID:	277+00 (top)	Date Cored:	3/23/15
Core Elevation:	65' ASL	Date Photographed:	3/23/15
Recovered Length (ft):	2.43	SC Thickness (ft):	2.58
RQD (%):	92	Void Depth (ft):	N/A
Notes:	Soft material from 0 to 0.45 feet.

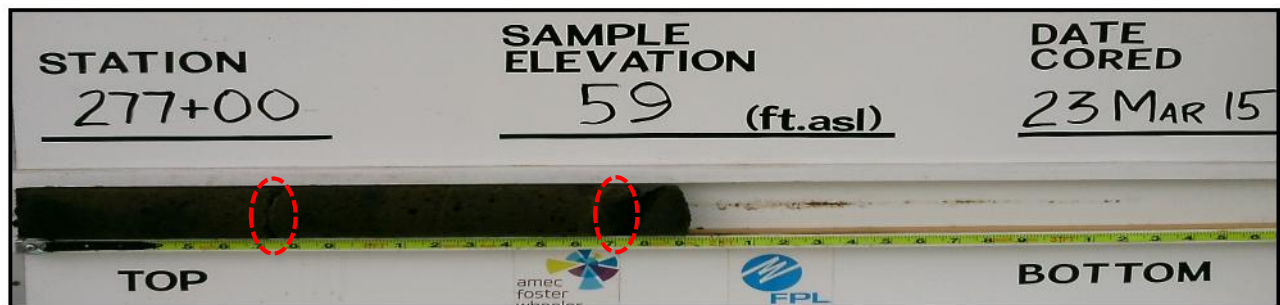
Location: STA 277+00

Core ID:	277+00 (middle)	Date Cored:	3/23/15
Core Elevation:	59' ASL	Date Photographed:	3/23/15
Recovered Length (ft):	1.9	SC Thickness (ft):	2.08
RQD (%):	89	Void Depth (ft):	N/A
Notes:	Soft material from 0 to 0.74 feet. Very soft material from 1.7 to 1.9 feet.

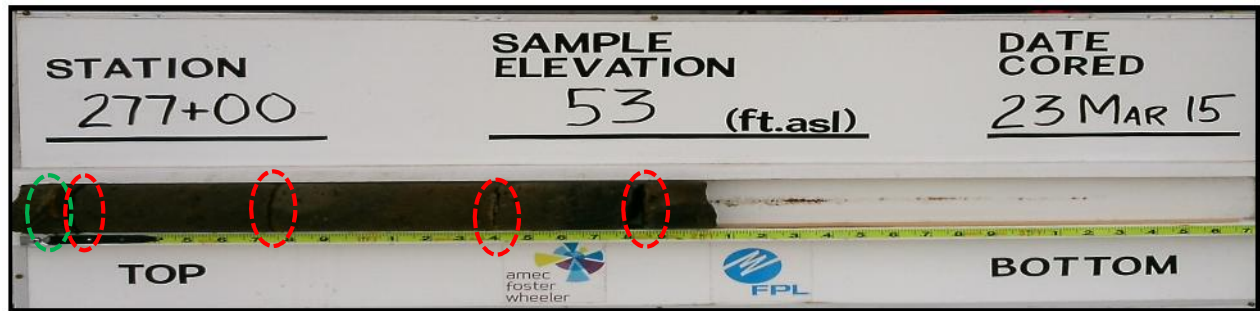
Location: STA 277+00

Core ID:	277+00 (bottom)	Date Cored:	3/23/15
Core Elevation:	53' ASL	Date Photographed:	3/23/15
Recovered Length (ft):	2.0	SC Thickness (ft):	2.42
RQD (%):	80	Void Depth (ft):	N/A
Notes:	Wood piece at 0.18 feet. Soft material 0.2 to 0.75 feet.

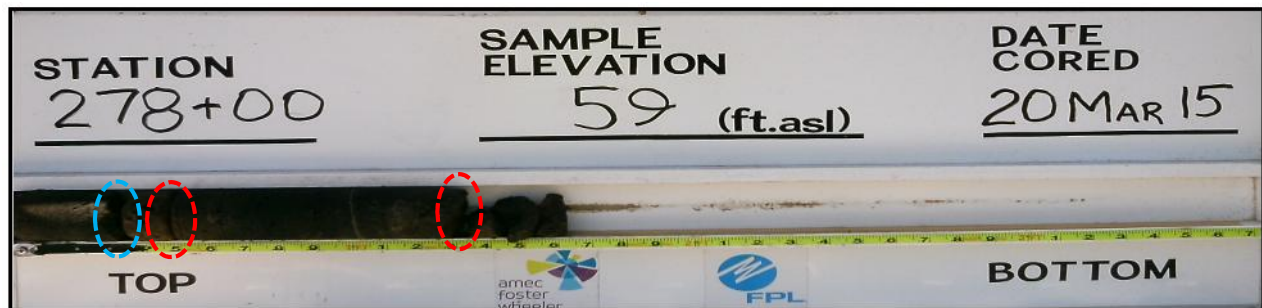
Location: STA 278+00

Core ID:	278+00 (middle)	Date Cored:	3/20/15
Core Elevation:	59' ASL	Date Photographed:	3/20/15
Recovered Length (ft):	1.6	SC Thickness (ft):	1.67
RQD (%):	31	Void Depth (ft):	N/A
Notes:	Soft material from 0 to 0.3 feet. Very soft material from 0.3 to 0.5 feet. Fragments from 1.3 to 1.6 feet.

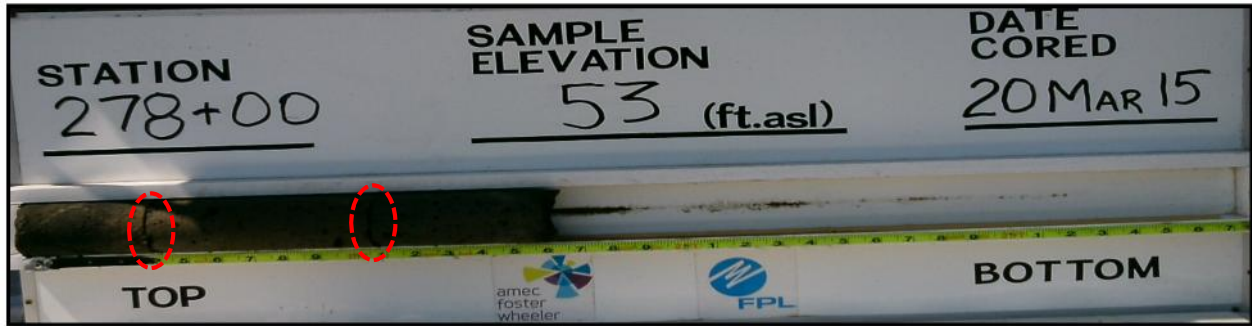
Location: STA 278+00

Core ID:	278+00 (bottom)	Date Cored:	3/20/15
Core Elevation:	53' ASL	Date Photographed:	3/20/15
Recovered Length (ft):	1.6	SC Thickness (ft):	1.6
RQD (%):	100	Void Depth (ft):	N/A
Notes:	Soft material from 0 to 0.4 feet.

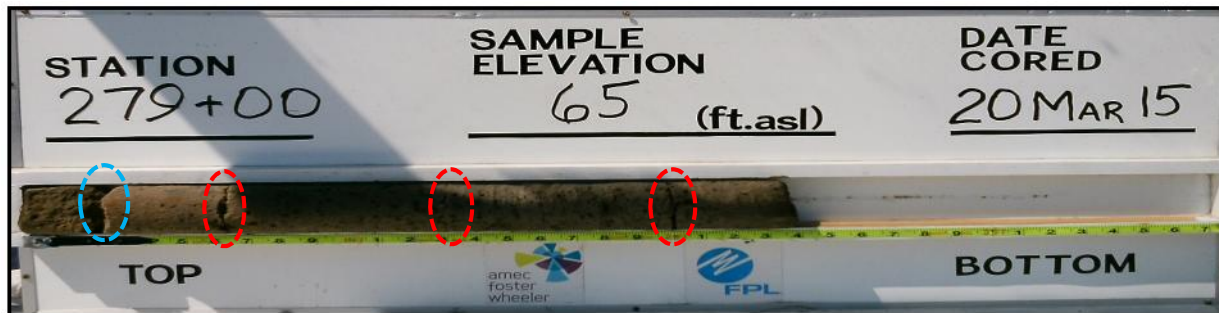
Location: STA 279+00

Core ID:	279+00 (top)	Date Cored:	3/20/15
Core Elevation:	65' ASL	Date Photographed:	3/20/15
Recovered Length (ft):	2.35	SC Thickness (ft):	2.35
RQD (%):	89	Void Depth (ft):	N/A
Notes:	Very soft material from 0 to 0.25 feet. Soft material from 0.25 to 0.64 feet.

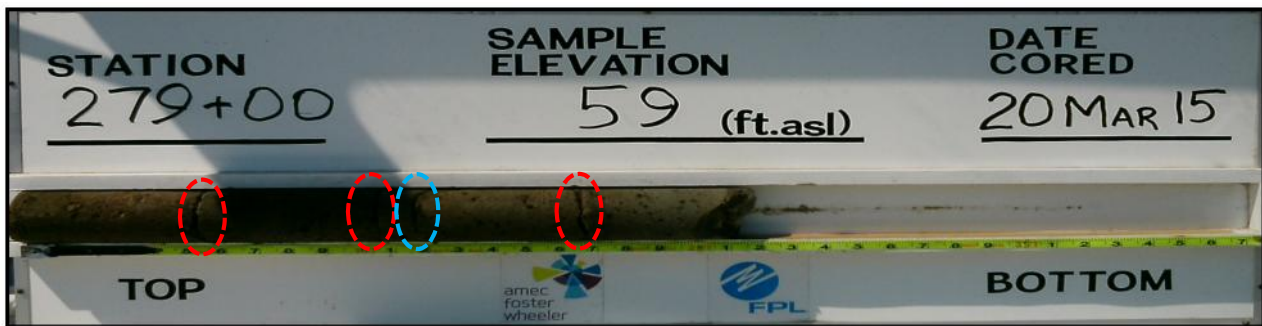
Location: STA 279+00

Core ID:	279+00 (middle)	Date Cored:	3/20/15
Core Elevation:	59' ASL	Date Photographed:	3/20/15
Recovered Length (ft):	2.1	SC Thickness (ft):	2.165
RQD (%):	94	Void Depth (ft):	N/A
Notes:	Very soft material from 0 to 0.55 feet. Soft material from 0.55 to 1.07 feet.

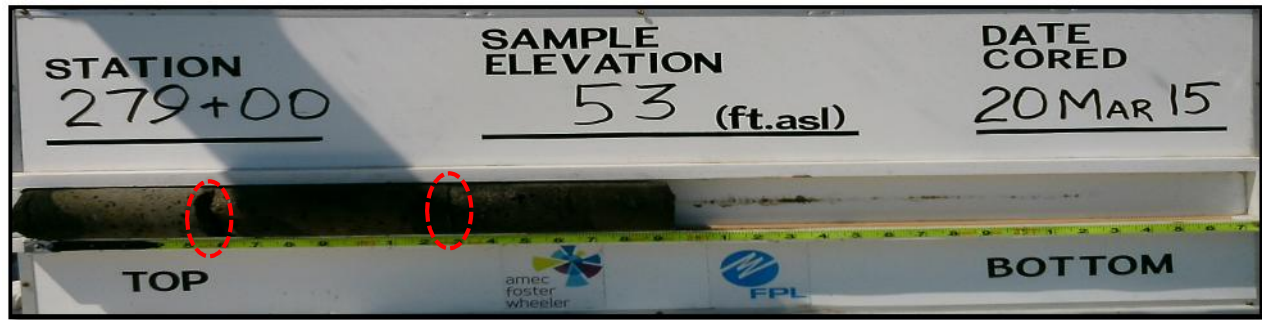
Location: STA 279+00

Core ID:	279+00 (bottom)	Date Cored:	3/20/15
Core Elevation:	53' ASL	Date Photographed:	3/20/15
Recovered Length (ft):	1.94	SC Thickness (ft):	2.165
RQD (%):	100	Void Depth (ft):	N/A
Notes:	Soft material from 0.58 to 1.28 feet.

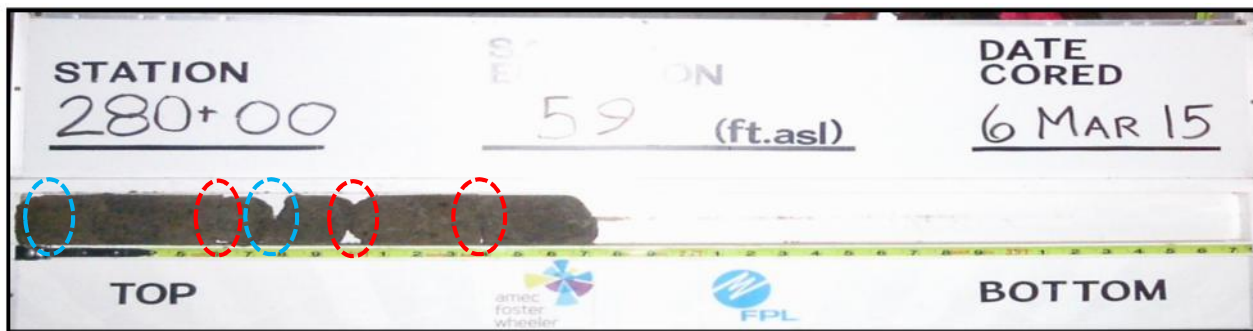
Location: STA 280+00

Core ID:	280+00 (middle)	Date Cored:	3/6/15
Core Elevation:	59' ASL	Date Photographed:	3/6/15
Recovered Length (ft):	1.65	SC Thickness (ft):	1.92
RQD (%):	44	Void Depth (ft):	N/A
Notes:	Soft material from 0 to 0.95 feet.

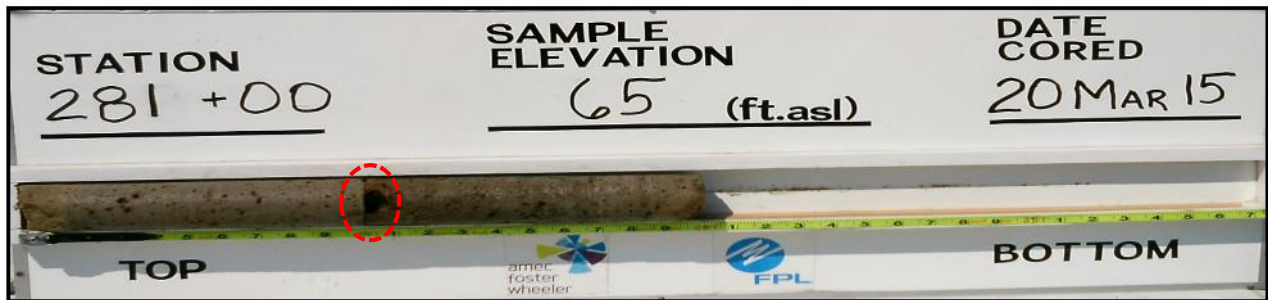
Location: STA 281+00

Core ID:	281+00 (top)	Date Cored:	3/20/15
Core Elevation:	65' ASL	Date Photographed:	3/20/15
Recovered Length (ft):	2.0	SC Thickness (ft):	2.165
RQD (%):	100	Void Depth (ft):	N/A
Notes:	Small void with rotting vegetation at 1.0 feet.

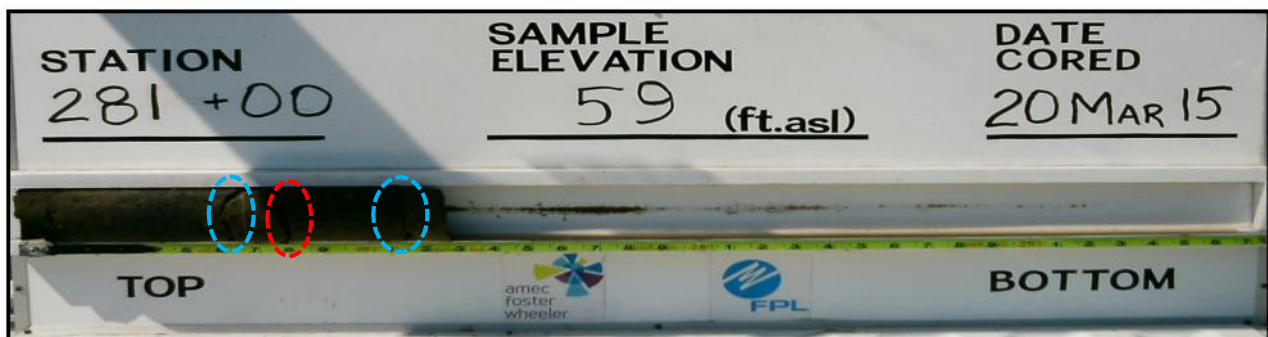
Location: STA 281+00

Core ID:	281+00 (middle)	Date Cored:	3/20/15
Core Elevation:	59' ASL	Date Photographed:	3/20/15
Recovered Length (ft):	1.25	SC Thickness (ft):	1.33
RQD (%):	50	Void Depth (ft):	N/A
Notes:	Soft material from 0 to 0.62 feet. Very soft material from 0.62 to 1.25 feet.

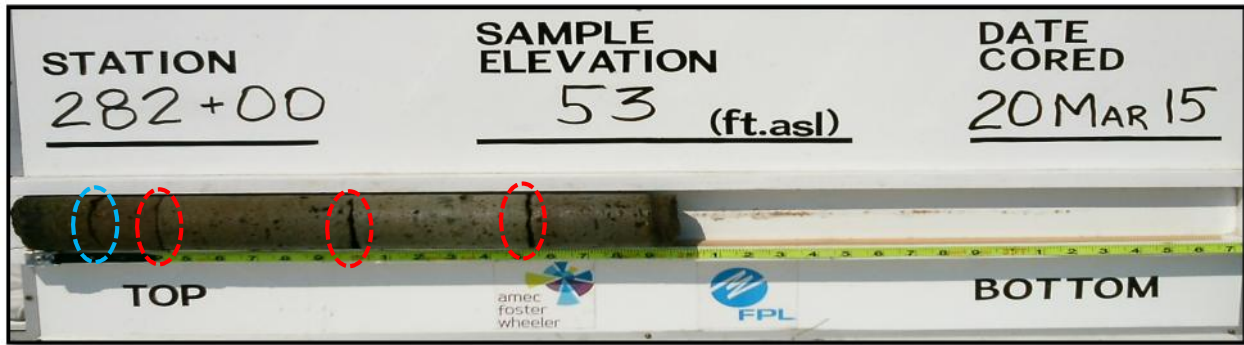
Location: STA 282+00

Core ID:	282+00 (bottom)	Date Cored:	3/20/15
Core Elevation:	53' ASL	Date Photographed:	3/20/15
Recovered Length (ft):	1.95	SC Thickness (ft):	2.0
RQD (%):	78	Void Depth (ft):	N/A
Notes:	Very soft material from 0 to 0.43 feet.

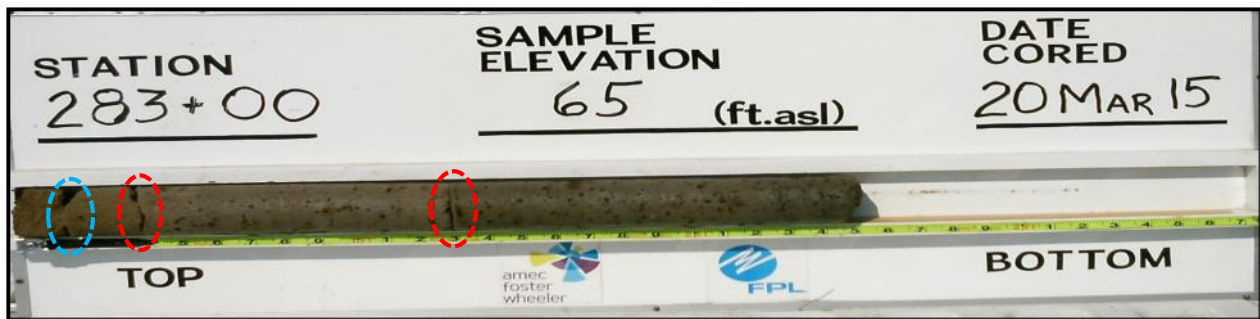
Location: STA 283+00

Core ID:	283+00 (top)	Date Cored:	3/20/15
Core Elevation:	65' ASL	Date Photographed:	3/20/15
Recovered Length (ft):	2.45	SC Thickness (ft):	2.58
RQD (%):	92	Void Depth (ft):	N/A
Notes:	Very soft material from 0 to 0.4 feet.

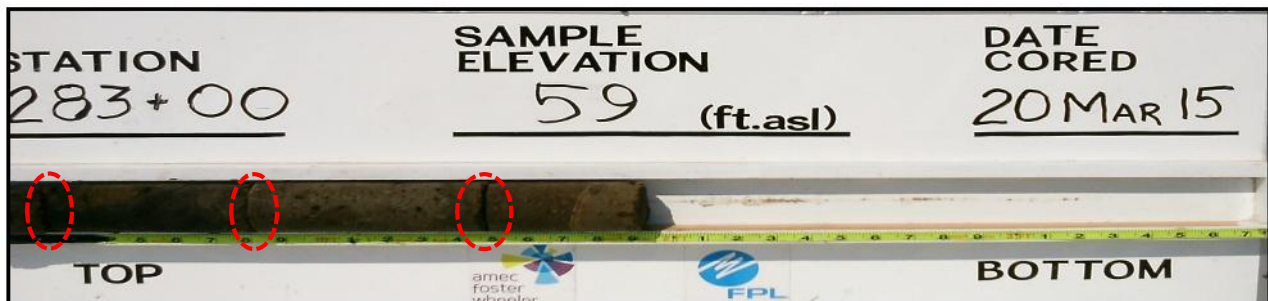
Location: STA 283+00

Core ID:	283+00 (middle)	Date Cored:	3/20/15
Core Elevation:	59' ASL	Date Photographed:	3/20/15
Recovered Length (ft):	1.9	SC Thickness (ft):	2.0
RQD (%):	87	Void Depth (ft):	N/A
Notes:	Very soft material from 0 to 0.83 feet.

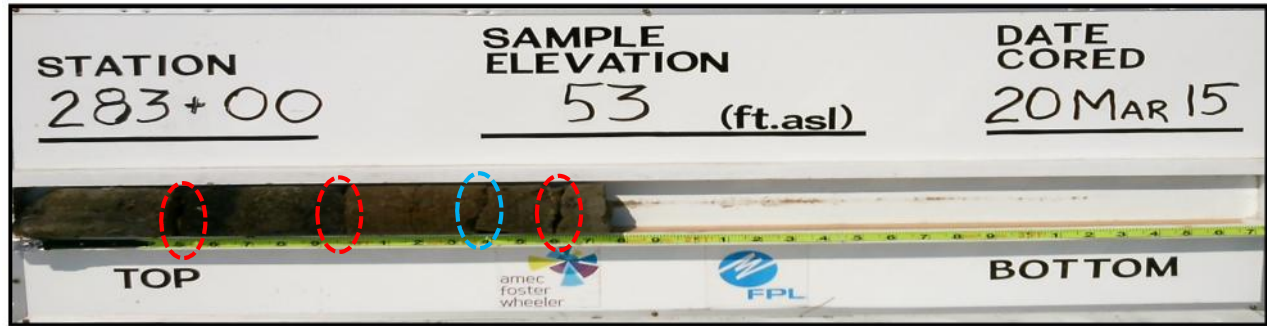
Location: STA 283+00

Core ID:	283+00 (bottom)	Date Cored:	3/20/15
Core Elevation:	53' ASL	Date Photographed:	3/20/15
Recovered Length (ft):	1.75	SC Thickness (ft):	2.0
RQD (%):	91	Void Depth (ft):	N/A
Notes:	Soft material from 0 to 0.5 feet. Very soft material from 0.5 to 0.98 feet. Soft material from 0.98 to 1.75 feet.

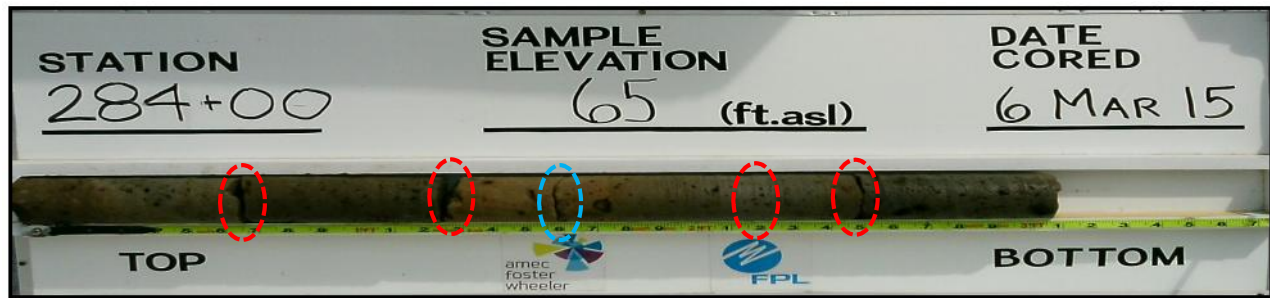
Location: STA 284+00

Core ID:	284+00 (top)	Date Cored:	3/6/15
Core Elevation:	65' ASL	Date Photographed:	3/6/15
Recovered Length (ft):	3.05	SC Thickness (ft):	3.05
RQD (%):	84	Void Depth (ft):	N/A
Notes:	Soft material from 1.25 to 1.75 feet.

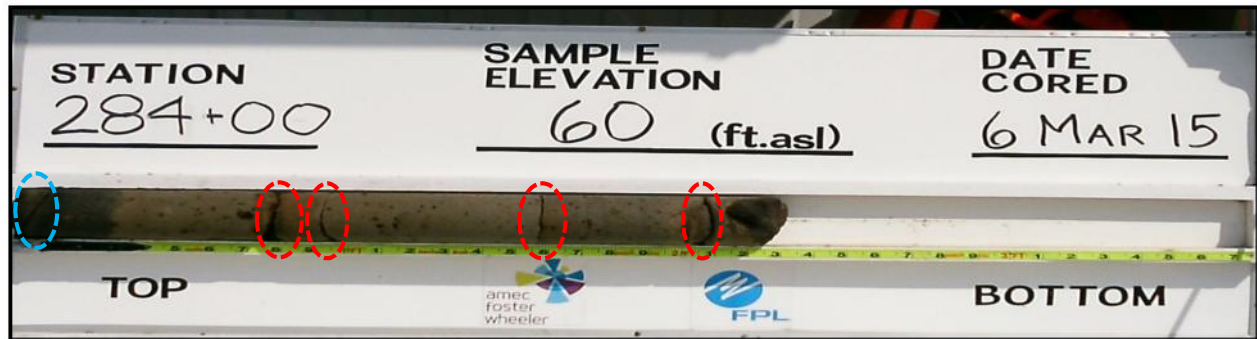
Location: STA 284+00

Core ID:	284+00 (middle)	Date Cored:	3/6/15
Core Elevation:	60' ASL	Date Photographed:	3/6/15
Recovered Length (ft):	2.25	SC Thickness (ft):	2.9
RQD (%):	77	Void Depth (ft):	N/A
Notes:	Soft material from 0 to 0.1, 0.75 to 0.95, and 2.05 to 2.25 feet.

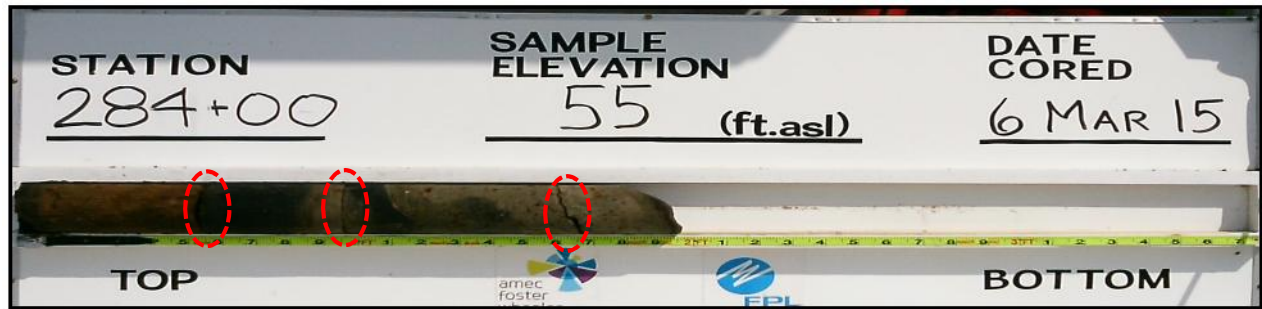
Location: STA 284+00

Core ID:	284+00 (bottom)	Date Cored:	3/6/15
Core Elevation:	55' ASL	Date Photographed:	3/6/15
Recovered Length (ft):	1.8	SC Thickness (ft):	2.6
RQD (%):	100	Void Depth (ft):	N/A
Notes:	Very soft material from 0 to 0.55 feet.

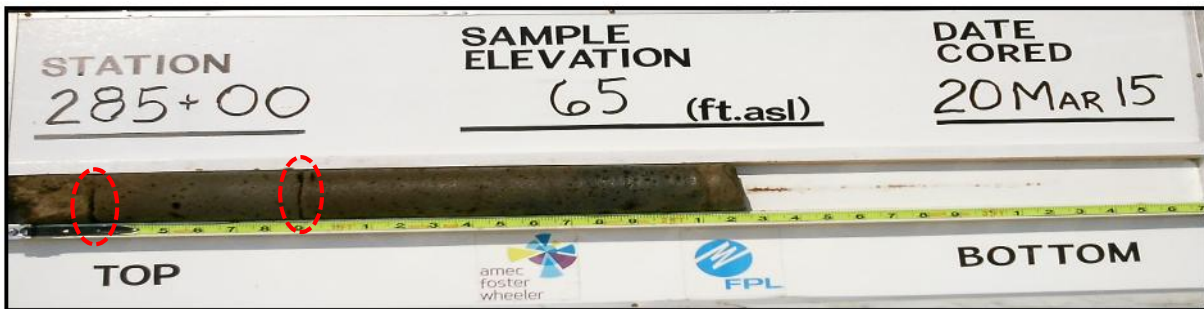
Location: STA 285+00

Core ID:	285+00 (top)	Date Cored:	3/20/15
Core Elevation:	65' ASL	Date Photographed:	3/20/15
Recovered Length (ft):	2.2	SC Thickness (ft):	2.25
RQD (%):	86	Void Depth (ft):	N/A
Notes:	Very soft material from 0 to 0.45 feet.

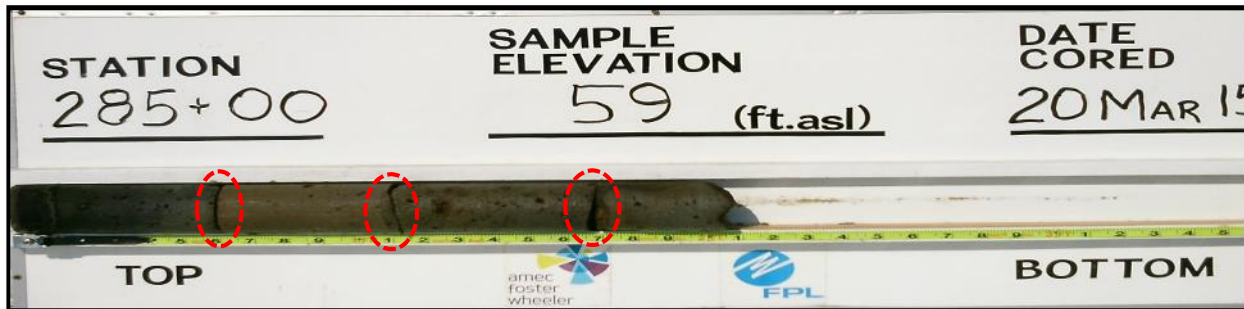
Location: STA 285+00

Core ID:	285+00 (middle)	Date Cored:	3/20/15
Core Elevation:	59' ASL	Date Photographed:	3/20/15
Recovered Length (ft):	2.03	SC Thickness (ft):	2.5
RQD (%):	100	Void Depth (ft):	N/A
Notes:	Soft material from 1.65 to 2.03 feet.

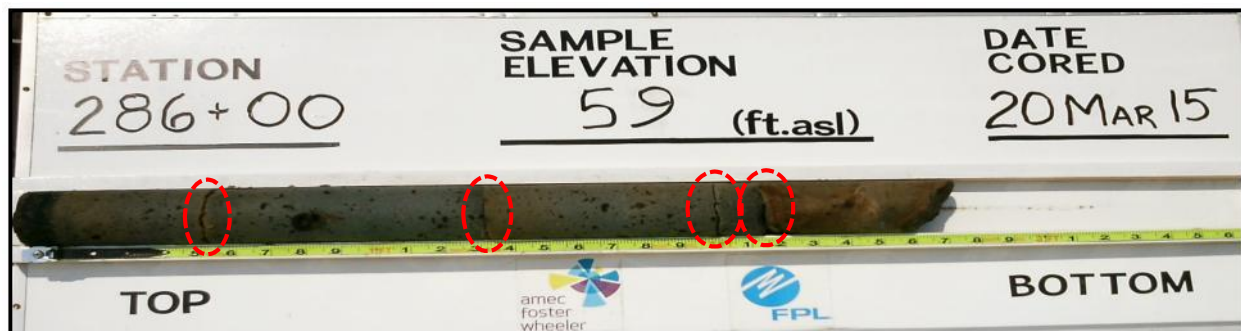
Location: STA 286+00

Core ID:	286+00 (middle)	Date Cored:	3/20/15
Core Elevation:	59' ASL	Date Photographed:	3/20/15
Recovered Length (ft):	2.6	SC Thickness (ft):	2.83
RQD (%):	100	Void Depth (ft):	N/A
Notes:	Very soft material from 2.14 to 2.6 feet.

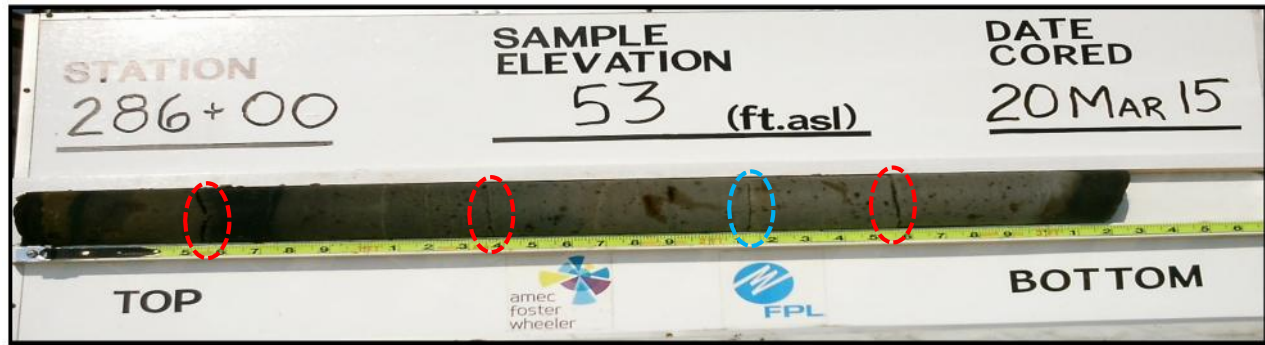
Location: STA 286+00

Core ID:	286+00 (bottom)	Date Cored:	3/20/15
Core Elevation:	53' ASL	Date Photographed:	3/20/15
Recovered Length (ft):	3.2	SC Thickness (ft):	3.33
RQD (%):	100	Void Depth (ft):	N/A
Notes:	Very soft material from 0 to 0.54 feet.

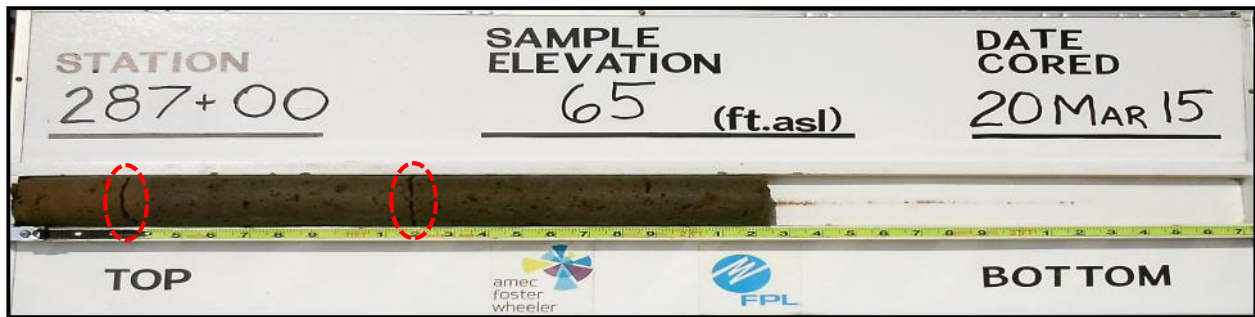
Location: STA 287+00

Core ID:	287+00 (top)	Date Cored:	3/20/15
Core Elevation:	65' ASL	Date Photographed:	3/20/15
Recovered Length (ft):	2.22	SC Thickness (ft):	2.25
RQD (%):	100	Void Depth (ft):	N/A
Notes:	Very soft material from 0 to 0.35 feet. Soft material from 0.35 to 2.22 feet.

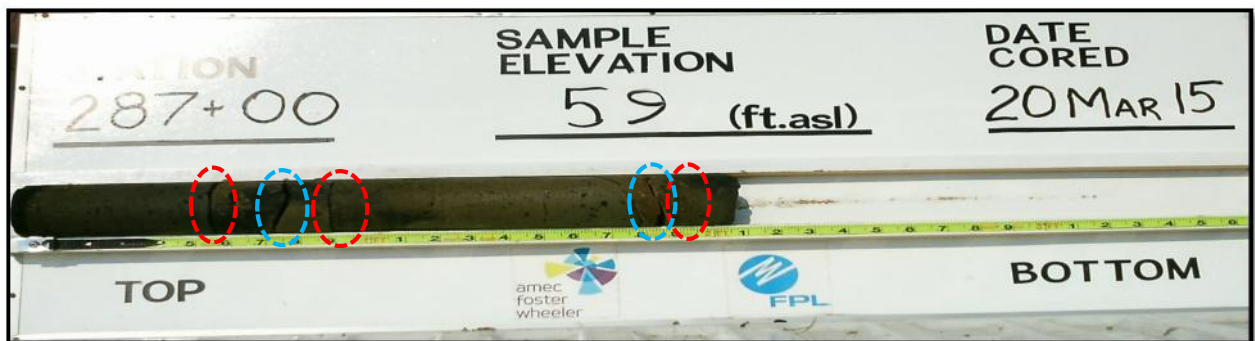
Location: STA 287+00

Core ID:	287+00 (middle)	Date Cored:	3/20/15
Core Elevation:	59' ASL	Date Photographed:	3/20/15
Recovered Length (ft):	2.05	SC Thickness (ft):	2.25
RQD (%):	84	Void Depth (ft):	N/A
Notes:	Very soft material from 0.55 to 0.9 and 1.83 to 2.05 feet.

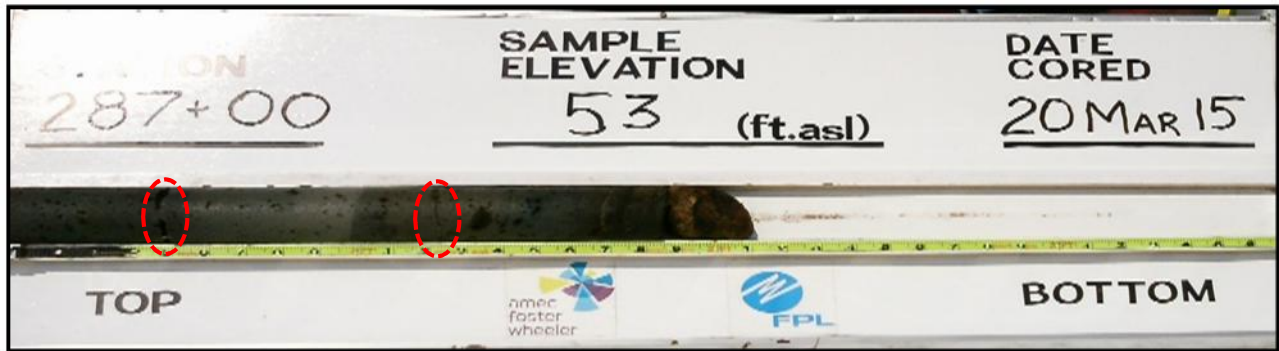
Location: STA 287+00

Core ID:	287+00 (bottom)	Date Cored:	3/20/15
Core Elevation:	53' ASL	Date Photographed:	3/20/15
Recovered Length (ft):	1.85	SC Thickness (ft):	2.33
RQD (%):	100	Void Depth (ft):	N/A
Notes:	Insitu soil from 1.85 to 2.05 feet.

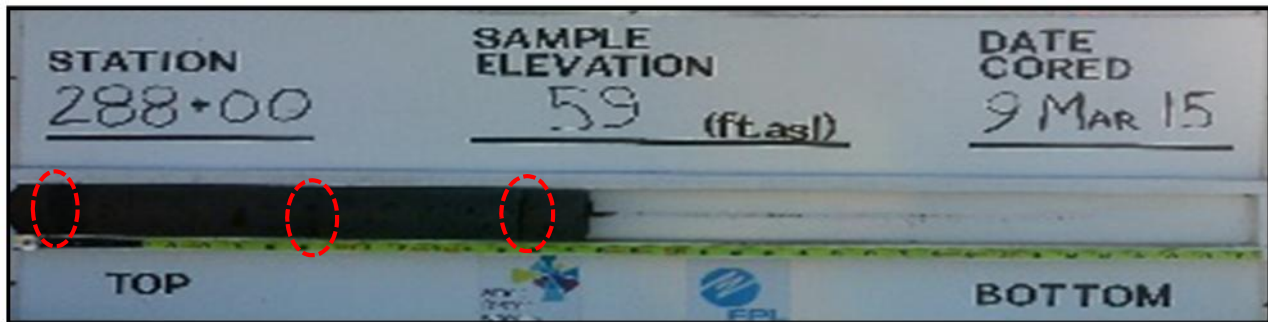
Location: STA 288+00

Core ID:	288+00 (middle)	Date Cored:	3/9/15
Core Elevation:	59' ASL	Date Photographed:	3/9/15
Recovered Length (ft):	1.75	SC Thickness (ft):	2.67
RQD (%):	80	Void Depth (ft):	N/A
Notes:	Soft material from 0 to 0.15 feet.

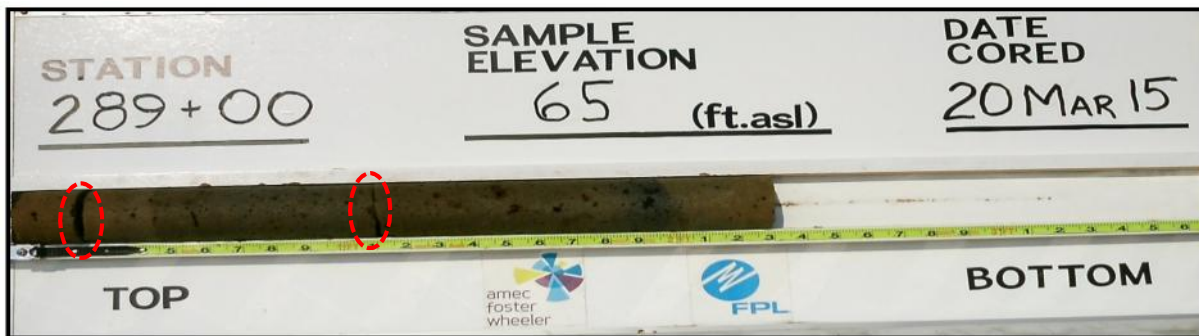
Location: STA 289+00

Core ID:	289+00 (top)	Date Cored:	3/20/15
Core Elevation:	65' ASL	Date Photographed:	3/20/15
Recovered Length (ft):	2.3	SC Thickness (ft):	2.33
RQD (%):	89	Void Depth (ft):	N/A
Notes:	Very soft material from 0 to 0.25 feet. Soft material from 0.25 to 2.3 feet.

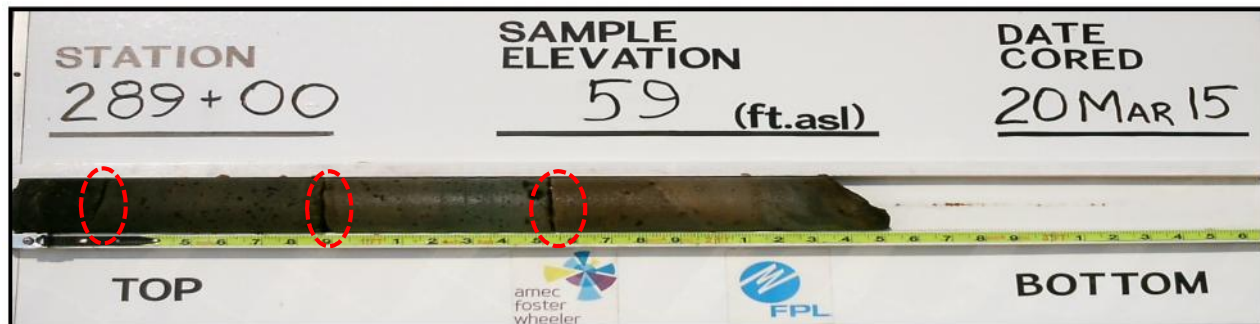
Location: STA 289+00

Core ID:	289+00 (middle)	Date Cored:	3/20/15
Core Elevation:	59' ASL	Date Photographed:	3/20/15
Recovered Length (ft):	2.35	SC Thickness (ft):	2.67
RQD (%):	89	Void Depth (ft):	N/A
Notes:	Very soft material from 0 to 0.25 feet. Soft material from 0.25 to 2.35 feet.

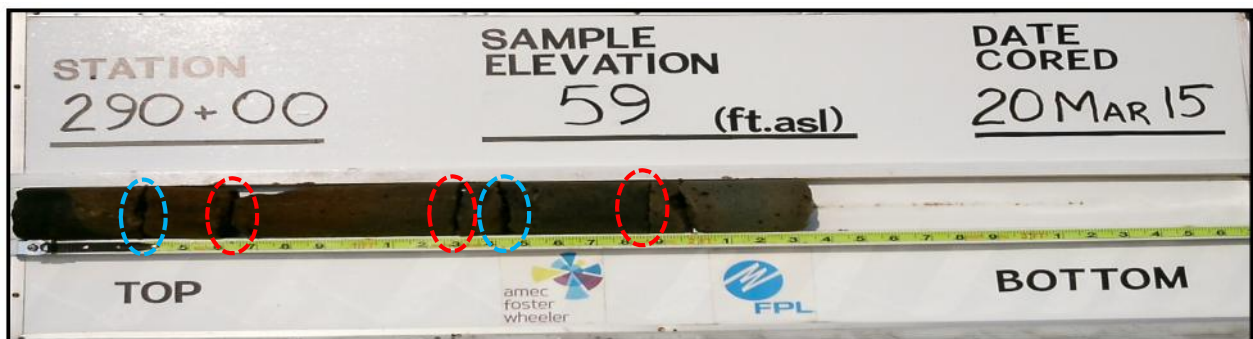
Location: STA 290+00

Core ID:	290+00 (middle)	Date Cored:	3/20/15
Core Elevation:	59' ASL	Date Photographed:	3/20/15
Recovered Length (ft):	2.3	SC Thickness (ft):	2.5
RQD (%):	70	Void Depth (ft):	N/A
Notes:	Very soft material from 0 to 2.0 feet. Soft material between 2.0 to 2.3 feet.

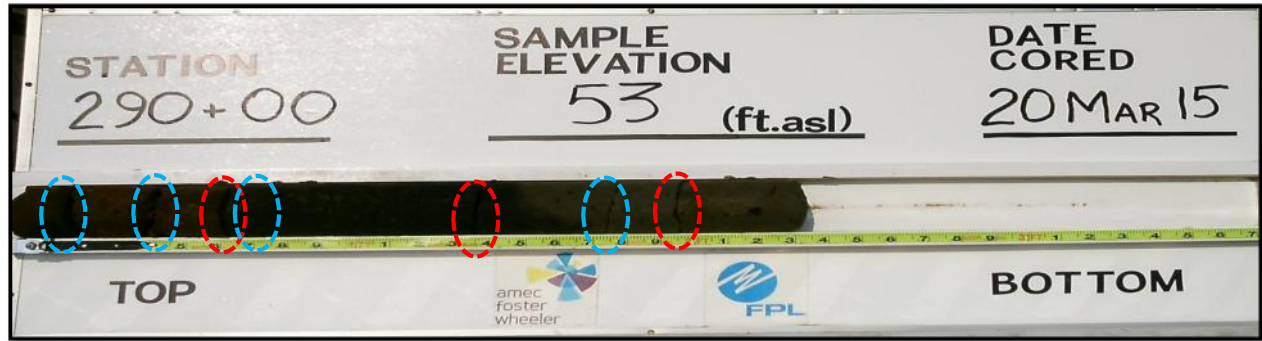
Location: STA 290+00

Core ID:	290+00 (bottom)	Date Cored:	3/20/15
Core Elevation:	53' ASL	Date Photographed:	3/20/15
Recovered Length (ft):	2.3	SC Thickness (ft):	2.42
RQD (%):	60	Void Depth (ft):	N/A
Notes:	Very soft material from 0 to 0.6 feet. Soft material 0.6 to 1.35 feet.

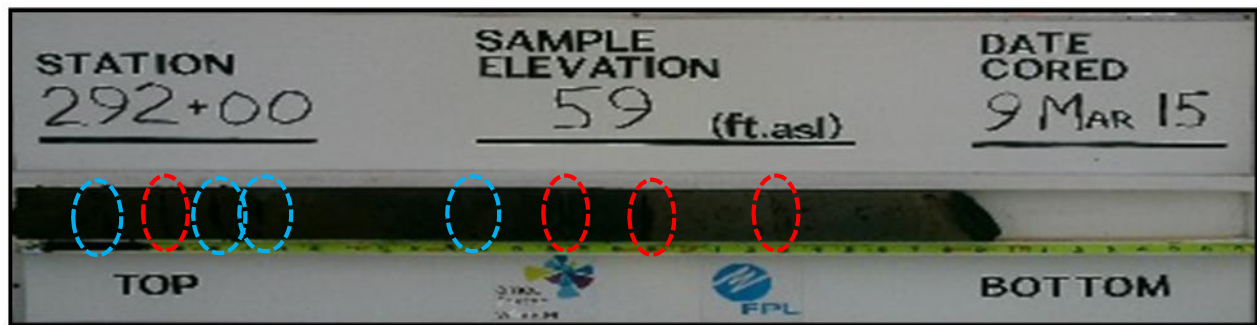
Location: STA 292+00

Core ID:	292+00 (middle)	Date Cored:	3/9/15
Core Elevation:	59' ASL	Date Photographed:	3/9/15
Recovered Length (ft):	5.9	SC Thickness (ft):	3.0
RQD (%):	2.85	Void Depth (ft):	N/A
Notes:	Very soft material from 0 to 1.0 feet.

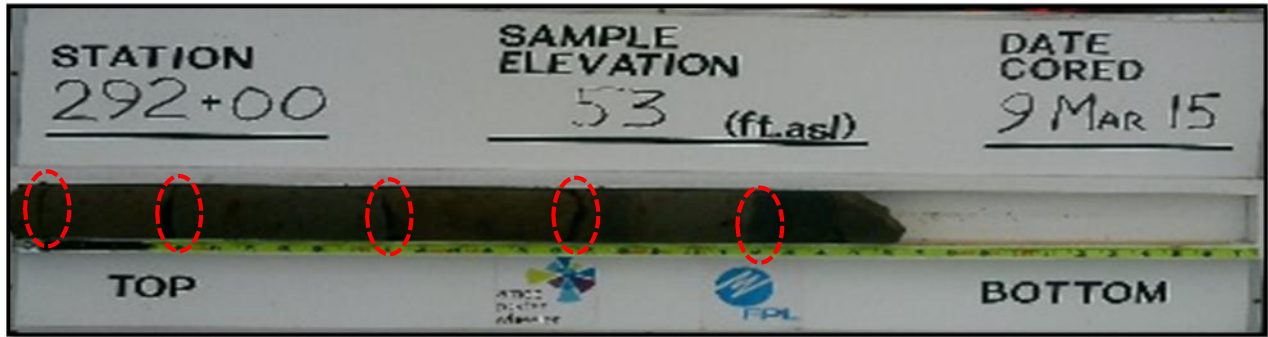
Location: STA 292+00

Core ID:	292+00 (bottom)	Date Cored:	3/9/15
Core Elevation:	53' ASL	Date Photographed:	3/9/15
Recovered Length (ft):	2.55	SC Thickness (ft):	2.67
RQD (%):	90	Void Depth (ft):	N/A
Notes:	Soft material from 0 to 0.1 feet. Very soft material from 1.1 to 1.65 feet.

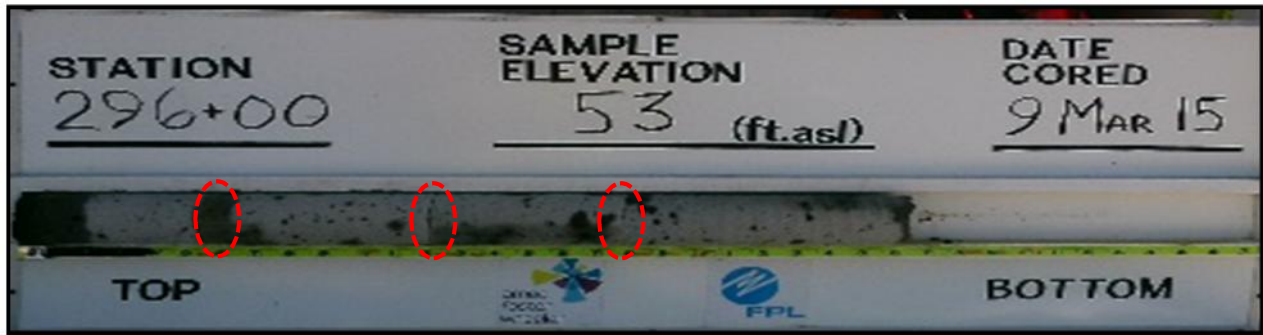
Location: STA 296+00

Core ID:	296+00 (bottom)	Date Cored:	3/9/15
Core Elevation:	53' ASL	Date Photographed:	3/9/15
Recovered Length (ft):	2.6	SC Thickness (ft):	2.6
RQD (%):	100	Void Depth (ft):	N/A
Notes:

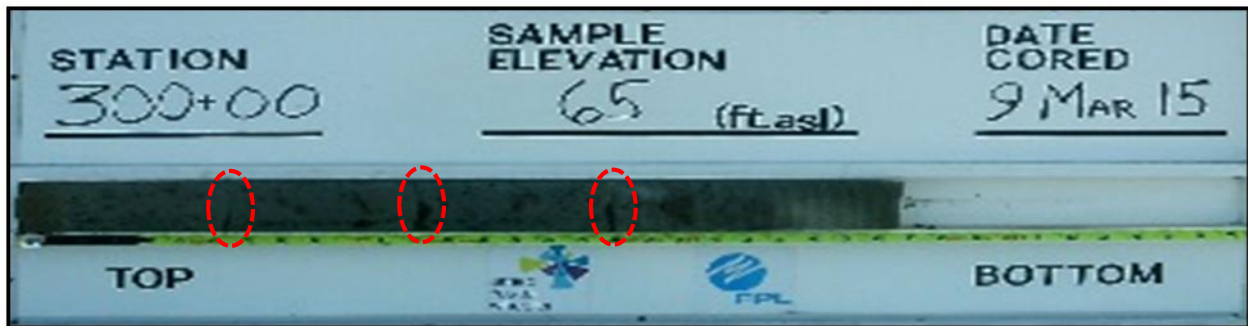
Location: STA 300+00

Core ID:	300+00 (top)	Date Cored:	3/9/15
Core Elevation:	65' ASL	Date Photographed:	3/9/15
Recovered Length (ft):	2.6	SC Thickness (ft):	2.92
RQD (%):	100	Void Depth (ft):	N/A
Notes:

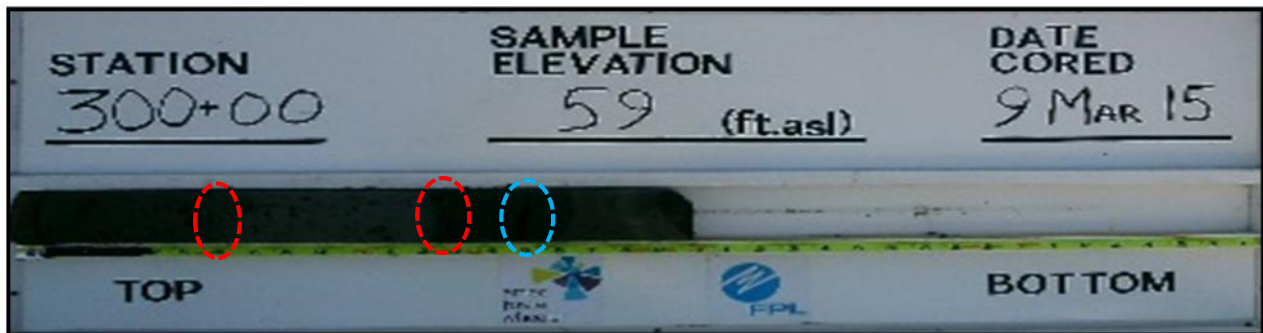
Location: STA 300+00

Core ID:	300+00 (middle)	Date Cored:	3/9/15
Core Elevation:	59' ASL	Date Photographed:	3/9/15
Recovered Length (ft):	1.95	SC Thickness (ft):	2.0
RQD (%):	84	Void Depth (ft):	N/A
Notes:	Soft material from 0 to 0.1 and 1.25 to 1.47 feet.

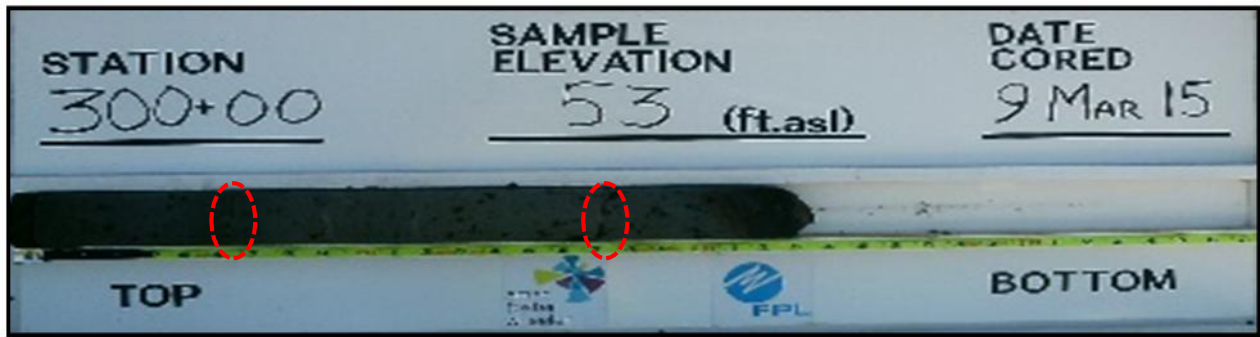
Location: STA 300+00

Core ID:	300+00 (bottom)	Date Cored:	3/9/15
Core Elevation:	53' ASL	Date Photographed:	3/9/15
Recovered Length (ft):	2.5	SC Thickness (ft):	2.75
RQD (%):	99	Void Depth (ft):	N/A
Notes:	Soft material from 0 to 0.1 feet.

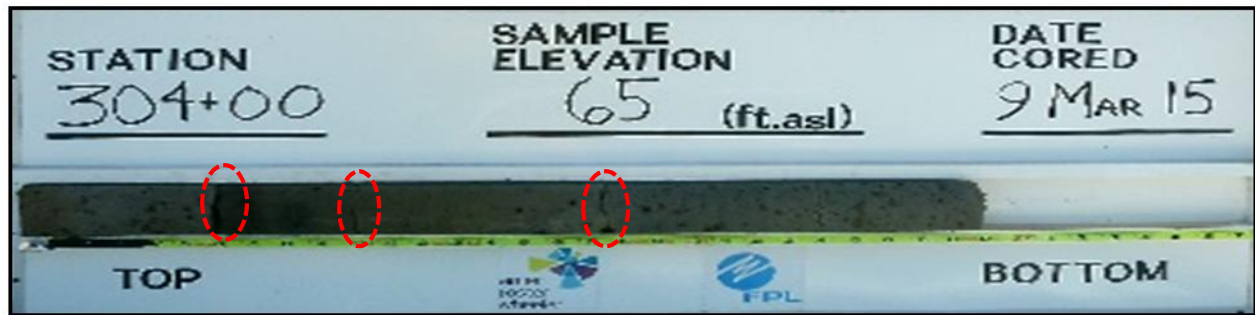
Location: STA 304+00

Core ID:	304+00 (top)	Date Cored:	3/9/15
Core Elevation:	65' ASL	Date Photographed:	3/9/15
Recovered Length (ft):	2.85	SC Thickness (ft):	2.85
RQD (%):	100	Void Depth (ft):	N/A
Notes:

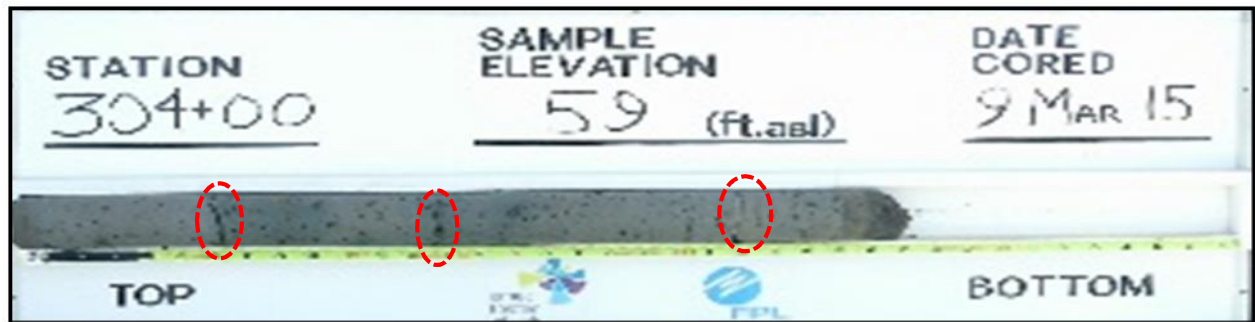
Location: STA 304+00

Core ID:	304+00 (middle)	Date Cored:	3/9/15
Core Elevation:	59' ASL	Date Photographed:	3/9/15
Recovered Length (ft):	2.55	SC Thickness (ft):	2.83
RQD (%):	100	Void Depth (ft):	N/A
Notes:	Insitu soil from 2.55 to 2.6 feet.

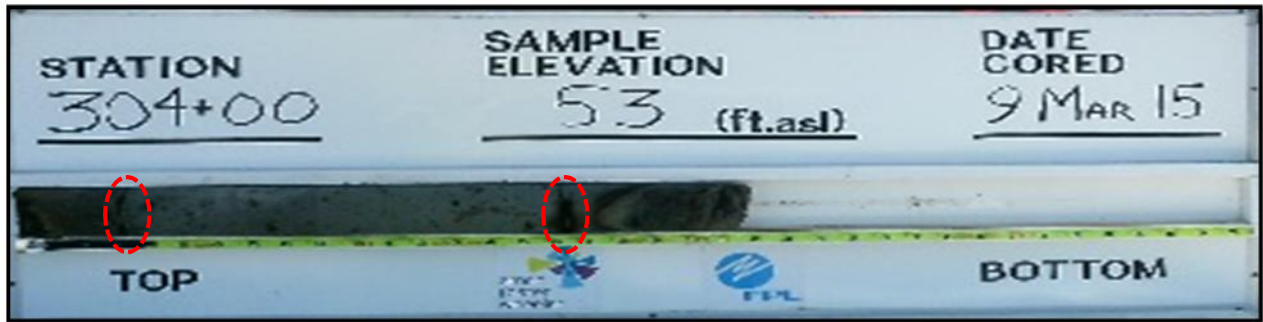
Location: STA 304+00

Core ID:	304+00 (bottom)	Date Cored:	3/9/15
Core Elevation:	53' ASL	Date Photographed:	3/9/15
Recovered Length (ft):	2.0	SC Thickness (ft):	2.58
RQD (%):	100	Void Depth (ft):	N/A
Notes:	Soft material from 0 to 0.35 feet. Insitu soil from 2.0 to 2.15 feet.

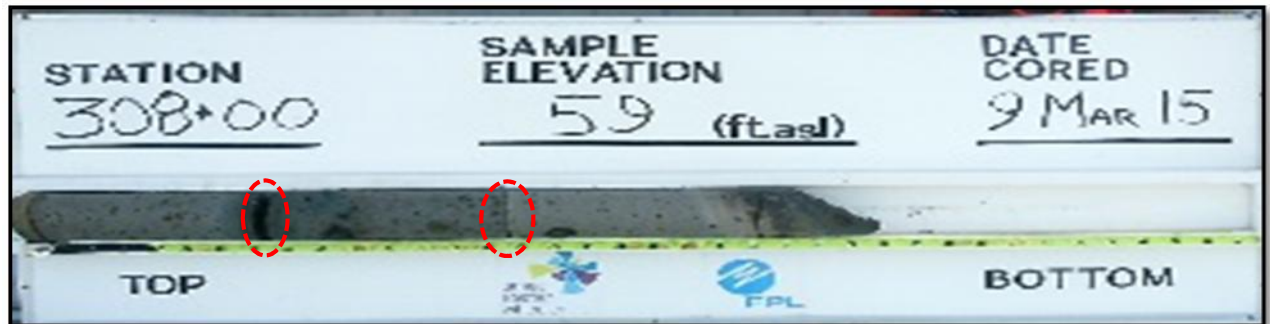
Location: STA 308+00

Core ID:	308+00 (middle)	Date Cored:	3/9/15
Core Elevation:	59' ASL	Date Photographed:	3/9/15
Recovered Length (ft):	2.45	SC Thickness (ft):	2.83
RQD (%):	86	Void Depth (ft):	N/A
Notes:	Soft material from 0 to 0.1 feet. Insitu soil from 2.2 to 2.45 feet.

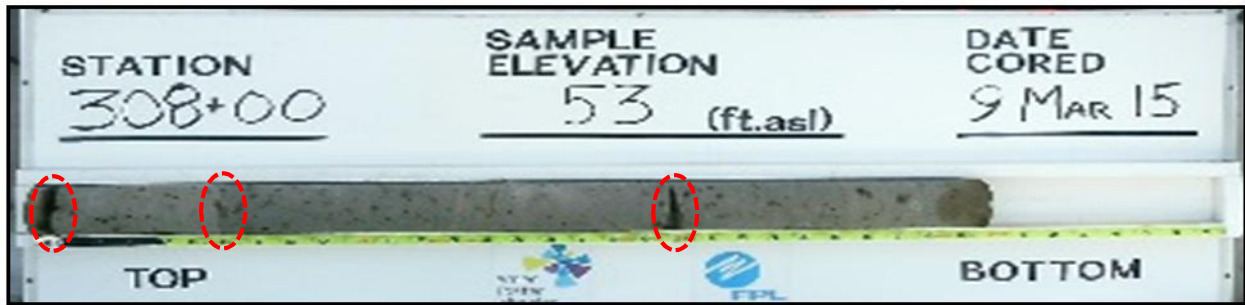
Location: STA 308+00

Core ID:	308+00 (bottom)	Date Cored:	3/9/15
Core Elevation:	53' ASL	Date Photographed:	3/9/15
Recovered Length (ft):	2.95	SC Thickness (ft):	3.33
RQD (%):	99	Void Depth (ft):	N/A
Notes:	Soft material from 0 to 0.1 feet.

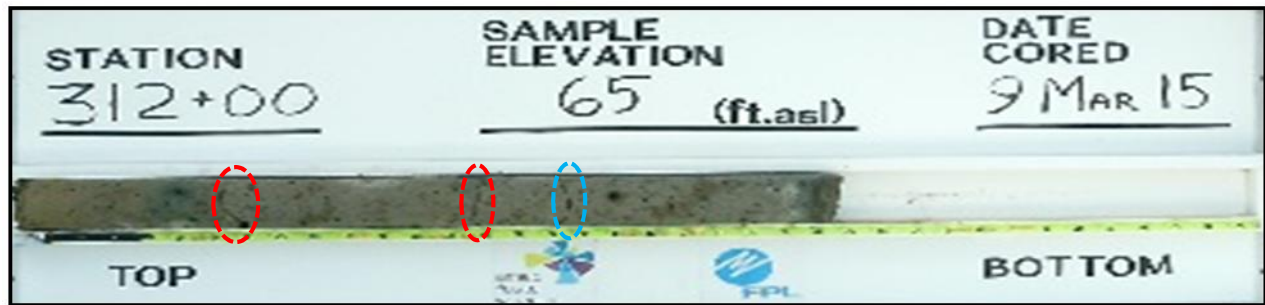
Location: STA 312+00

Core ID:	312+00 (top)	Date Cored:	3/9/15
Core Elevation:	65' ASL	Date Photographed:	3/9/15
Recovered Length (ft):	2.4	SC Thickness (ft):	2.6
RQD (%):	90	Void Depth (ft):	N/A
Notes:	Soft material from 0 to 0.2 feet.

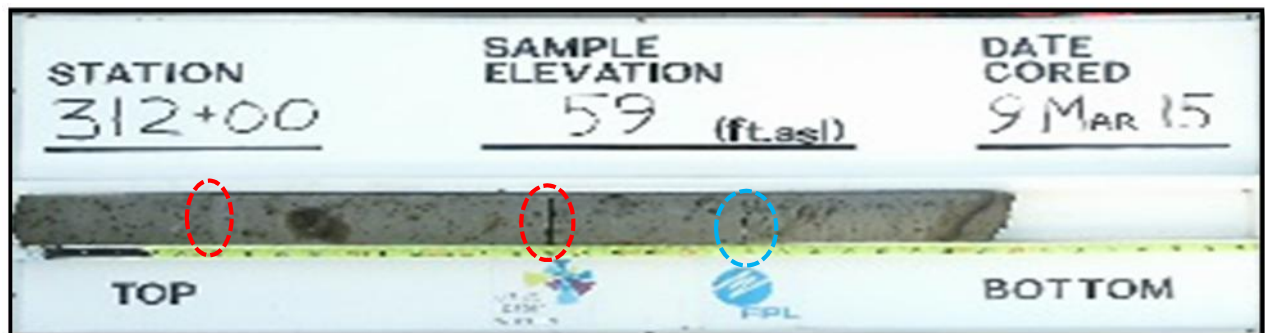
Location: STA 312+00

Core ID:	312+00 (middle)	Date Cored:	3/9/15
Core Elevation:	59' ASL	Date Photographed:	3/9/15
Recovered Length (ft):	2.95	SC Thickness (ft):	3.165
RQD (%):	100	Void Depth (ft):	N/A
Notes:

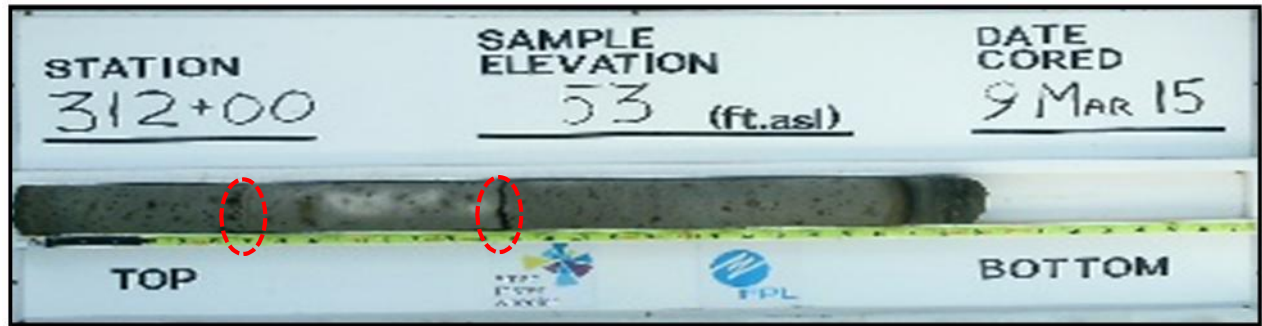
Location: STA 312+00

Core ID:	312+00 (bottom)	Date Cored:	3/9/15
Core Elevation:	53' ASL	Date Photographed:	3/9/15
Recovered Length (ft):	2.77	SC Thickness (ft):	3.0
RQD (%):	100	Void Depth (ft):	N/A
Notes:	Insitu soil from 2.77 to 2.87 feet.

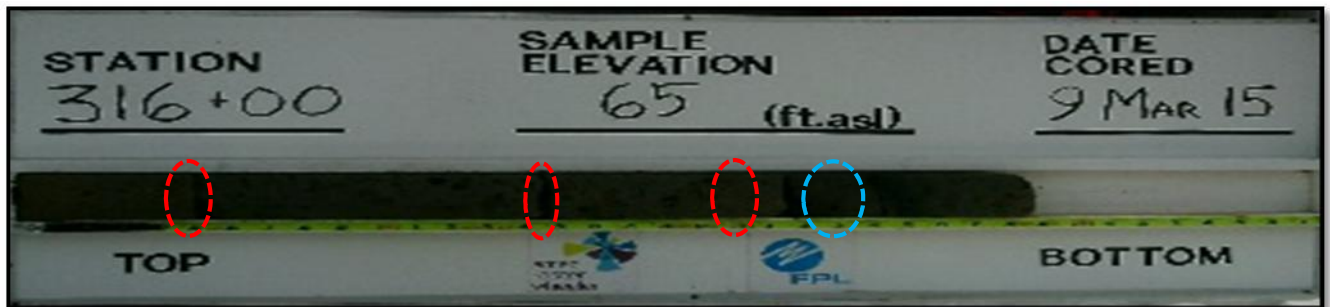
Location: STA 316+00

Core ID:	316+00 (top)	Date Cored:	3/9/15
Core Elevation:	65' ASL	Date Photographed:	3/9/15
Recovered Length (ft):	2.8	SC Thickness (ft):	2.8
RQD (%):	89	Void Depth (ft):	N/A
Notes:

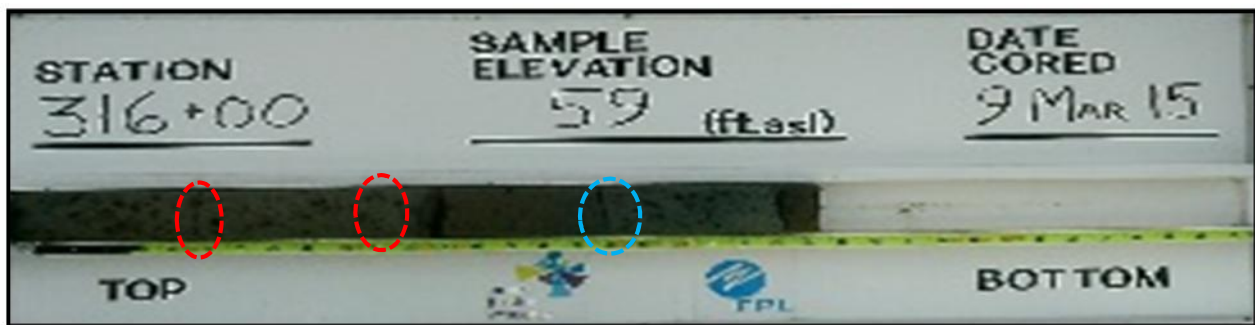
Location: STA 316+00

Core ID:	316+00 (middle)	Date Cored:	3/9/15
Core Elevation:	59' ASL	Date Photographed:	3/9/15
Recovered Length (ft):	2.25	SC Thickness (ft):	2.4
RQD (%):	100	Void Depth (ft):	N/A
Notes:	Insitu soil from 2.25 to 2.4 feet.

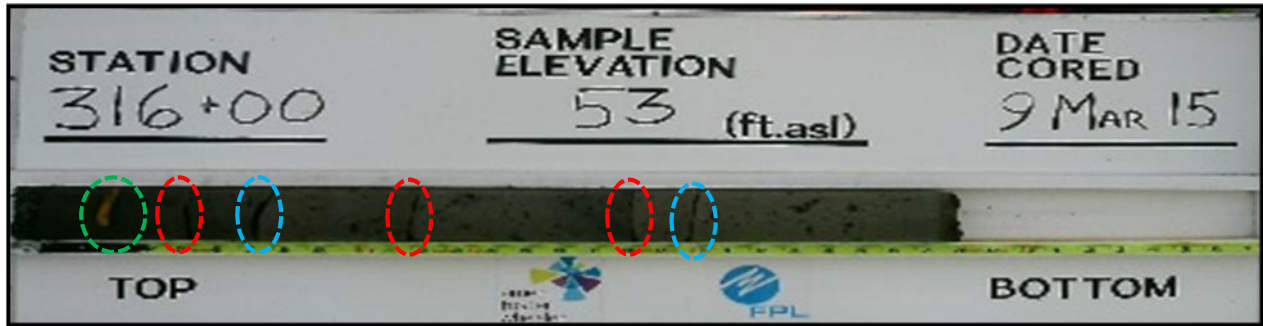
Location: STA 316+00

Core ID:	316+00 (bottom)	Date Cored:	3/9/15
Core Elevation:	53' ASL	Date Photographed:	3/9/15
Recovered Length (ft):	2.75	SC Thickness (ft):	2.83
RQD (%):	87	Void Depth (ft):	N/A
Notes:	Wood piece embedded at 0.3 feet.

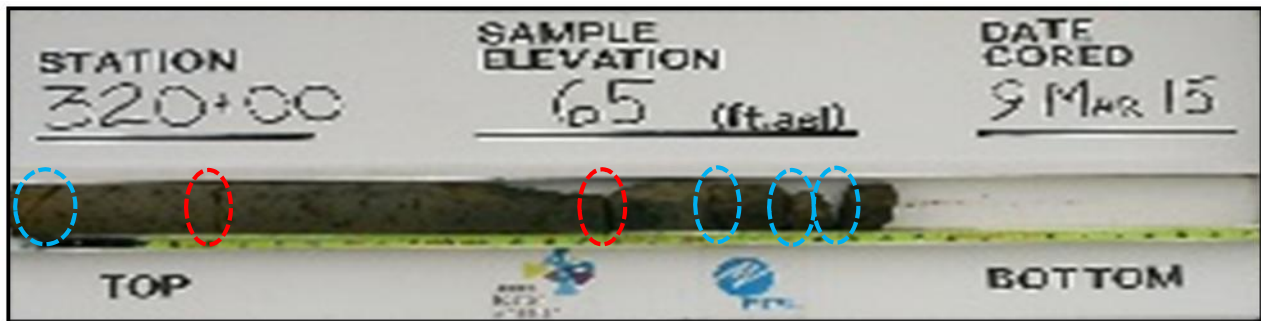
Location: STA 320+00

Core ID:	320+00 (top)	Date Cored:	3/9/15
Core Elevation:	65' ASL	Date Photographed:	3/9/15
Recovered Length (ft):	2.6	SC Thickness (ft):	3.26
RQD (%):	38	Void Depth (ft):	N/A
Notes:	Soft material from 0 to 0.2 feet.
