**Assessment and Design Report
Soil-Cement Condition Assessment and Design Project
Manatee Plant Cooling Pond Dam
Parrish, Florida
Project Number 300906**

To: Mr. Lewis Rounds, P.E.
FPL Manatee Plant

Date: June 2015

From: Jeff Beriswill
Amec Foster Wheeler Environment & Infrastructure, Inc.

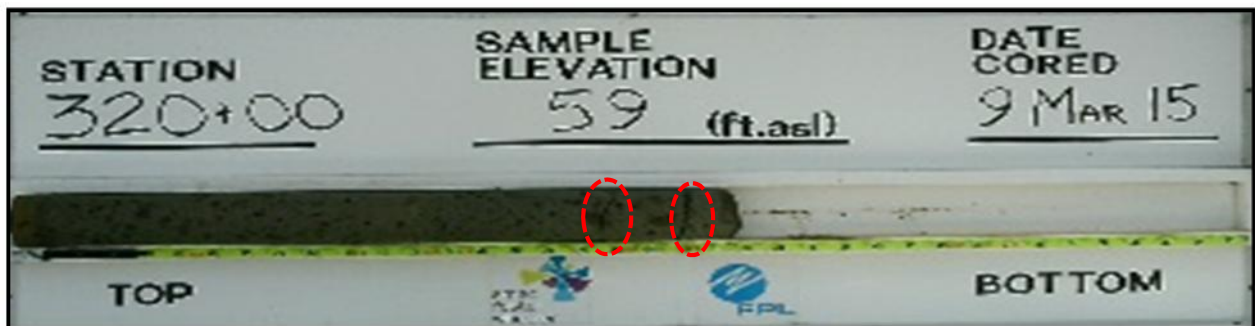
Location: STA 320+00

Core ID:	320+00 (middle)	Date Cored:	3/9/15
Core Elevation:	59' ASL	Date Photographed:	3/9/15
Recovered Length (ft):	2.15	SC Thickness (ft):	2.5
RQD (%):	81	Void Depth (ft):	N/A
Notes:

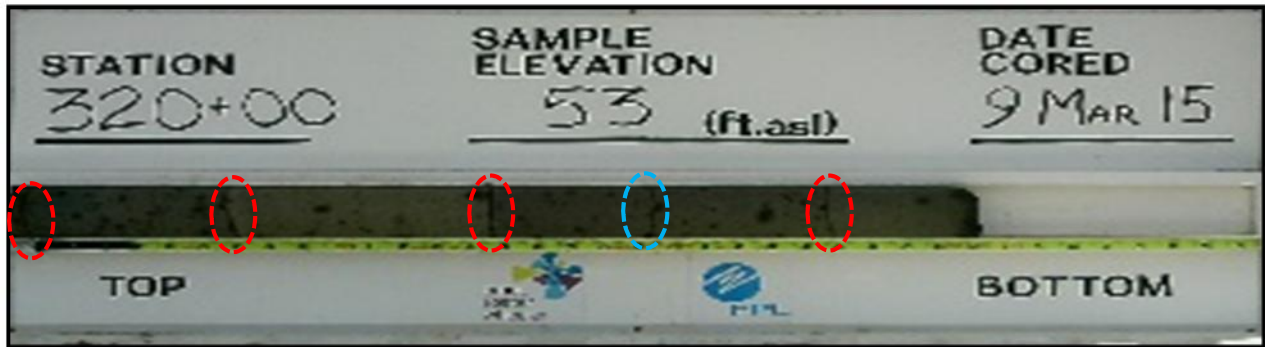
Location: STA 320+00

Core ID:	320+00 (bottom)	Date Cored:	3/9/15
Core Elevation:	53' ASL	Date Photographed:	3/9/15
Recovered Length (ft):	2.9	SC Thickness (ft):	3.0
RQD (%):	99	Void Depth (ft):	N/A
Notes:

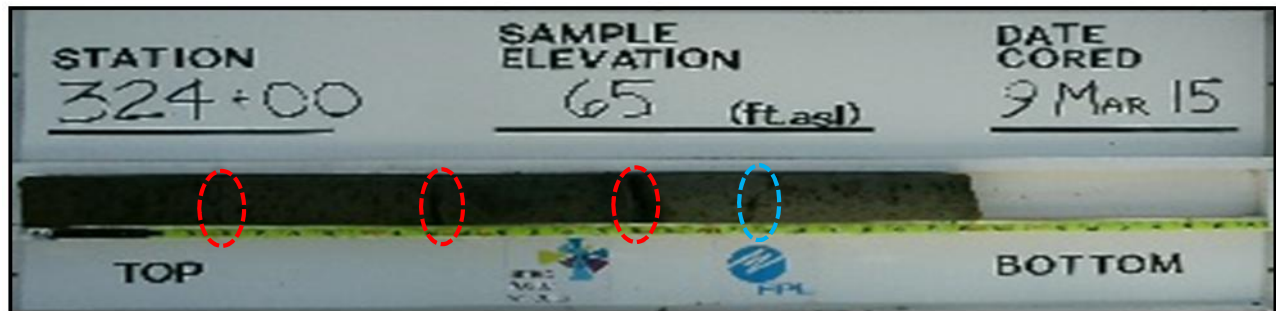
Location: STA 324+00

Core ID:	324+00 (top)	Date Cored:	3/9/15
Core Elevation:	65' ASL	Date Photographed:	3/9/15
Recovered Length (ft):	2.8	SC Thickness (ft):	2.8
RQD (%):	100	Void Depth (ft):	N/A
Notes:

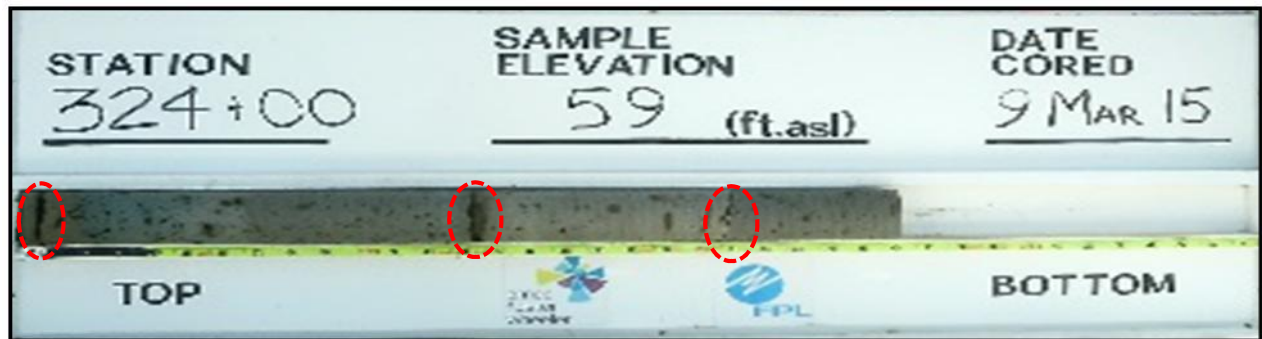
Location: STA 324+00

Core ID:	324+00 (middle)	Date Cored:	3/9/15
Core Elevation:	59' ASL	Date Photographed:	3/9/15
Recovered Length (ft):	2.6	SC Thickness (ft):	2.6
RQD (%):	99	Void Depth (ft):	N/A
Notes:	Soft material from 0 to 0.1 feet.

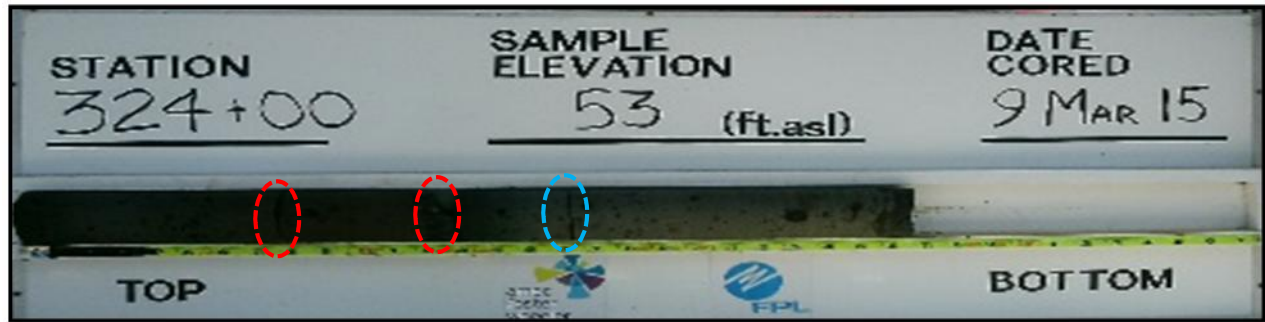
Location: STA 324+00

Core ID:	324+00 (bottom)	Date Cored:	3/9/15
Core Elevation:	53' ASL	Date Photographed:	3/9/15
Recovered Length (ft):	2.6	SC Thickness (ft):	2.6
RQD (%):	100	Void Depth (ft):	N/A
Notes:

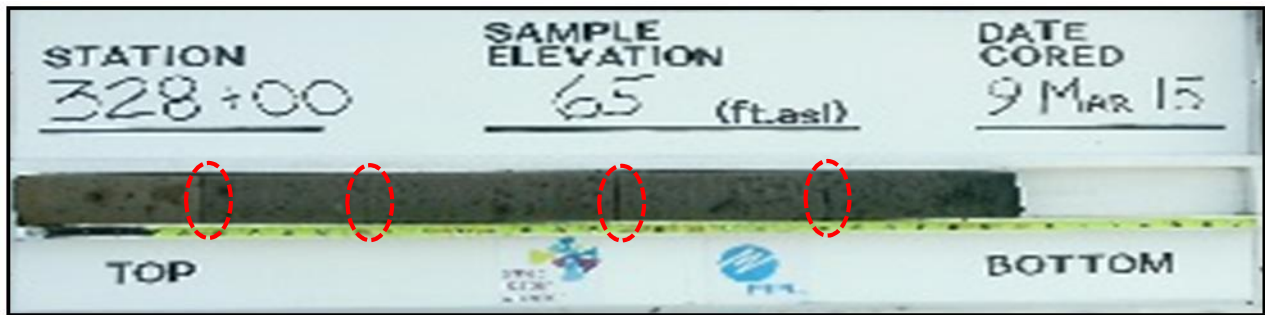
Location: STA 328+00

Core ID:	328+00 (top)	Date Cored:	3/9/15
Core Elevation:	65' ASL	Date Photographed:	3/9/15
Recovered Length (ft):	2.98	SC Thickness (ft):	2.98
RQD (%):	100	Void Depth (ft):	N/A
Notes:

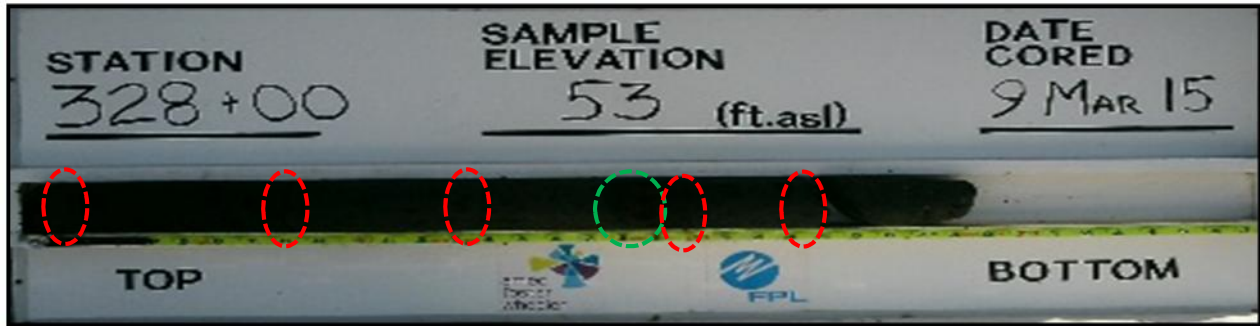
Location: STA 328+00

Core ID:	328+00 (bottom)	Date Cored:	3/9/15
Core Elevation:	53' ASL	Date Photographed:	3/9/15
Recovered Length (ft):	2.8	SC Thickness (ft):	3.165
RQD (%):	79	Void Depth (ft):	N/A
Notes:	Piece of wood embedded from 1.77 to 1.95 feet.

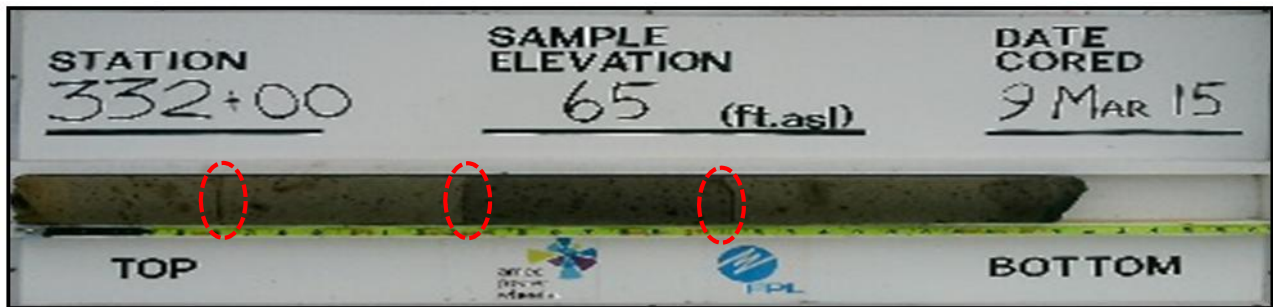
Location: STA 332+00

Core ID:	332+00 (top)	Date Cored:	3/9/15
Core Elevation:	65' ASL	Date Photographed:	3/9/15
Recovered Length (ft):	3.05	SC Thickness (ft):	3.05
RQD (%):	100	Void Depth (ft):	N/A
Notes:

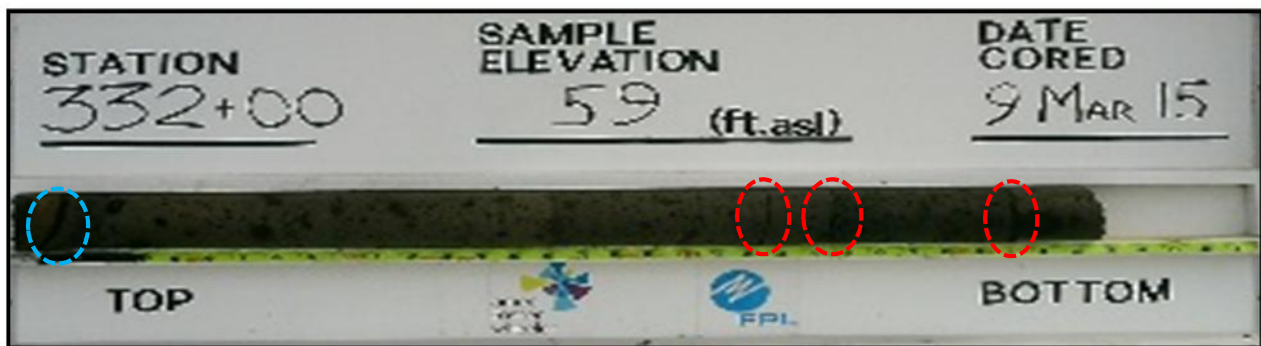
Location: STA 332+00

Core ID:	332+00 (middle)	Date Cored:	3/9/15
Core Elevation:	59' ASL	Date Photographed:	3/9/15
Recovered Length (ft):	3.25	SC Thickness (ft):	3.25
RQD (%):	93	Void Depth (ft):	N/A
Notes:

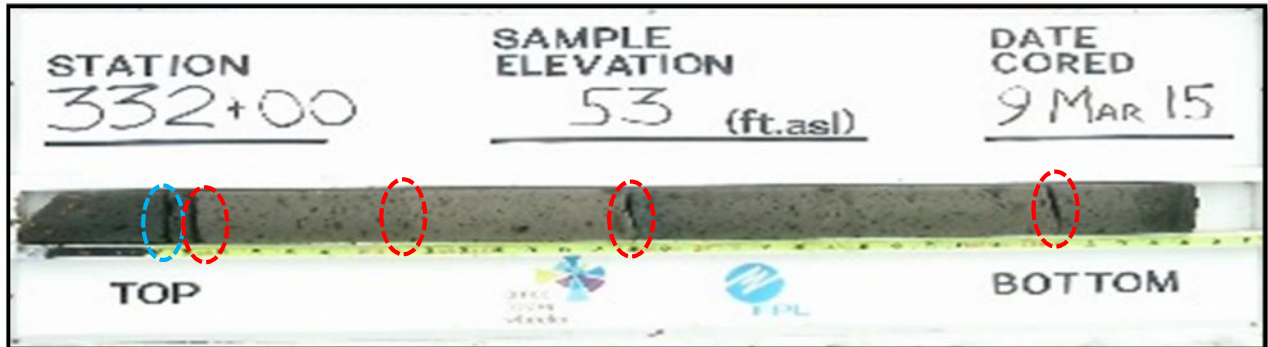
Location: STA 332+00

Core ID:	332+00 (bottom)	Date Cored:	3/9/15
Core Elevation:	53' ASL	Date Photographed:	3/9/15
Recovered Length (ft):	3.5	SC Thickness (ft):	3.5
RQD (%):	100	Void Depth (ft):	N/A
Notes:

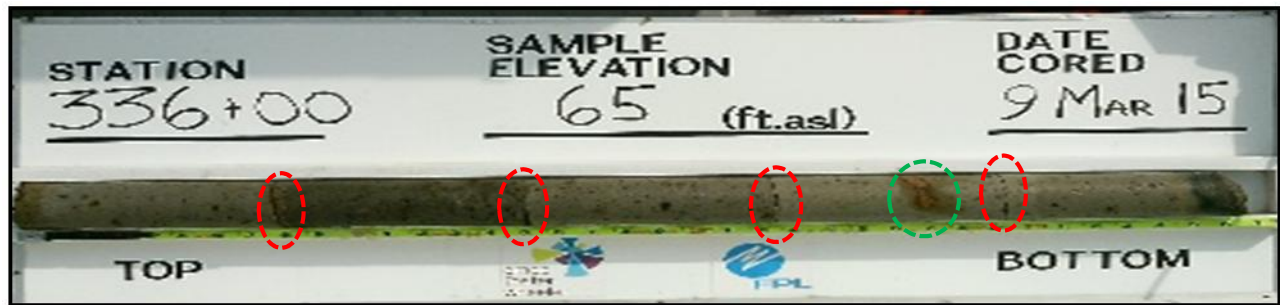
Location: STA 336+00

Core ID:	336+00 (top)	Date Cored:	3/9/15
Core Elevation:	65' ASL	Date Photographed:	3/9/15
Recovered Length (ft):	3.6	SC Thickness (ft):	3.6
RQD (%):	100	Void Depth (ft):	N/A
Notes:

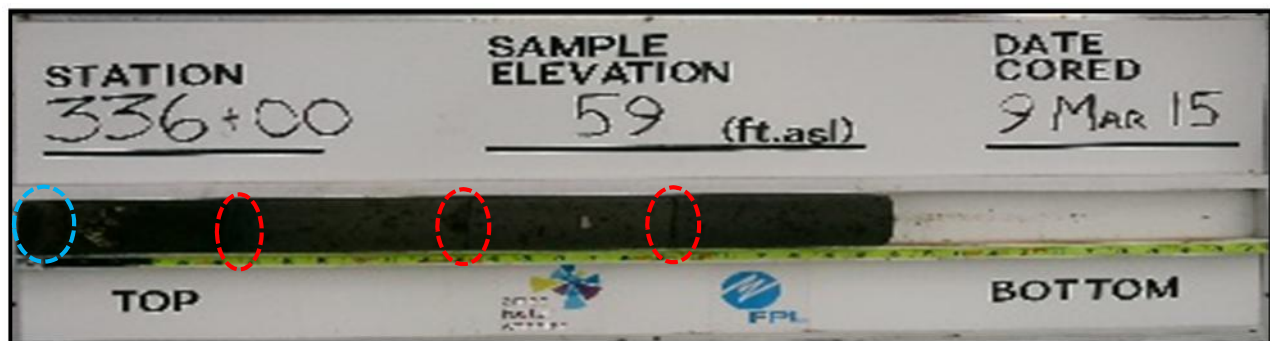
Location: STA 336+00

Core ID:	336+00 (middle)	Date Cored:	3/9/15
Core Elevation:	59' ASL	Date Photographed:	3/9/15
Recovered Length (ft):	2.55	SC Thickness (ft):	3.33
RQD (%):	75	Void Depth (ft):	N/A
Notes:

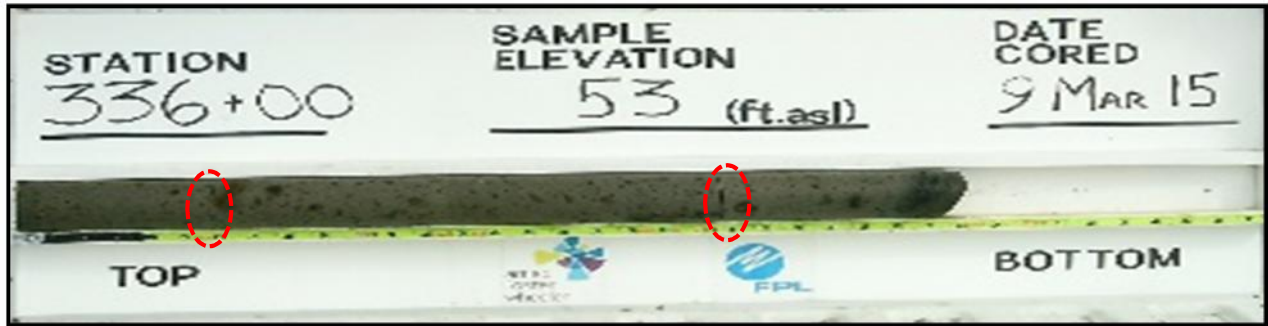
Location: STA 336+00

Core ID:	334+00 (bottom)	Date Cored:	3/9/15
Core Elevation:	53' ASL	Date Photographed:	3/9/15
Recovered Length (ft):	2.7	SC Thickness (ft):	3.0
RQD (%):	100	Void Depth (ft):	N/A
Notes:

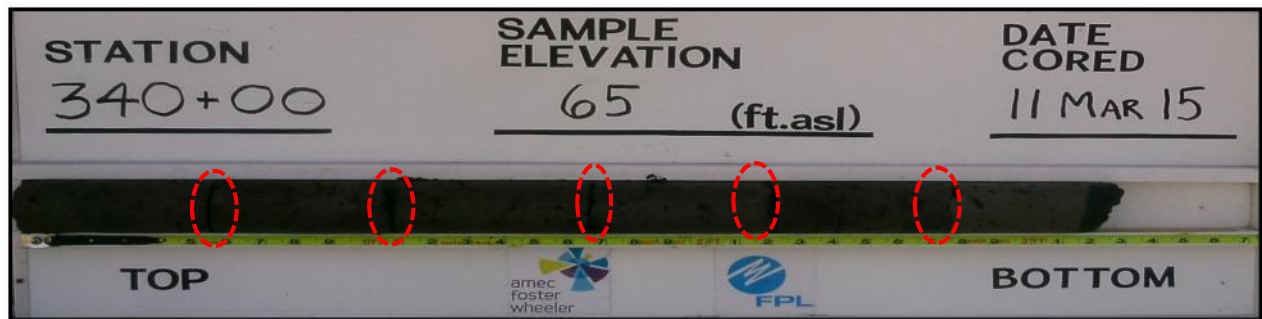
Location: STA 340+00

Core ID:	340+00 (top)	Date Cored:	3/11/15
Core Elevation:	65' ASL	Date Photographed:	3/11/15
Recovered Length (ft):	3.15	SC Thickness (ft):	3.15
RQD (%):	100	Void Depth (ft):	N/A
Notes:

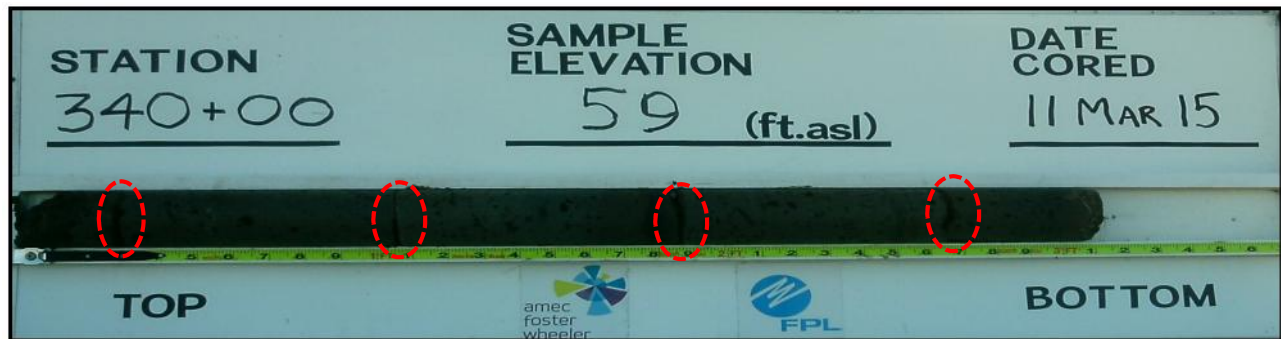
Location: STA 340+00

Core ID:	340+00 (middle)	Date Cored:	3/11/15
Core Elevation:	59' ASL	Date Photographed:	3/11/15
Recovered Length (ft):	3.07	SC Thickness (ft):	3.3
RQD (%):	99	Void Depth (ft):	N/A
Notes:

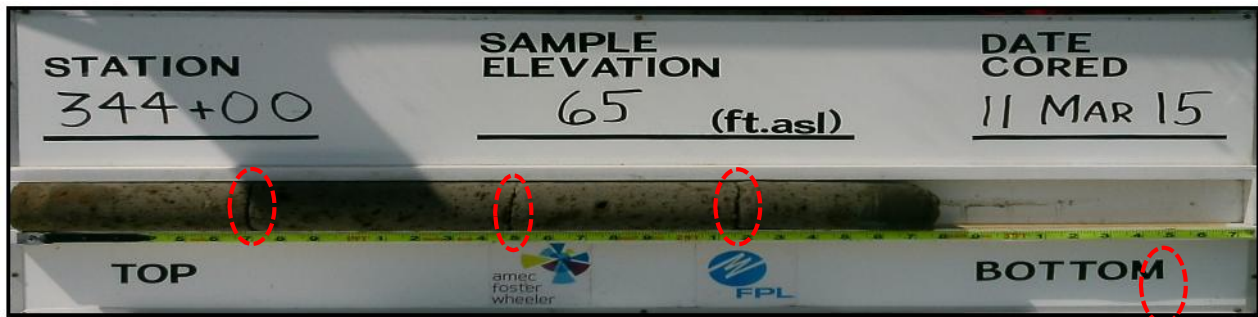
Location: STA 344+00

Core ID:	344+00 (top)	Date Cored:	3/11/15
Core Elevation:	65' ASL	Date Photographed:	3/11/15
Recovered Length (ft):	2.7	SC Thickness (ft):	2.7
RQD (%):	100	Void Depth (ft):	N/A
Notes:

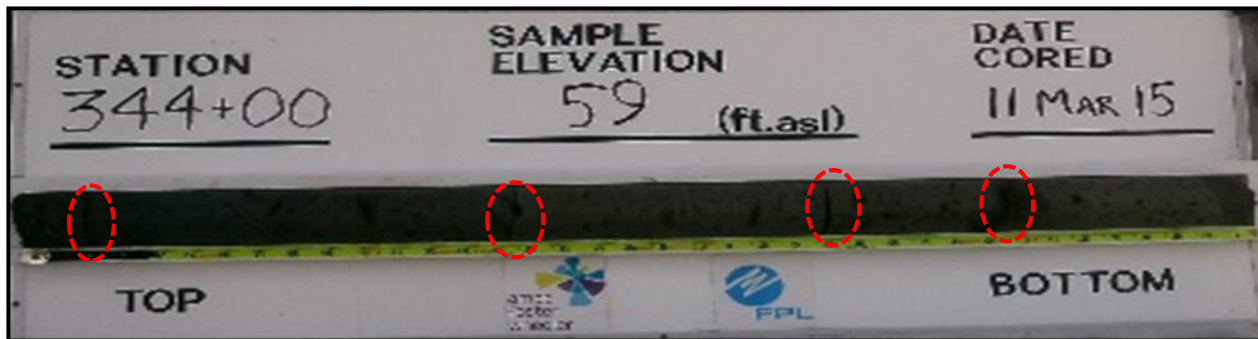
Location: STA 342+00

Core ID:	344+00 (middle)	Date Cored:	3/11/15
Core Elevation:	59' ASL	Date Photographed:	3/11/15
Recovered Length (ft):	3.7	SC Thickness (ft):	3.7
RQD (%):	95	Void Depth (ft):	N/A
Notes:	Soft material from 0 to 0.2 feet.

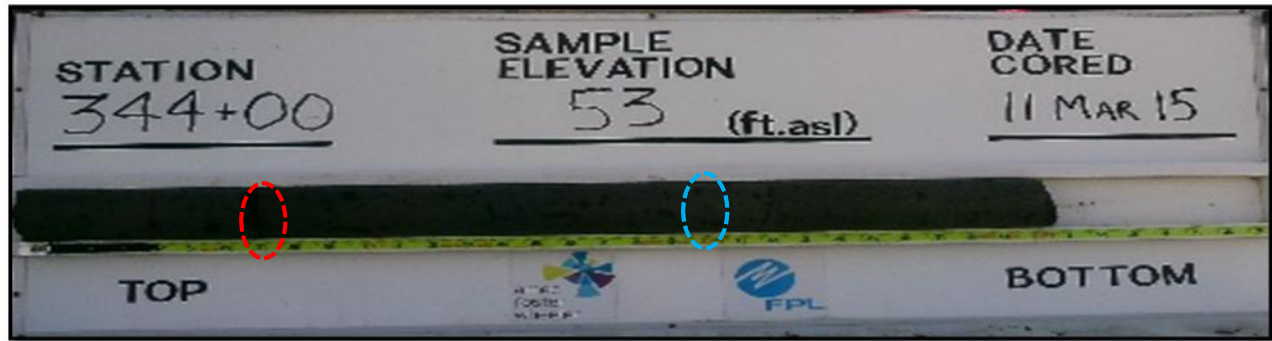
Location: STA 344+00

Core ID:	344+00 (bottom)	Date Cored:	3/11/15
Core Elevation:	53' ASL	Date Photographed:	3/11/15
Recovered Length (ft):	3.03	SC Thickness (ft):	3.5
RQD (%):	100	Void Depth (ft):	N/A
Notes:

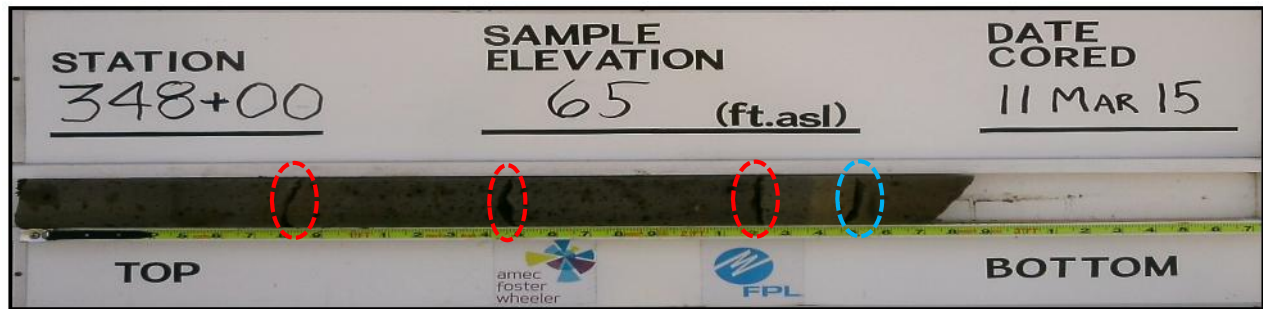
Location: STA 348+00

Core ID:	348+00 (top)	Date Cored:	3/11/15
Core Elevation:	65' ASL	Date Photographed:	3/11/15
Recovered Length (ft):	2.7	SC Thickness (ft):	2.75
RQD (%):	91	Void Depth (ft):	N/A
Notes:

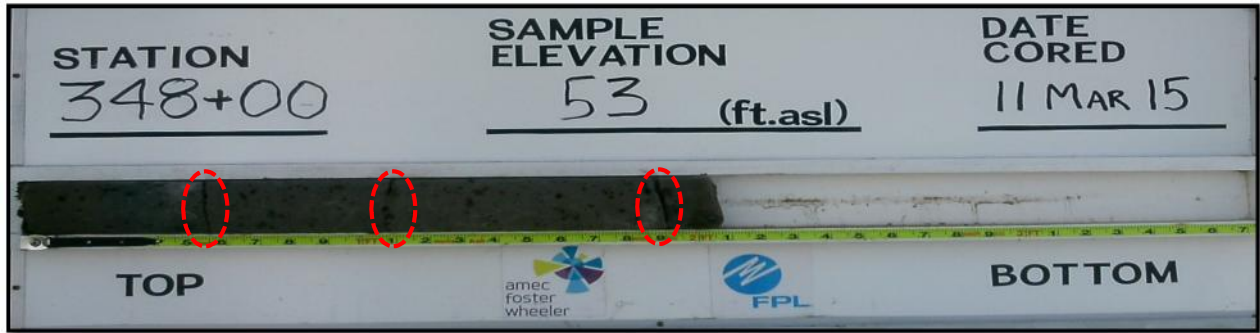
Location: STA 348+00

Core ID:	348+00 (bottom)	Date Cored:	3/11/15
Core Elevation:	53' ASL	Date Photographed:	3/11/15
Recovered Length (ft):	2.05	SC Thickness (ft):	2.05
RQD (%):	93	Void Depth (ft):	N/A
Notes:

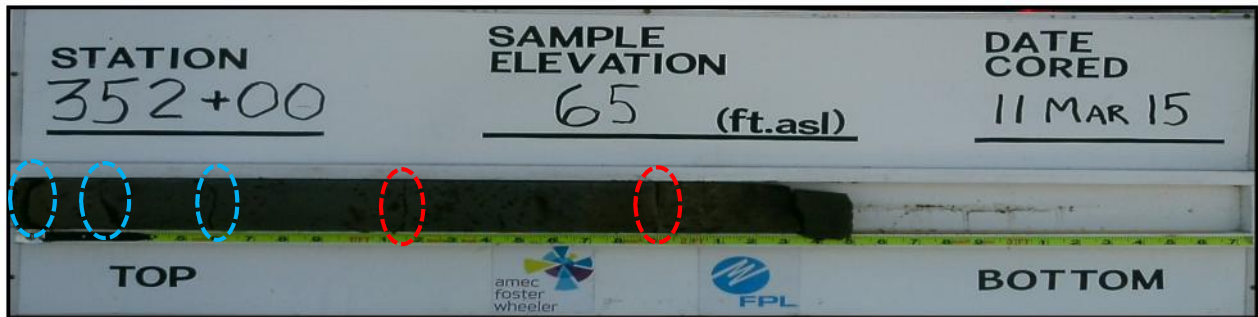
Location: STA 352+00

Core ID:	352+00 (top)	Date Cored:	3/11/15
Core Elevation:	65' ASL	Date Photographed:	3/11/15
Recovered Length (ft):	2.45	SC Thickness (ft):	2.67
RQD (%):	61	Void Depth (ft):	N/A
Notes:	Soft material from 0 to 0.1 feet. Fractured pieces from 1.9 to 2.45 feet.

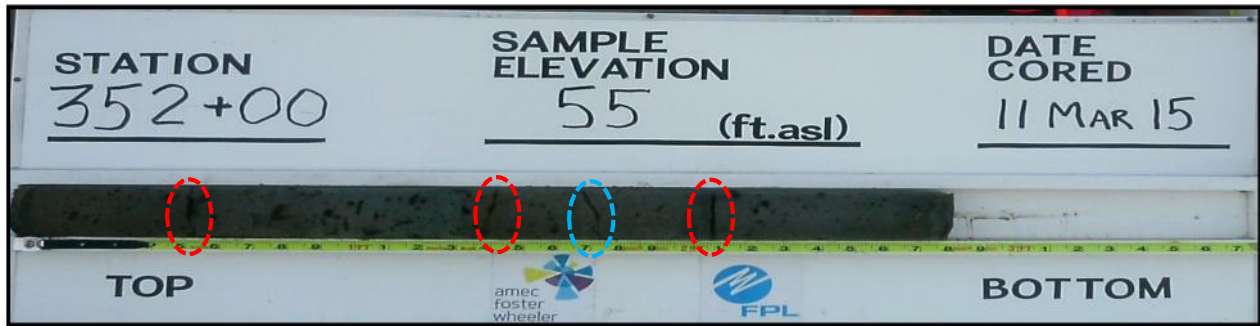
Location: STA 352+00

Core ID:	352+00 (bottom)	Date Cored:	3/11/15
Core Elevation:	55' ASL	Date Photographed:	3/11/15
Recovered Length (ft):	2.77	SC Thickness (ft):	3.16
RQD (%):	100	Void Depth (ft):	N/A
Notes:
